VAN'S AIRCRAFT

NOTIFICATION 16-10-14

Subject: RV-12 Revised Step Installation

Affected Models: RV-12

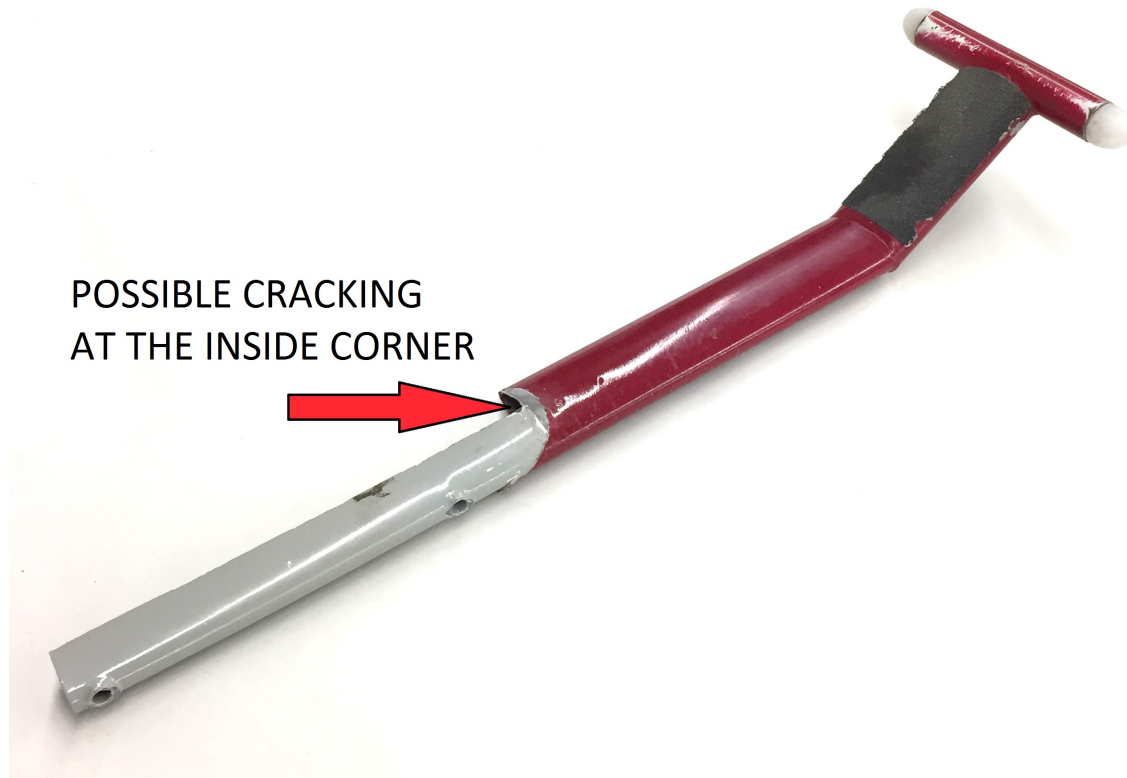
Some RV-12 steps have failed due to high impact loads fatiguing the step over time. A redesigned step is now available that will withstand much higher loading.

FIGURE 1: Location of possible cracking.

Required Action: Replace the WD-1233-L/R steps with WD-1233-L/R-1 if cracking is found at the location specified in Figure 1.
