# VAN'S AIRCRAFT, INC.

## SERVICE BULLETIN

Subject: Electric flap bearing retention

Applies: RV-4, RV-6/6A, RV-7/7A, RV-8/8A, RV-9/9A

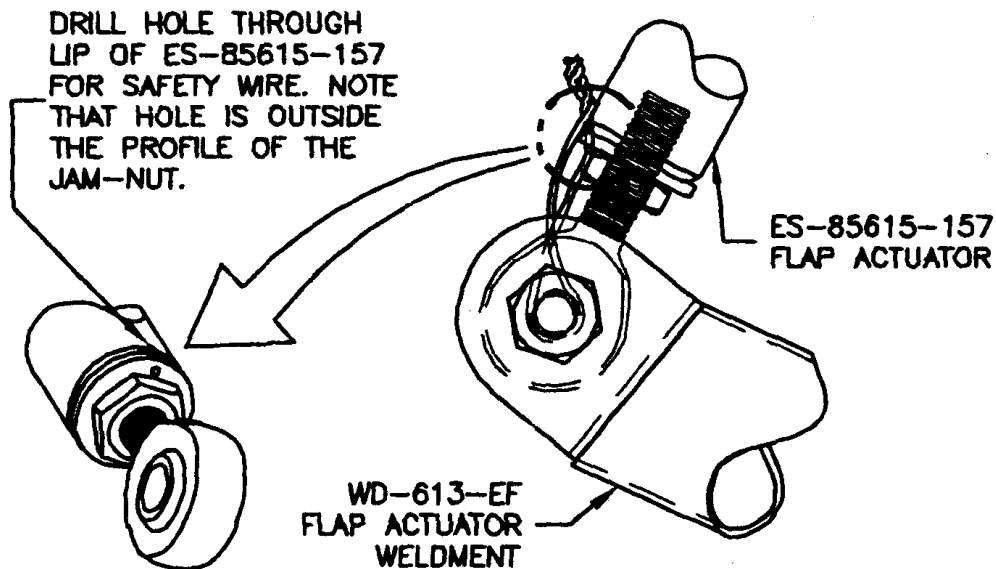
FLAP ACTUATOR SAFETY WIRE DETAIL

*Synopsis:* If the rod end bearing on the flap motor jackscrew is not secured, the rotation of the jackscrews may cause the bearing to unscrew and separate. This will render the flaps inoperative.

*Action:* A jam nut is provided and, properly installed and tightened, will secure the rod end bearing to the shaft of the jackscrew. As an extra precaution, Van's Aircraft, Inc. recommends drilling the end of the shaft and securing the connection with safety wire as shown in the accompanying illustration.
