# TOTAL PERFORMANCE VAN'S AIRCRAFT

## SERVICE BULLETIN 14-08-29

**Date Released:** August 29, 2014  
**Date Effective:** August 29, 2014  
**Subject:** RV-10 engine mount elastomer plate cracking.  
**Affected Models:** All RV-10 aircraft.

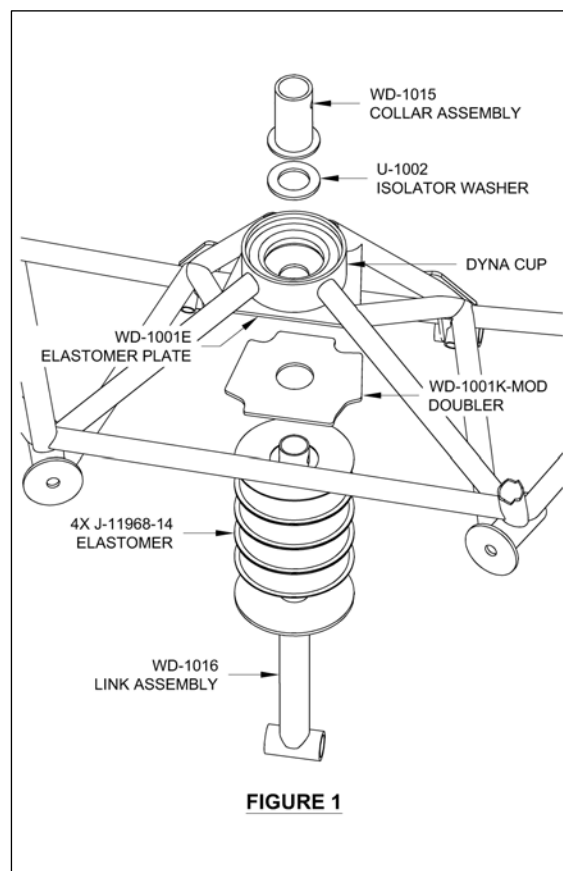
Cracks have been discovered in the elastomer plate of some RV-10 engine mounts. To date, all incidents of cracking have occurred on aircraft operating on rough fields.

**Step 1:** Obtain a WD-1001K-MOD Doubler from Van's Aircraft. See Figure 1.

**Step 2:** Place the WD-1001K-MOD Doubler on the bottom face of the WD-1001E Elastomer Plate with the four edges aligned. See Figure 1. The doubler is not symmetrical and might have to be flipped over to be correctly positioned. When it is correctly positioned, all four edges will be aligned and the center hole will be concentric with the hole in the elastomer plate.

**Step 3:** If there is any interference with the corner welds and the doubler that prevents the doubler edges from contacting the elastomer plate, grind or file the doubler to remove the interference.

**Step 4:** Paint the doubler and allow it to dry.
