# VAN'S AIRCRAFT

### SERVICE BULLETIN 18-03-30

**Subject:** Elevator stop inspection

**Affected Models:** RV-10 aircraft with empennage kits purchased after April 2012

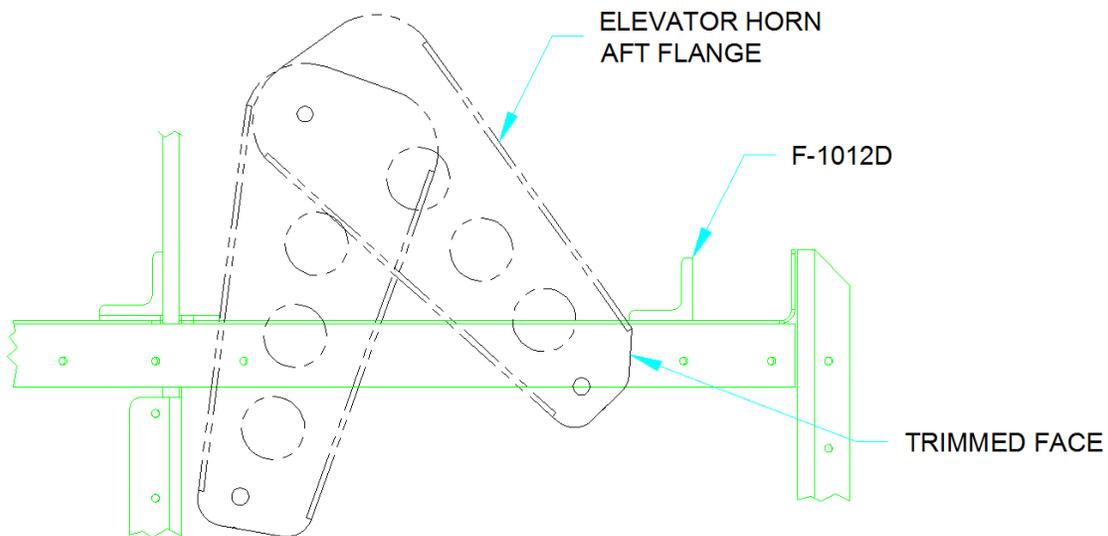
**FIGURE 1: NORMAL CONTROL STOP OPERATION**

Step 2: Inspect the pitch control system for proper contact of elevator control horn aft flange against the F-1012D Up Elevator Stop as shown in Figure 1. An improper installation in which the flange does not make contact is shown in Figure 2. If your aircraft matches Figure 1 proceed to the last step of this service bulletin. If your aircraft matches Figure 2 proceed to the next step.

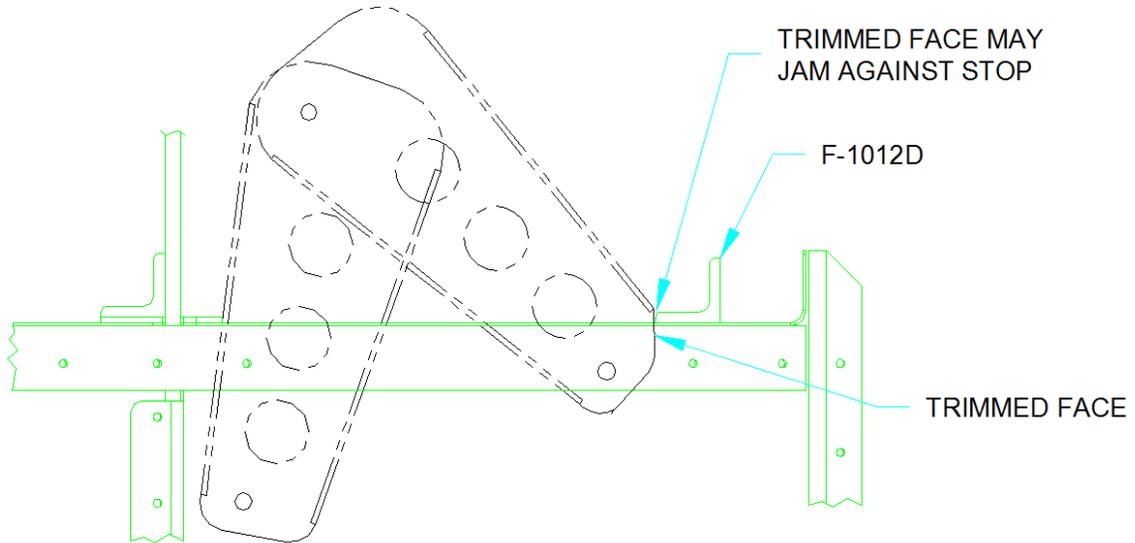
**FIGURE 2: ABNORMAL CONTROL STOP OPERATION**

In April 2012 the lower aft portion of the elevator horn was removed. See the trimmed face called out in Figure 1. This portion of the horn typically needs to be removed for use on most RV aircraft. The RV-10 does not require this trim. It has come to our attention that due to production tolerances it would be possible for the horn to jam against the up elevator control stop. This condition would also permit excessive elevator up travel. If either of these problems exist, the aft stop F-1012D Up Elevator Stop should be replaced.

Step 3: Remove the F-1012D Up Elevator Stop. See RV-10 Page 10-13.

**Step 5:** Install the new F-1012D Up Elevator Stop as shown on RV-10 Page 10-13, 10-21 and 10-22. Adjust the control stop as shown on RV-10 Page 11-06 to permit the correct amount of elevator travel. It is permissible to use a spacer underneath F-1012D if necessary.
