VAN'S AIRCRAFT

NOTIFICATION 18-07-12

Subject: Change to higher pressure rating aux. fuel pump

Affected Models: RV-12 or RV-12iS aircraft equipped with a Rotax 912 ULS

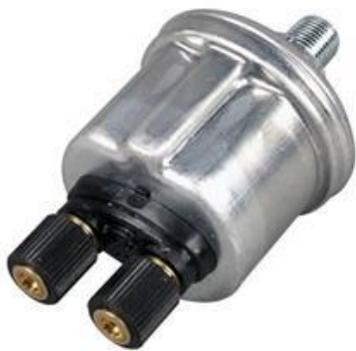
VDO Sensor

Step 2: Some older RV-12's were equipped with a VDO type fuel pressure sensor. If you have not done so already, and have pressure issues, replace the VDO sensor with a Kavlico 1/8-27 NPT, 15 PSI P4055-15G-E4A sensor. See the latest revision of KAI Section 45A and 46 available on the RV-12 Service Information Page.
