SAFETY ALERT RV-12 (3-17-11)

Subject: WD-1215-L-PC and WD-1215-R-PC incomplete welds

Affected Models: RV-12 only (Finish Kit or later)

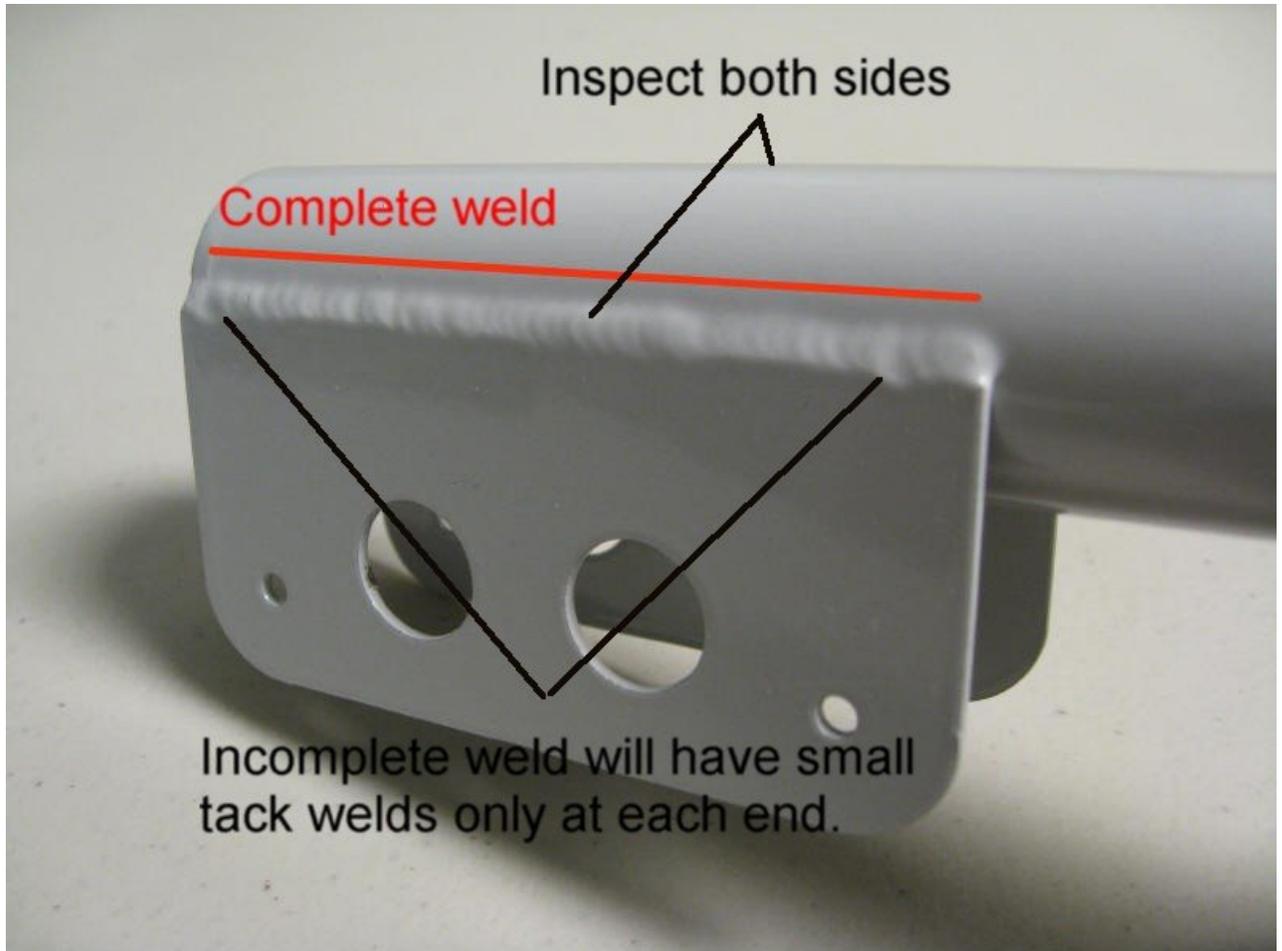
Two reports from the field have been received of incomplete welds on WD-1215 Flaperon Torque Arms.

1. If Torque Arms are not installed, visually inspect them for complete welds in the area indicated in the photo below.
2. If Torque Arms are installed on the aircraft and the fuel tank is not installed, remove the F-1206E Baggage Cover and inspect the Torque Arms for complete welds in the area indicated in the photo below.
3. If Torque Arms are installed and the fuel tank is installed, accomplish the inspection by either of the following methods:
 - a. Remove the fuel tank and inspect the Torque Arms as described in method #2 above or...

If a WD-1215 is found with an incomplete weld, contact Van's Aircraft for a replacement component.
