## **NOTIFICATION 14-05-14**

**Subject:** Minor cracks in HS-1204 Fwd Inbd Rib

Affected Models: All RV-12 SLSA and ELSA flying aircraft or kits under

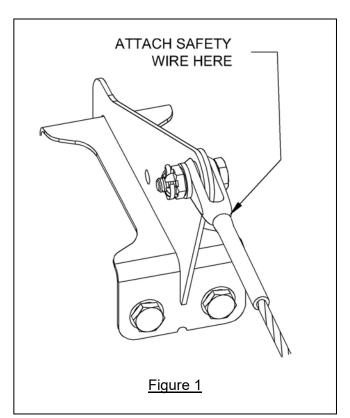
<u>Step 2:</u> Wrap safety wire securely around the swaged barrels of the F-1247B Aft Stabilator Cable clevis ends where indicated in Figure 1. Route the safety wire downward and tie it to the tie-down ring. Place a small block of wood between the wire and the bulkhead to protect the edge of the skin.

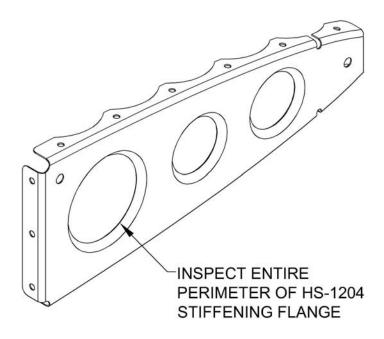
Figure 2

A small number of unassembled ribs were found to have minor cracks in the stiffening flange of the aft lightening hole. While crack propagation is not likely, it is recommended that any detected cracks be dressed.

Step 10: Inspect the four inboard-most HS-1204 Fwd Inbd Ribs for cracks in the stiffening flange of the aft lightening hole as shown in Figure 2.

Step 12: If cracks are found contact Van's Aircraft technical support for further instructions and information.

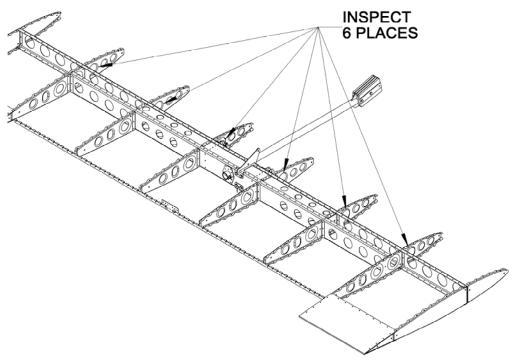
Figure 3: Ribs to be Inspected

Step 11: The two outboard HS-1204 Fwd Inbd Ribs can be inspected by looking through the aft tooling hole in the HS-1205 Fwd Outbd Rib while shining a bright light through the forward tooling hole on the same rib.

See Figure 3 for the positions of the ribs specified in this notification.
