TOTAL PERFORMANCE VAN'S AIRCRAFT

NOTIFICATION 14-06-30

Subject: VA-215 Oil Return Hose Re-Route

Affected Models: RV-12

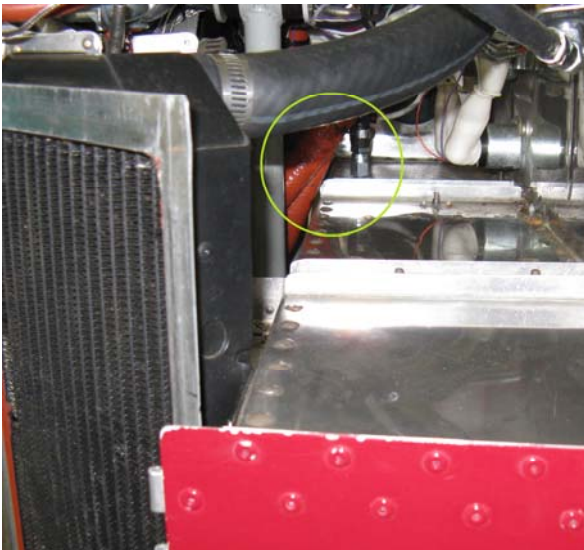
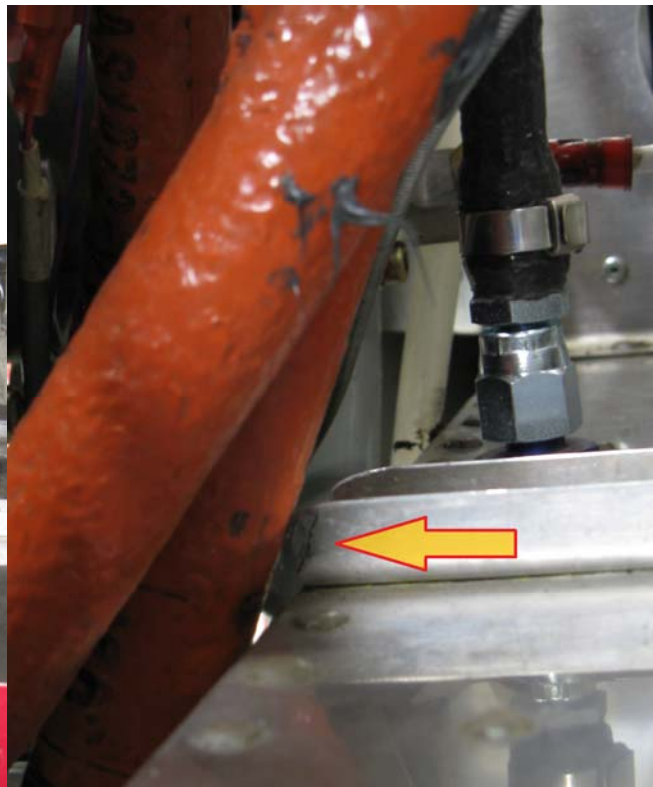
FIGURE 1: POSSIBLE OIL LINE INTERFERENCE

Routing of the oil supply return hoses has been improved to decrease the possibility of interference with the F-1257 Rudder Pedal Support Channel or other parts of the firewall. See Figure 1.

Step 2: Inspect the VA-213 Oil Supply Hose and VA-215 Oil Return Hose for interference with the firewall structure (F-1257 Rudder Pedal Channel or corner edge of the shelf) and possible damage. See Figure 1. If only the fire sleeve has been damaged by the channel the hose assembly may be returned to service by sealing the hole with high temp RTV. If the channel has worn into the oil hose the hose assembly must be replaced.
