## **NOTIFICATION 17-05-19**

Subject: Soft Engine Isolators

Affected Models: RV-12 E-LSA aircraft that received a Powerplant Kit between

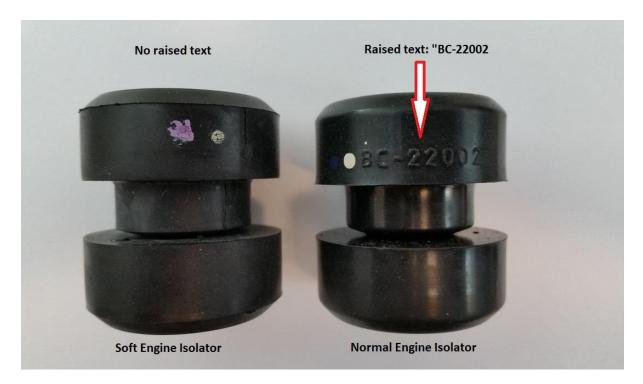
**FIGURE 1:** ENGINE ISOLATOR IDENTIFICATION

Soft engine mount isolators were supplied that allow greater than normal engine movement.

If the isolator has the text "BC-22002" as shown in the figure below on at least one half of the isolator the correct isolators are installed. Make a logbook entry noting compliance with this notification and place a copy of this notification in the back of the Maintenance Manual.

If the isolator has no text as shown in the figure below contact Van's Aircraft for a replacement engine isolator set. Replace the isolators using KAI Section 46 as reference. Make a logbook entry noting compliance with this notification and place a copy of this notification in the back of the Maintenance Manual.

Replacement parts if applicable Qty 4... EA 22002-15 (isolator) Qty 4... MS24665-283 (cotter pin)
