VAN'S AIRCRAFT, INC.

This service letter details inspection of RV-12 aft fuselage bulkheads for minor cracking. Only RV-12 Emp/Cone Kits shipped prior to December 4, 2008 are affected by this Service Letter.

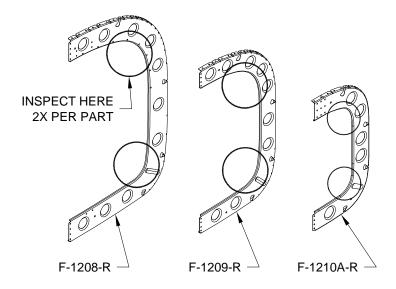
FIGURE 1: INSPECTION AREA

<u>Step 1</u>: Inspect the circled regions for cracks in the 3/16 in. interior flanges of the parts depicted in Figure 1. Also inspect the left-handed parts; F-1208-L, F-1209-L, F-1210A-L (not shown).

(ALSO APPLIES TO F-1208-L, F-1209-L, F-1210A-L)

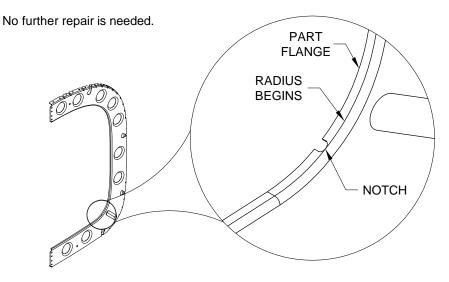
FIGURE 2: CRACK REMOVAL

If cracks are found that do not extend into the radius of the flange they should be removed using the following method.

<u>Step 2</u>: Notch the flange just enough to remove the crack. This may be accomplished using a round file or a notching tool if available. See Figure 2.

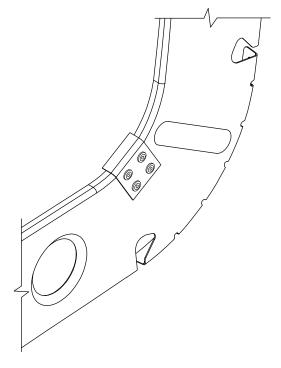
FIGURE 5: COMPLETED REPAIR

A part with a crack that extends into the radius of the flange should be repaired using the following method.
