November 16, 2007

MASTER SWITCH SNAFU

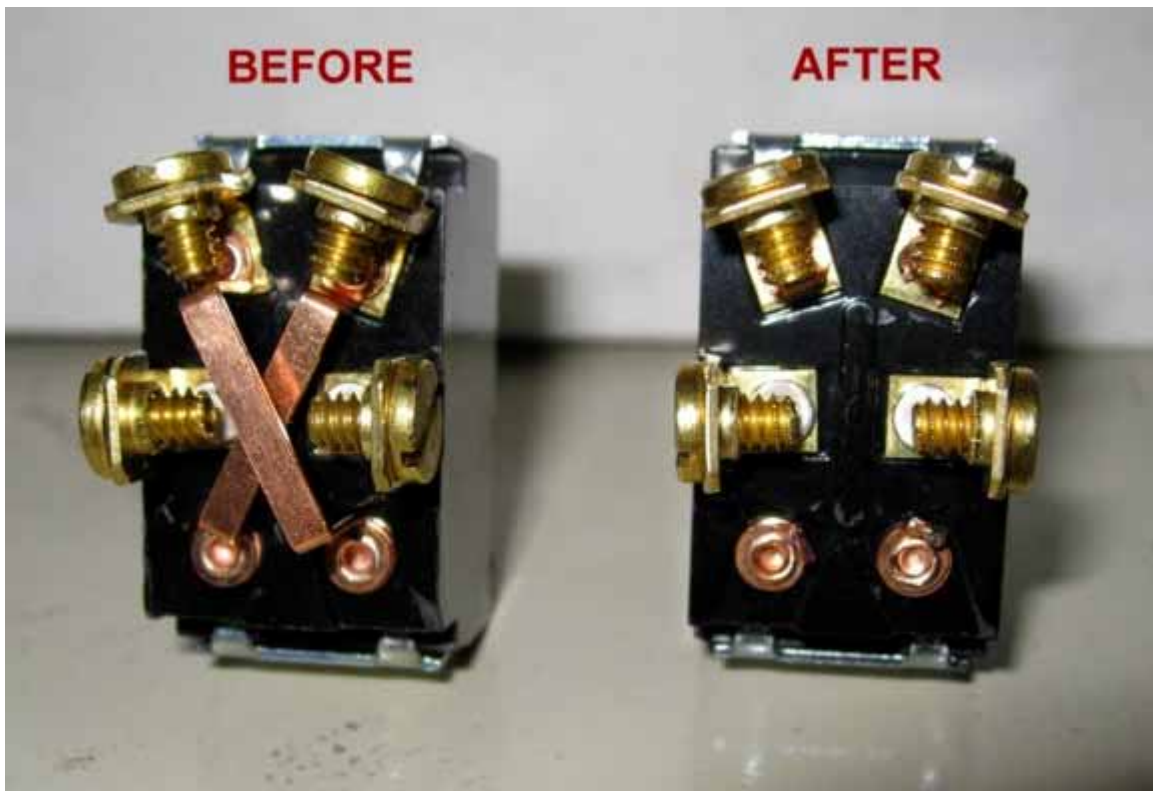
Our supplier of ES 2GK54-73 Master Switches sent us a batch of different switches that will not work as we intended. We received these switches October 2, 2007 and started shipping them shortly thereafter. If you received a switch between October 2 and November 25, 2007, check to be sure you have the correct switch.

The incorrect switch has small copper jumper straps in a “X” pattern on the back. In the correct switch there are no jumper wires. If jumper straps are found, cut them away. The switch will then operate as intended.
