TOTAL PERFORMANCE VAN'S AIRCRAFT

SERVICE BULLETIN 13-08-29

Date Released: August 8, 2013
Date Effective: August 8, 2013
Subject: Nut Retaining Throttle Cable Lead to Throttle Arm
Affected Models: All RV-12 Powerplant Kits and flying RV-12 aircraft
Required Action: Replace Rotax locking nuts with MS21045-3
Time of Compliance: At disassembly of affected hardware or next condition inspection

Supersedes Notice: SB 13-08-08

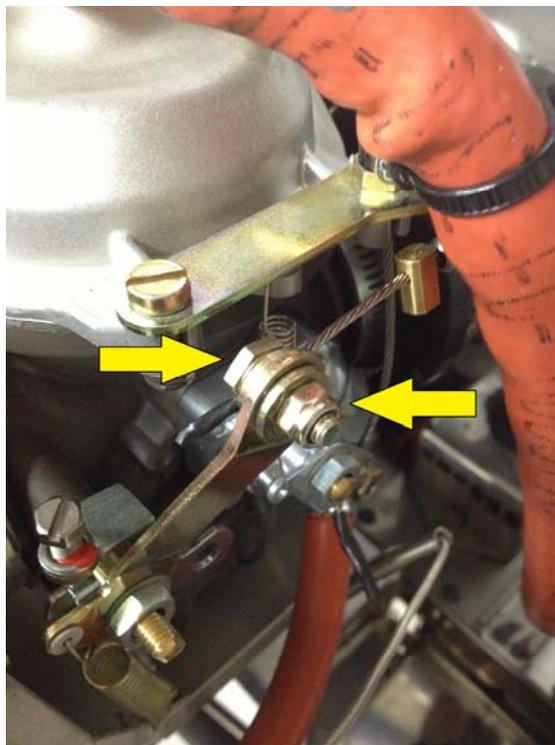
VA-219 bolt supplied uses 10-32 threads while nut specified is metric thread. A nut of compatible thread needs to be used.

Affected throttle cables were supplied with VA-219 bolts (AN3 bolt with a hole drilled in the shank). Check both the left and right throttle installations using the Figure 1 and your copy of Kit Assembly Instructions (KAI), Page 50-05.

FIGURE 1: VA-219 INSTALLED WITH INCORRECT M5 ROTAX NUT

Remove both Rotax M5 nuts.

Inspect the threads of the VA-219 bolts and replace if any damage is present.

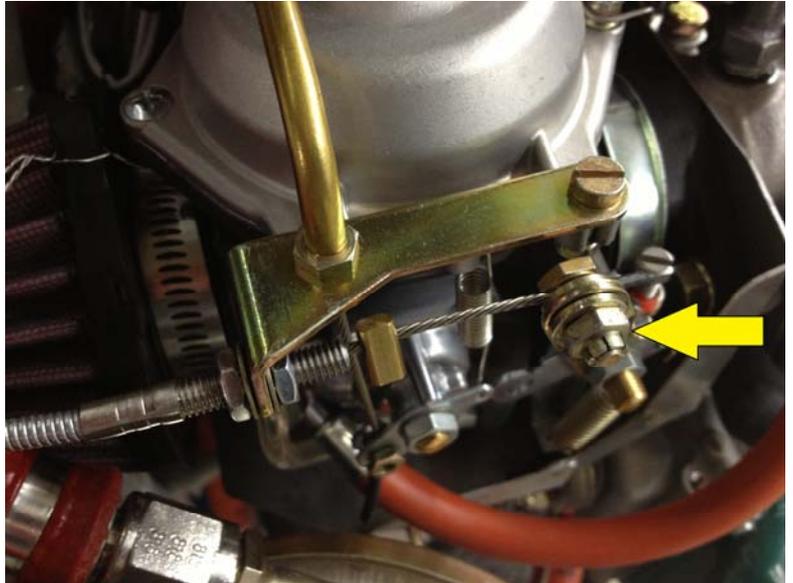
FIGURE 2: MS21045-3 INSTALLED

Replace both M5 nuts with MS21045-3 nuts as shown in Figure 2.
