SERVICE BULLETIN 13-12-12

Subject: Sealing avionics bay to prevent water intrusion.

Affected Models: All RV-12 SLSA aircraft serial numbers up to and including 12012 and Fuselage Kits shipped prior to December 13, 2013.

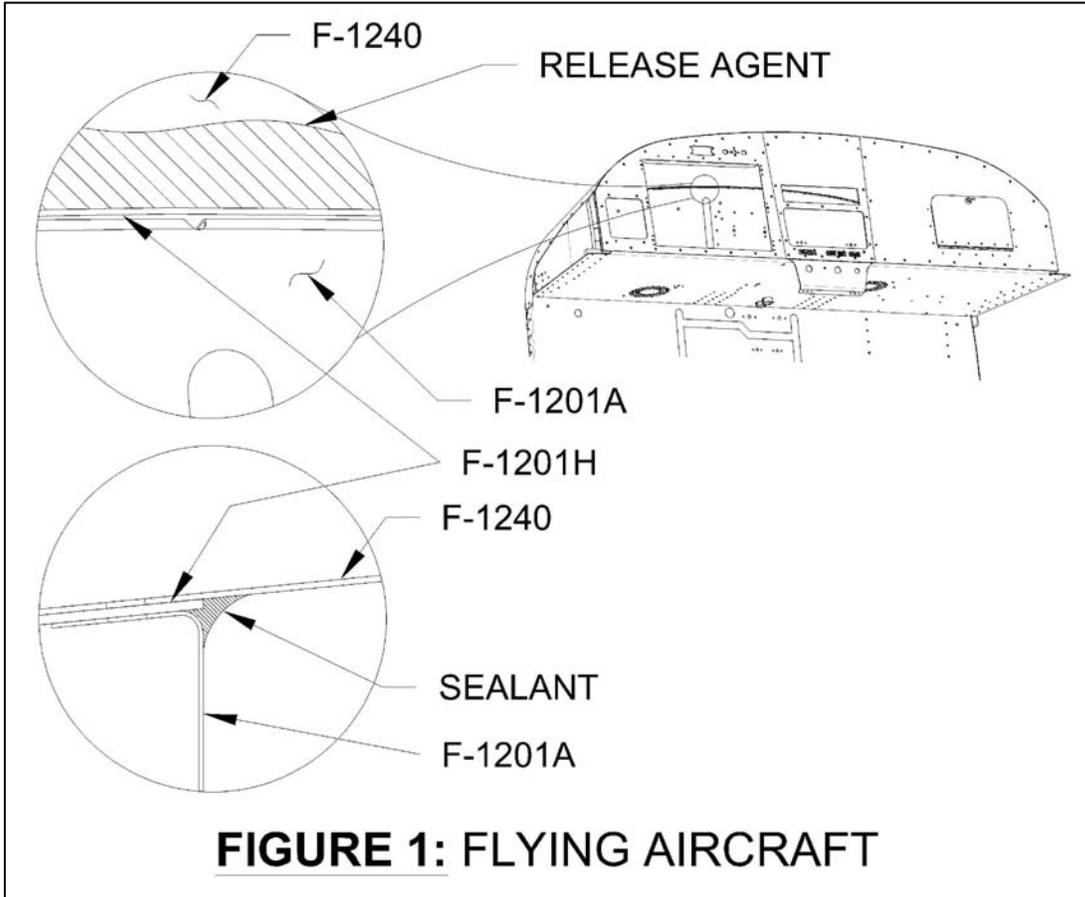
Aircraft in the field experienced electrical failure caused by water entering avionics bay. Without seal, water may infiltrate structure between mating surfaces of F-1240 Upper Forward Fuselage Skin and F-1201H Upper Fwd Fuse Doubler.

Flying aircraft: (see Figure 1)

Step 3. Apply release agent, such as Boelube, to the inner surface of the F-1240 Upper Forward Fuselage Skin. This will allow the skin to be removed later if required.

Step 4. Apply approximately 1/4 in. radius fillet of sealant, such as Permatex 16BR Black Silicone Adhesive Sealant #81158 or equivalent, per manufacturer's instructions to the inside corner formed by the F-1240 Skin and F-1201A Firewall Upper and allow to cure.
