## SERVICE BULLETIN 13-04-05

**Subject:** Oil Tank Mount Brackets

**Affected Models:** All RV-12 Kits and flying RV-12 aircraft incorporating Fuselage kits shipped prior to April 5<sup>th</sup>, 2013.

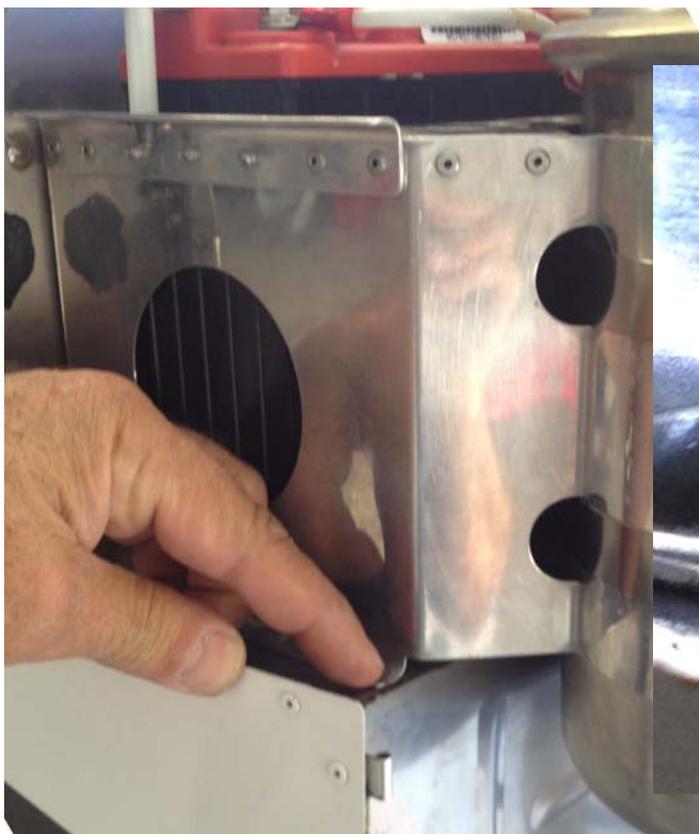
Cracks have been found in the F-1201E-L & -R Oil Tank Side Brackets at the location shown in Figures 1 & 2 below. Installation of an extra F-1201G-MOD Rib is required to prevent cracks in this area.

**FIGURE 1:** Crack Location

**Required Action:** Stop drill or remove cracks. Install a second F-1201G Rib.

If a crack is present and longer than 1/8 inch, stop-drill the crack using a #40 drill bit.

If a crack is present and shorter than 1/8 inch use a round file of at least 1/4 inch in diameter to remove the crack. File past the end of the visible crack an extra 1/16 inch to ensure the end of the crack has been removed.

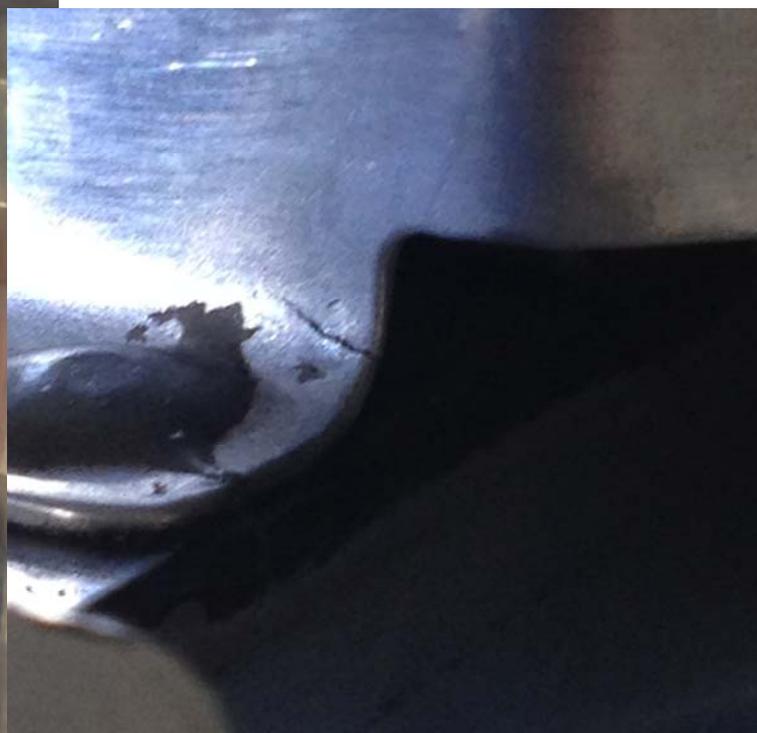
**FIGURE 2:** Typical Crack

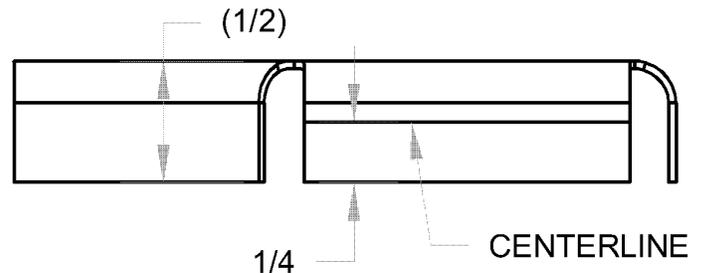
**FIGURE 3:** Typical Centerline

Draw a centerline on the four forward facing rib flanges. See Figure 3.

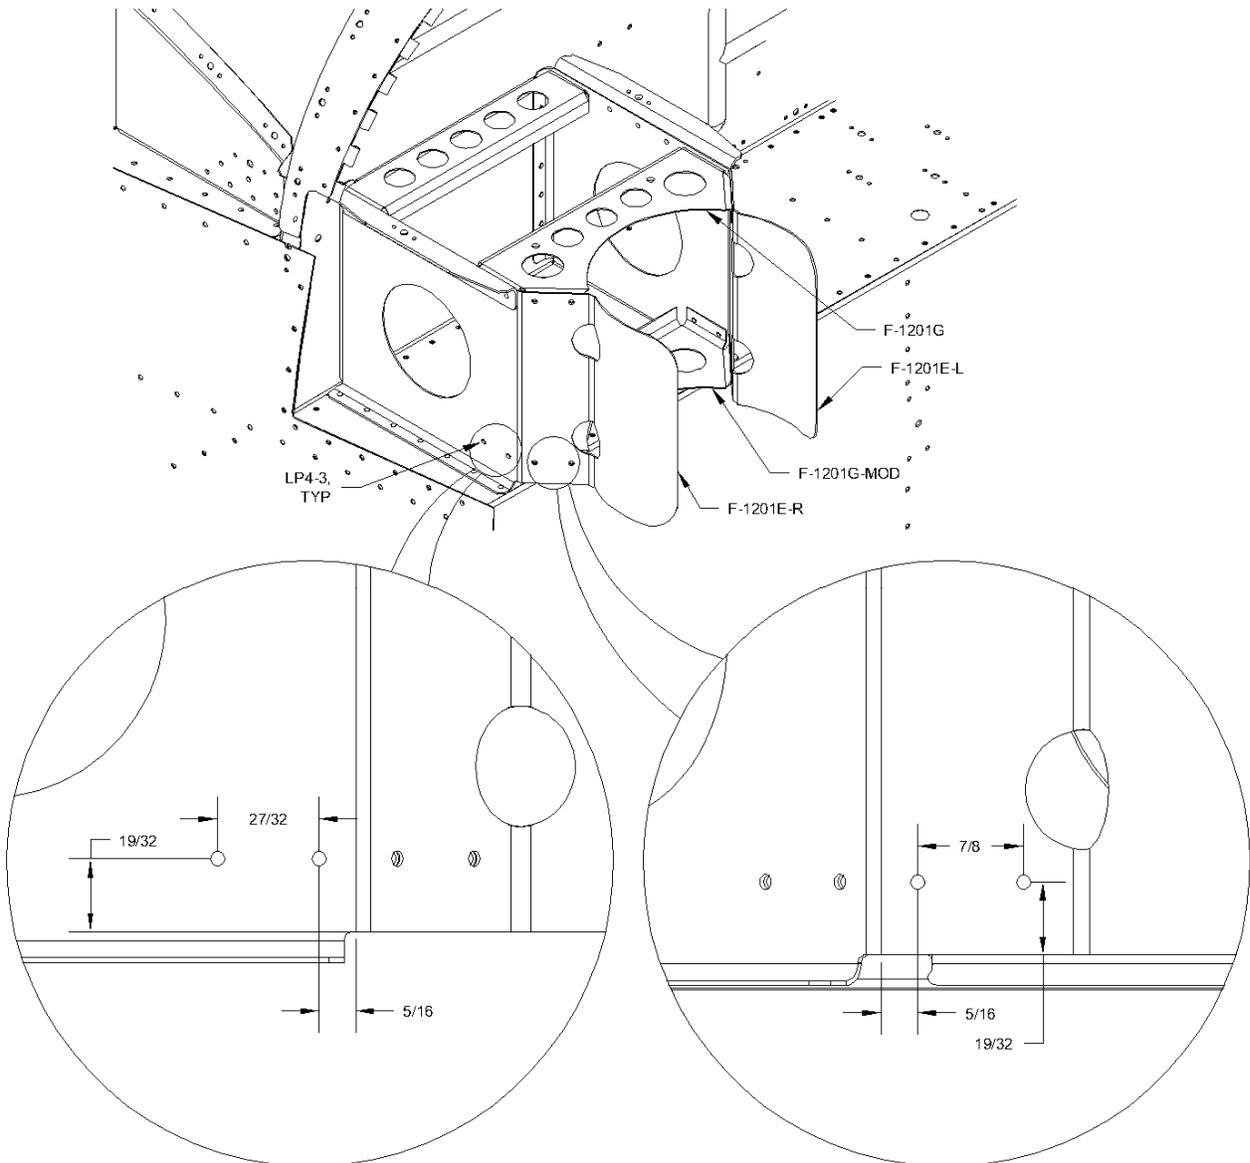
**FIGURE 4:** Rib Installation

Step 6: Using the dimensions in Figure 4 layout then drill #30 the hole pattern shown into the F-1201E-L & -R Brackets.

Orient the rib, flanges facing up as shown in Figure 4 so that the centerlines drawn on the flanges are centered on the holes drilled in the previous step.

Match-Drill #30 the holes in the F-1201E-L & -R into the rib.

Rivet the rib to the brackets using the rivets called out in Figure 4.
