TOTAL PERFORMANCE
VAN'S AIRCRAFT

SERVICE BULLETIN 14-01-31

Subject: Cracking near the bend in horizontal stabilizer front spar.

Affected Models: All RV-6/6A,7/7A,8/8A Flying or under construction

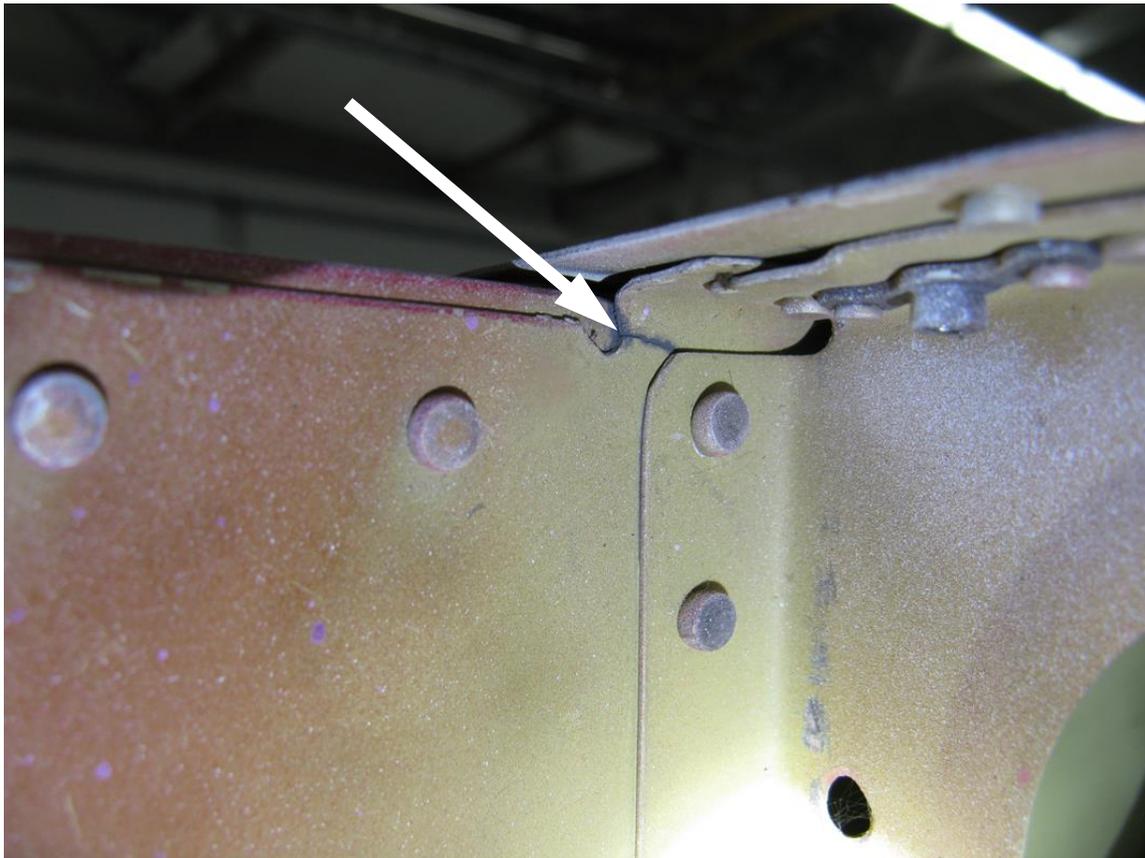
Cracks in the forward spar of the horizontal stabilizer have been found emanating from the stress relief notch at the inboard end of the spar flanges. See Figure 1 and remaining figures in this bulletin.

FIGURE 1: Typical crack in horizontal front spar web emanating from relief notch.

Inspect for cracks as described. If cracks are present, stop drill cracks and install HS-00001 Doubler (RV-6,7) or HS-00003 Doubler (RV-8) and HS-00002 Rib Flange Angle (RV-6,7) or HS-00004 Rib Flange Angle (RV-8) to both sides of the aircraft before further flight.

If cracks are 1/8 inch or shorter use a file to increase the size of the stress relief notch enough to remove the crack. File past the visible end of the crack 1/16 inch. Blend the shape of the filed away area by increasing the overall size of the relief notch.

If cracks are longer than 1/8 inch stop drill the crack using a #40 drill bit and then deburr.

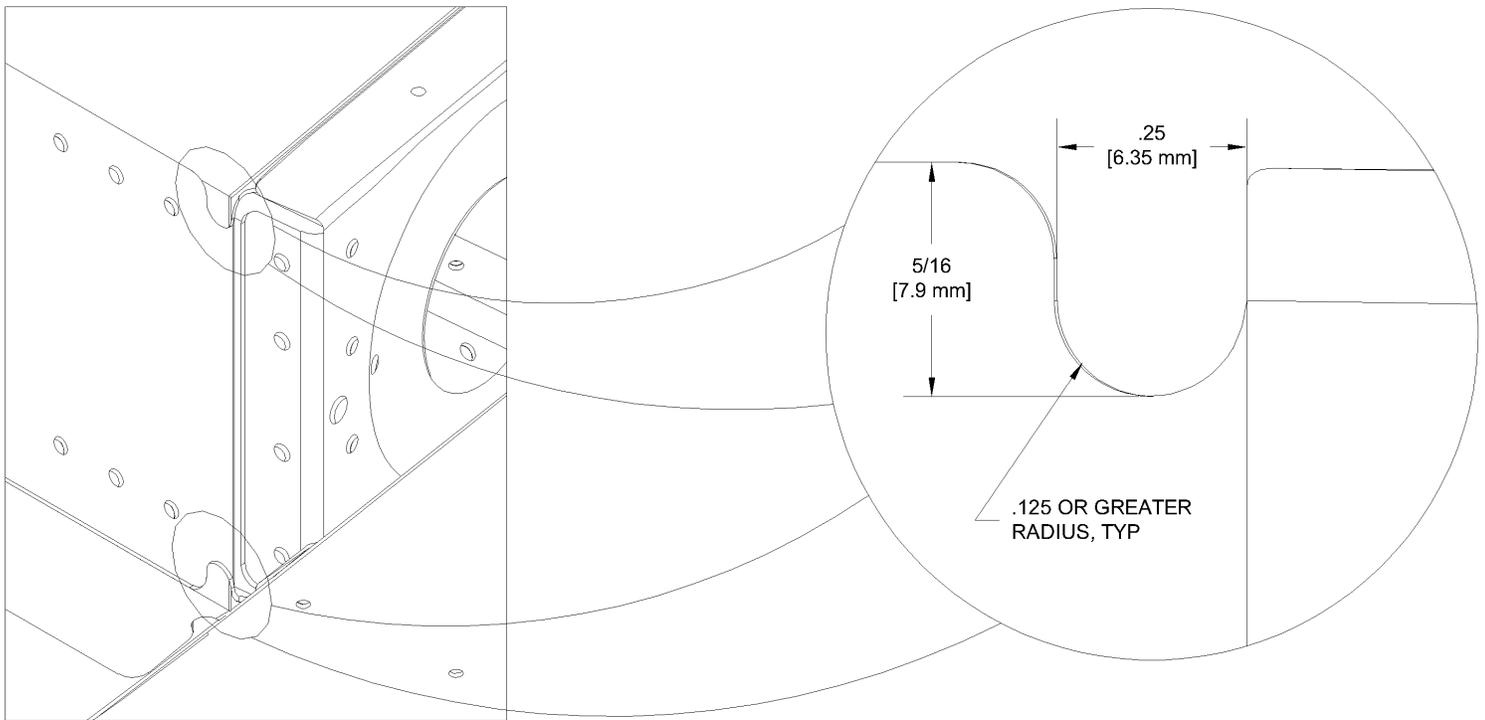
FIGURE 3: RELIEF NOTCHES

Inspection: Remove the Empennage fairing. Carefully inspect for cracks emanating from the stress relief notch at the inboard end of the forward horizontal stabilizer spar flanges. (see Figure 1 and figure 3). Clean the area and remove any paint, overspray or primer that could hide a crack. Cracks may be very small and hard to detect.

Step 8: Inspect the corners at the inboard end of the top and bottom fwd spar flanges on the left and right spar halves for the presence of relief notches as depicted in Figure 3.

If notches are not present, use a round file to add relief notches (first refer to the following step... adding a missing notch may be done in conjunction with removing a crack). This will require trimming the skin slightly as shown in Figure 2 to gain access for the file.

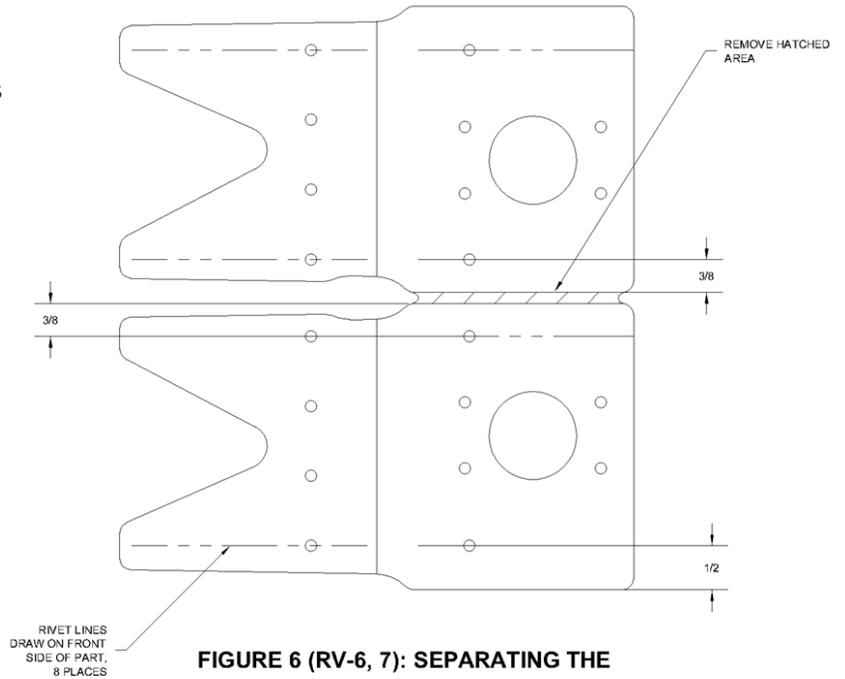
**FIGURE 6 (RV-6, 7): SEPARATING THE
HS-00001 SPAR DOUBLERS
(FRONT VIEW)**

Step 14: Separate the HS-00001 (RV-6,7) or HS-00003 (RV-8) Spar Doublers into left and right parts as shown in Figure 6. Deburr the edges of the doublers.

Step 15: Draw rivet lines on the front side of the doublers as shown in Figure 6. When viewed from the front, the flanges will appear to be bent down.

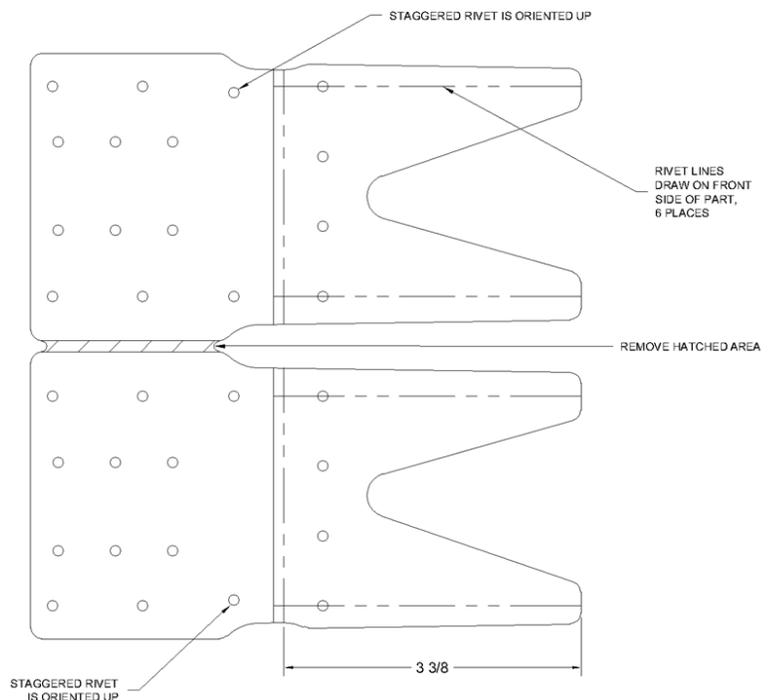
**FIGURE 6 (RV-8): SEPARATING THE
HS-00003 SPAR DOUBLERS
(FRONT VIEW)**

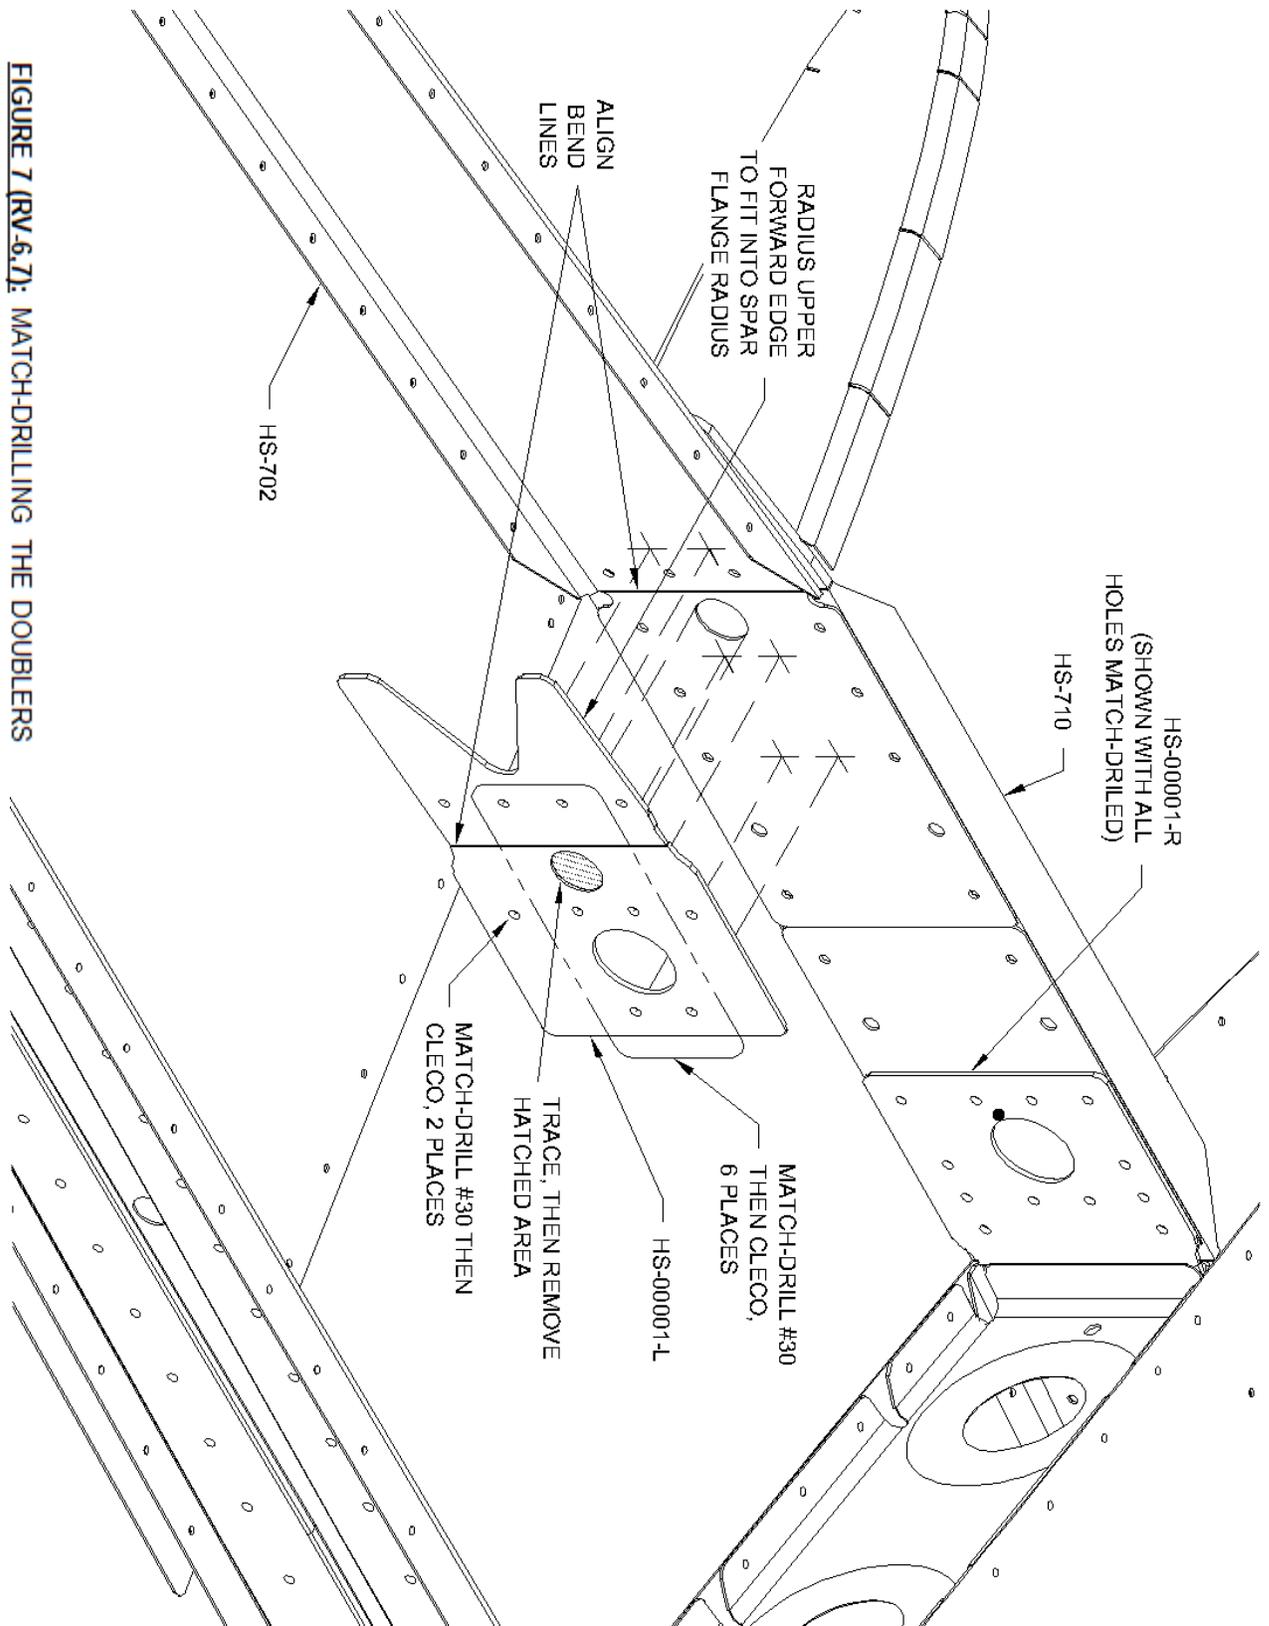
FIGURE 7 (RV-6, 7): MATCH-DRILLING THE DOUBLERS

Step 16: Radius the edge noted in Figure 7 to fit against the upper radius of the front spar.

Match-Drill #30 then cleco the six (for RV-6,7) or eight (for RV-8) center holes in each doubler indicated in Figure 7 into the front spars then remove the clamps.

Match-Drill #30 the doublers using the two spar web hole locations shown in Fig 7.

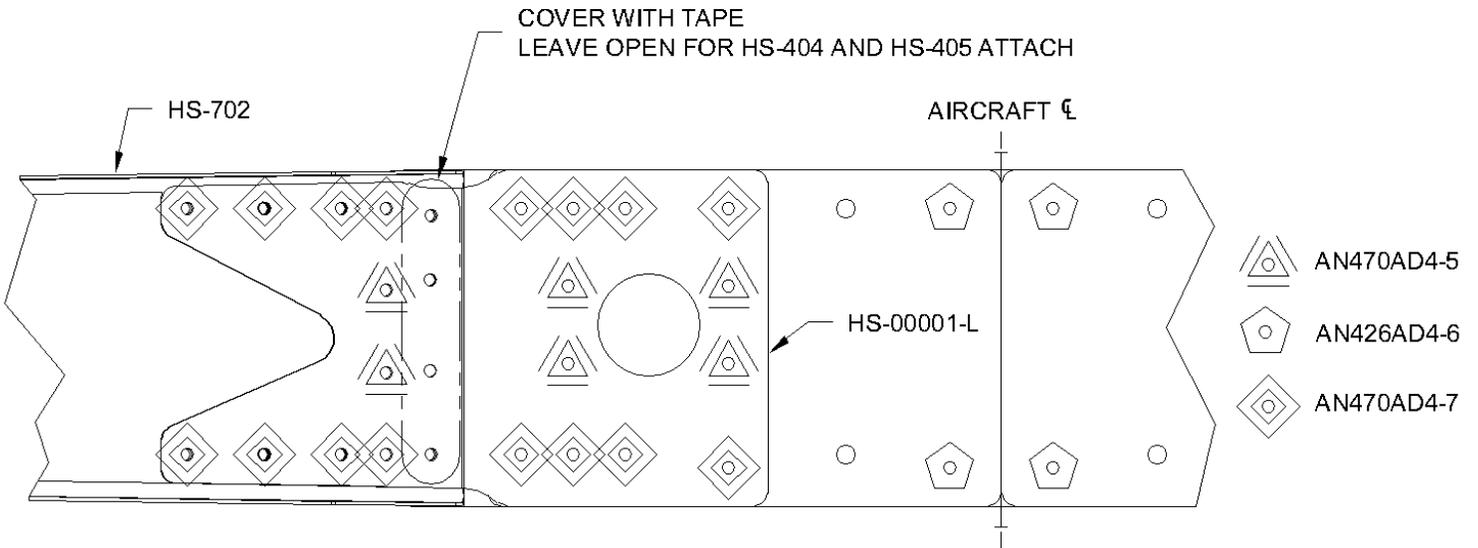
FIGURE 8 (RV-6,7): RIVETING THE DOUBLERS

Rivet all remaining rivet locations with rivet symbols as shown in Figure 8. Install rivets with the manufactured head against the thinner material.

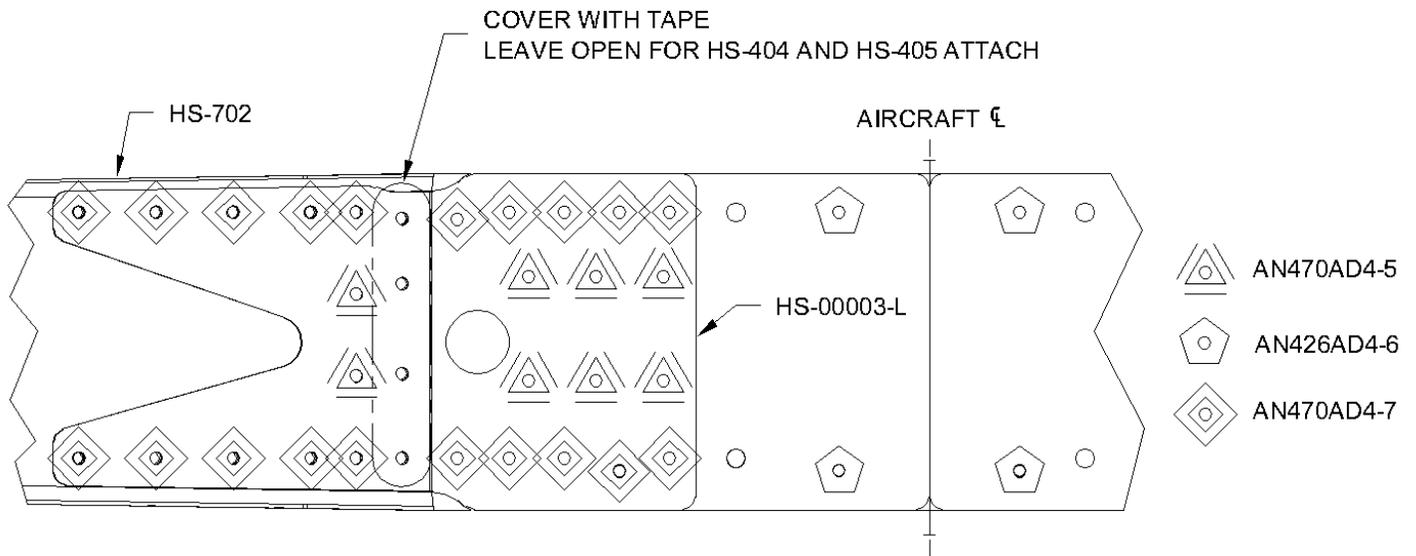
FIGURE 8 (RV-8): RIVETING THE DOUBLERS

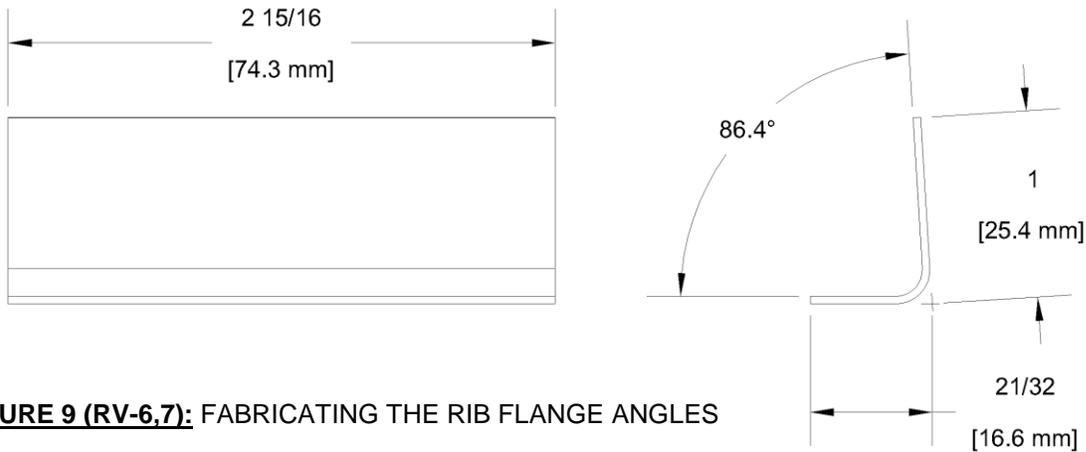
FIGURE 9 (RV-6,7): FABRICATING THE RIB FLANGE ANGLES

Step 22: Fabricate two HS-00002 Rib Flange Angles (RV-6,7) or HS-00004 Rib Flange Angles (RV-8) from AA3-040X3/4X1X10.5 per the dimensions given in Figure 9.

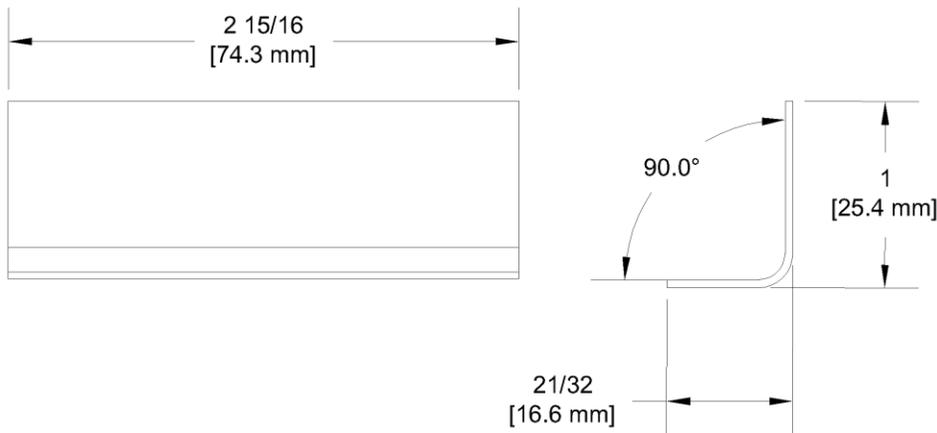
FIGURE 9 (RV-8): FABRICATING THE RIB FLANGE ANGLES

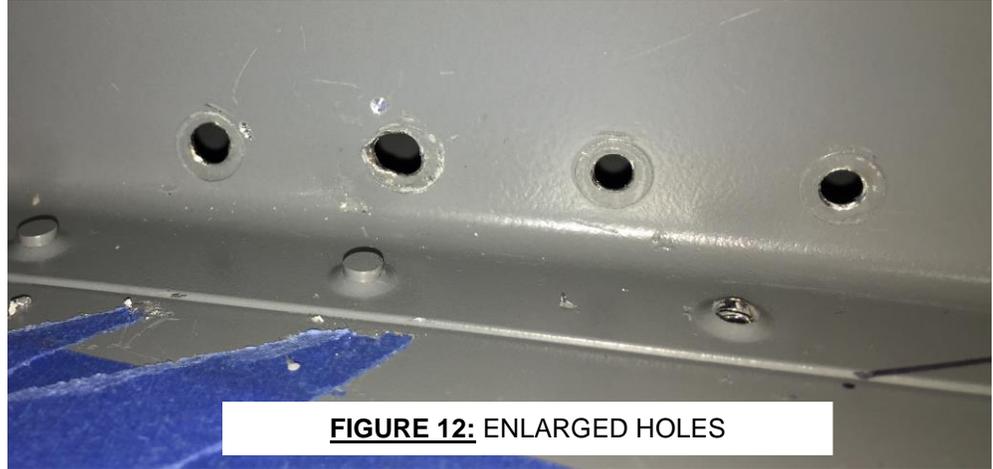
Mistakes drilling out rivets may elongate or enlarge the rivet holes. See Figure 12. Rivet holes may be enlarged for a 5/32 rivet using up to a #20 drill bit. If this does not clean up the hole contact Van's Aircraft for further technical assistance.

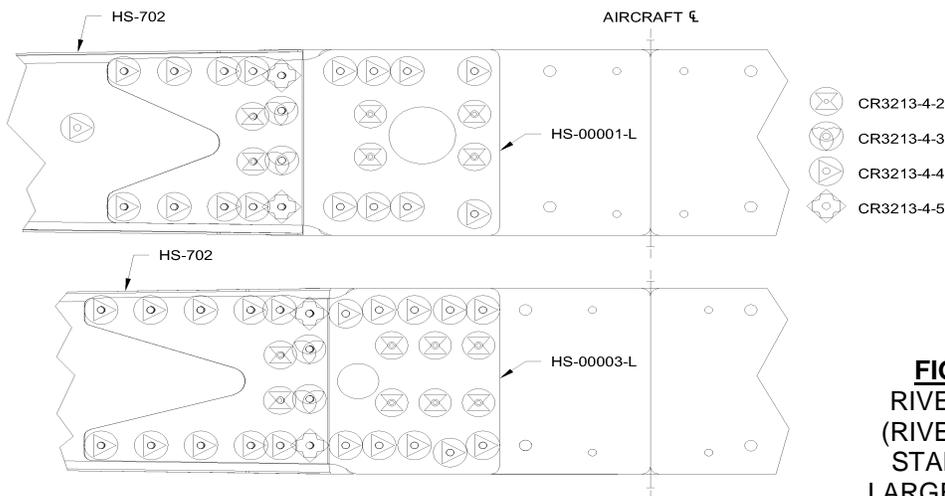
FIGURE 13: BLIND RIVET SUBSTITUTION (RIVET CALLOUTS FOR STANDARD 1/8 HOLE. LARGER RIVETS WILL BE REQUIRED FOR ENLARGED HOLES)

Cherry Max blind rivets may be substituted in place of conventional rivets. See Figure 13. Note rivets called out (available from Van's Aircraft are for a standard 1/8 hole not enlarged holes. Cherry Max rivets for use with 5/32 holes are not available through Van's Aircraft.

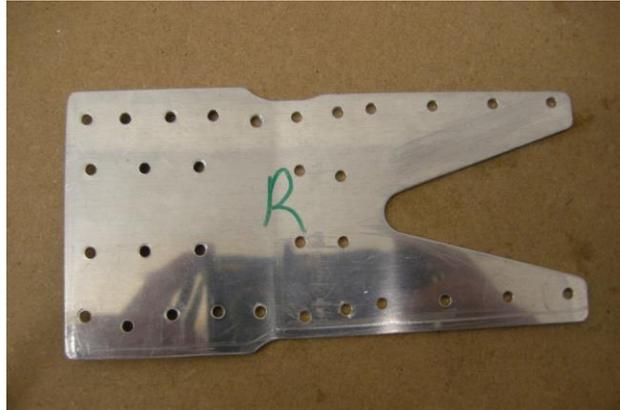
In some cases the edge distance may be compromised on the upper outboard rivet holes in the HS-00001 (RV-7) or HS-00003 (RV-8) Spar Doubler as shown in Figure 13.

FIGURE 13: Part with reduced edge distance.

The minimum allowable spar doubler edge distance is shown in Figure 14 below. If the edge distance is less than specified a rivet hole location may be added equidistant between the hole with reduced edge distance and the next rivet hole inboard. The new hole must maintain a $5/32$ minimum edge distance to the edge of the spar doubler and minimum $3/16$ edge distance from the edge of the HS-710 or HS-810-1 Angles located on the front side of the spar.
