SERVICE BULLETIN 16-03-28

Date Released: May 6, 2016 (Initial release)
March 7, 2018 (Replaced AN470AD4-11 with AN426AD4-11 in Figure 13, added corresponding machine countersinking instructions to Step 24.)

Affected Models: All RV-3, 4, 6/6A, 7/7A, 8/8A, 9/9A, 10, and 14/14A aircraft.

Subject: Cracking of wing aft spar web at the inboard aileron hinge bracket attach rivets. In addition, for RV-10 and RV-14/14A aircraft, there is a potential for cracking of the flange bends of the inboard aileron hinge brackets.

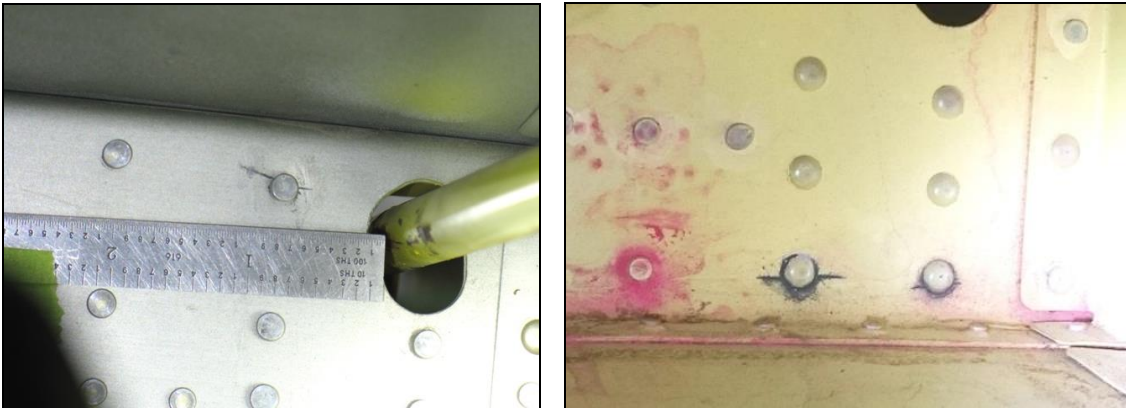
FIGURE 1: REAR SPAR WEB CRACKS

Cracks have been found radiating outward from the lower or upper most rivets that attach the inboard aileron hinge brackets to the webs of the wing rear spars. See Figure 1. On RV-10 or RV-14/14A aircraft, there is a potential for cracks in the flange bends of the inboard aileron hinge brackets (though there is no record of any at the time this S.B. was issued)

Required Action: For RV-3/3A/3B, 4, 7/7A, 8/8A, 9/9A aircraft: Inspect for cracks as described in this document. If cracks are present in the spar web, stop drill the cracks and install aileron attach doublers as described in this service bulletin.

For RV-10 and RV-14/14A aircraft: Inspect for cracks as described in this document. If cracks are found in the spar web or the inboard aileron brackets, stop drill the cracks in the spar web (if present), install aileron attach doublers, and replace the aileron hinge brackets with updated brackets.

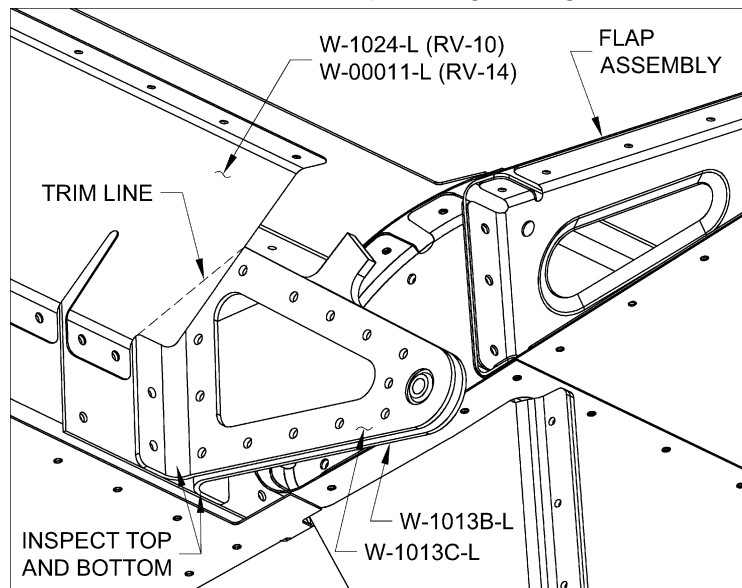
FIGURE 2: INSPECT AILERON HINGE BRACKET

Inspect for cracks in the flange bends at the top and bottom of the W-1013C & B Aileron Hinge Bracket Sides.

Step 2 (RV-10 & 14 only): To gain access for inspecting the top of the W-1013C Aileron Hinge Bracket Sides, remove the ailerons from the wings as instructed in Step 3 and 4, then trim off the corner from the W-1024 / W-00011 Aileron Gap Fairings along the "TRIM LINE" shown in Figure 2.

- If cracks are detected, continue with the remaining steps in this service bulletin before further flight.
- If cracks are not detected, reattach the ailerons and make a log entry indicating that recurrent inspection is due at the next condition inspection.

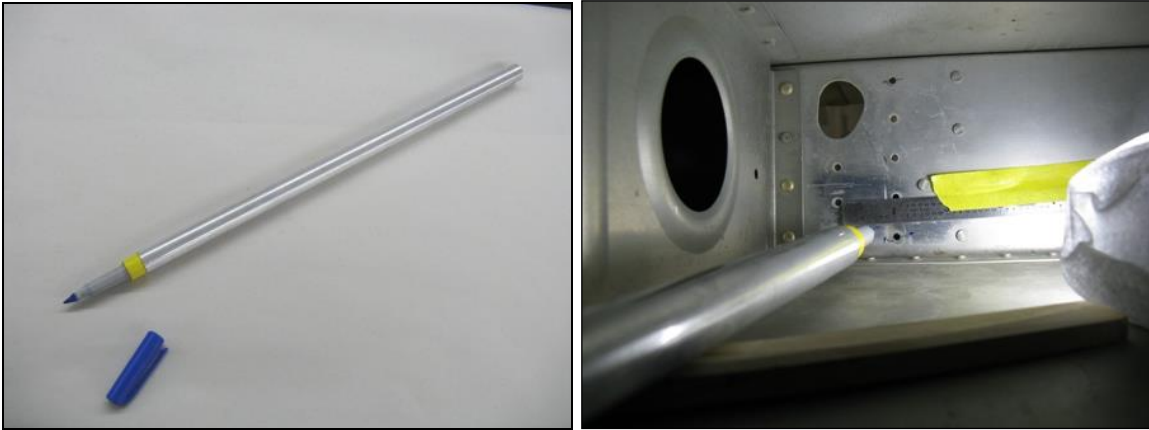
FIGURE 5: MARKING THE STOP-DRILL CENTER POINTS ON THE SPAR.

NOTE: The drill guide will be used to locate any required stop-drill holes. Typically, a crack in aluminum aircraft structure extends beyond the point where it is visible with the naked eye. Stop-drilling at the apparent endpoint could miss the end of the crack allowing it to continue to propagate. Therefore, when stop-drilling a crack, the center point of the stop-drill hole should be positioned slightly beyond the apparent end of the crack. This way, if the crack continues to propagate, it will do so toward the hole and then stop.

Step 10: Use a piece of tubing to make an extension handle for a fine point marking pen (a 5/8 inch diameter aluminum or steel tube works well), then, in a color that is easily visible, mark the optimal stop-drill hole center locations on the forward side of the rear spar. See Figure 5. To make the pen easier to control, you can rest it on a small piece of wood that has been cut to the approximate height of the hole location being marked.
