## SERVICE BULLETIN 16-04-10

**Subject:** RV-12 switch module harness update (single or dual EFIS)

**Affected Models:** ELSA RV-12 SkyView or Garmin Avionics kits delivered between Feb 14, 2014 and April 10, 2016.  
SLSA RV-12 serial numbers 12033 thru 12067.

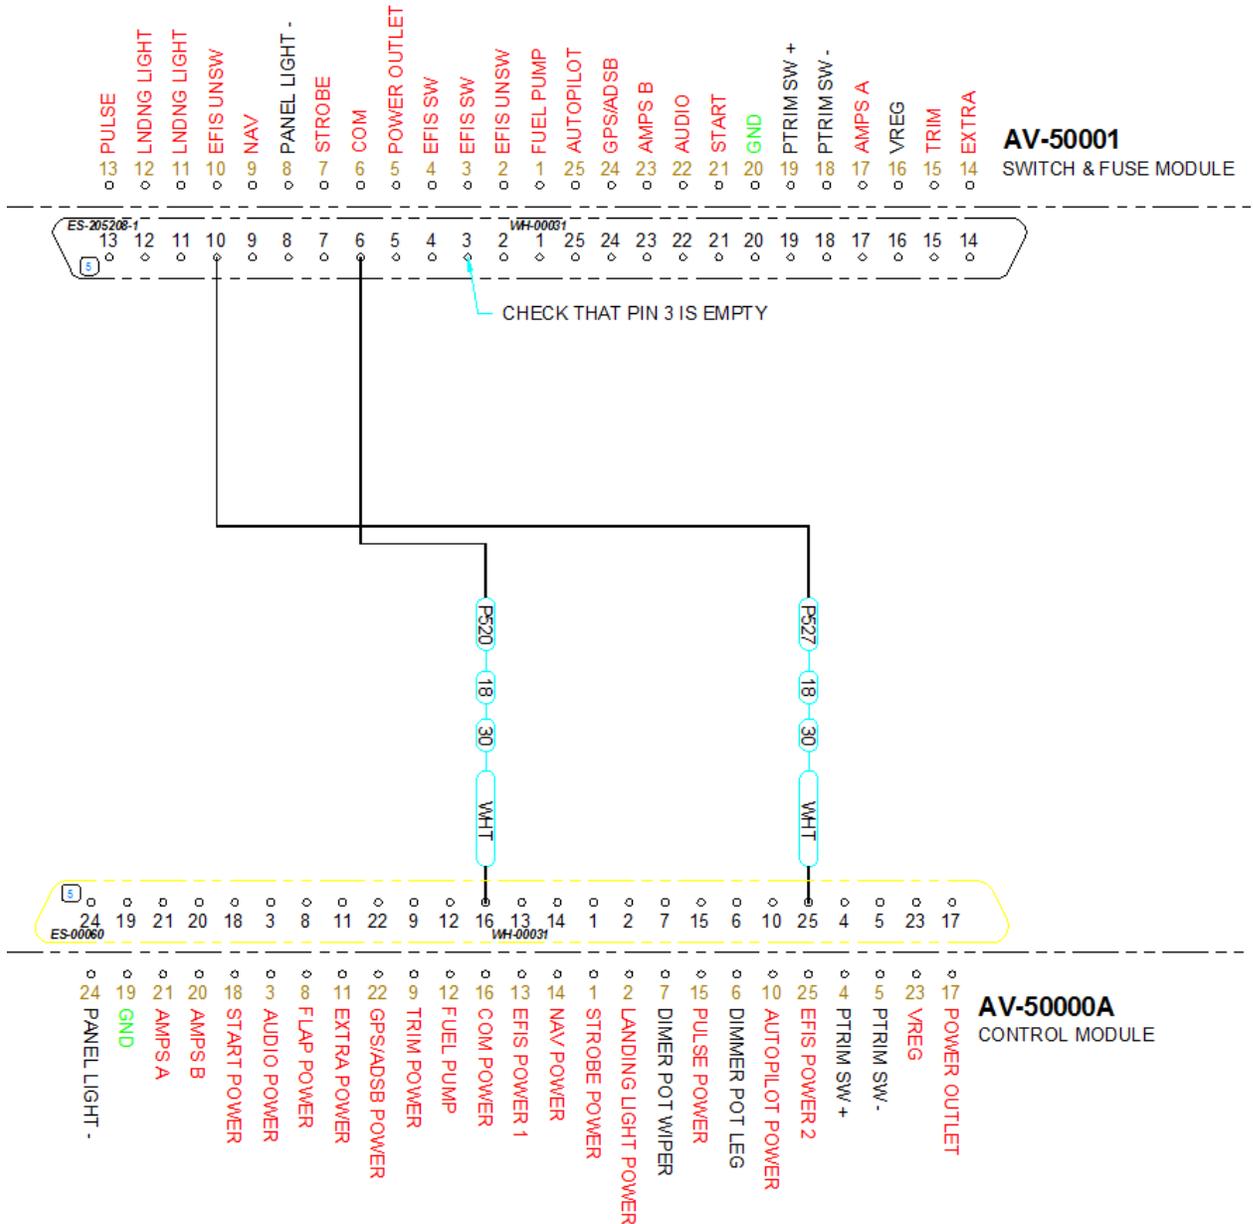
Step 6: Use an ohmmeter to check that wires P520 and P527 wires are connected as shown in Figure 1.

**FIGURE 1:** Harness Rev 2 Configuration – only wires applicable to this SB shown for clarity

If they are not, locate and move the wire pinout locations in the AV-50001 Switch & Fuse Module D-Sub connector as required to match the configuration shown in Figure 1.
