SERVICE BULLETIN 16-12-16

Subject: RV-8QB Missing Center Section Bolts

Affected Models: RV-8 QuickBuild Kits and flying aircraft built from QuickBuild Kits

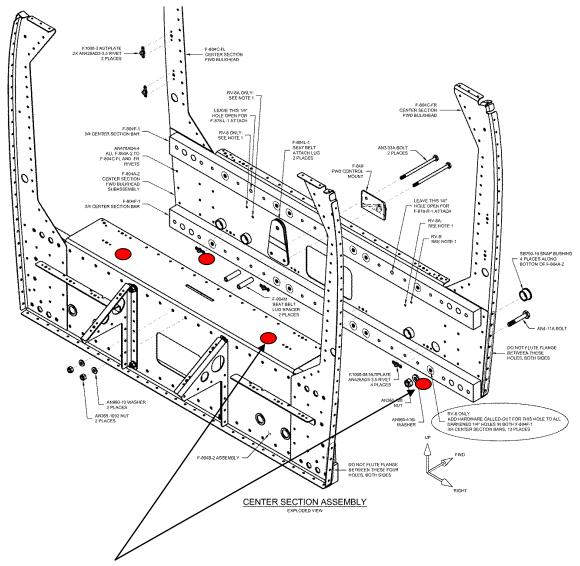
Several reports from the field indicate that some RV-8 QuickBuild Kits have been completed and flown without certain center section hardware being installed. There are specific steps called out in the assembly instructions to install this hardware. See RV-8, Dwg 64 and page 8-10 of the assembly manual. This hardware is NOT installed during the QB assembly process at the factory.

<u>Step 1</u>: Using Figure 1 as a reference, gain access to the center section area and determine if the indicated twelve AN4-11A bolts are installed in the forward portion of the center section.

<u>Step 2:</u> If the hardware is missing, install the appropriate hardware as called out in Figure 1. Access to install the outboard-most nuts will be difficult on aircraft with the wings already installed. It is permissible to open access holes in either the F-802B upper flange and/or the belly skin to install the washer and nut on those bolts. Reference Section 5.20 of the assembly instructions for torque specifications. This hardware was included with all RV-8 QuickBuild Fuselage Kits.

Holes (1" max. diameter) in F-802B upper flange and/or belly skin to access installation of washers and nuts on aircraft with wings already installed.

$\underline{\text{NOTE:}}$ Ensure that center section bars are not damaged when drilling access holes.
