VAN'S AIRCRAFT

SERVICE BULLETIN 18-02-03

Subject: Inspect anti servo tab (AST) skins for cracks and replace AST ribs at the control horns with upgraded parts.

Affected Models: Van's RV-12 and empennage kits shipped prior to December 09, 2016.

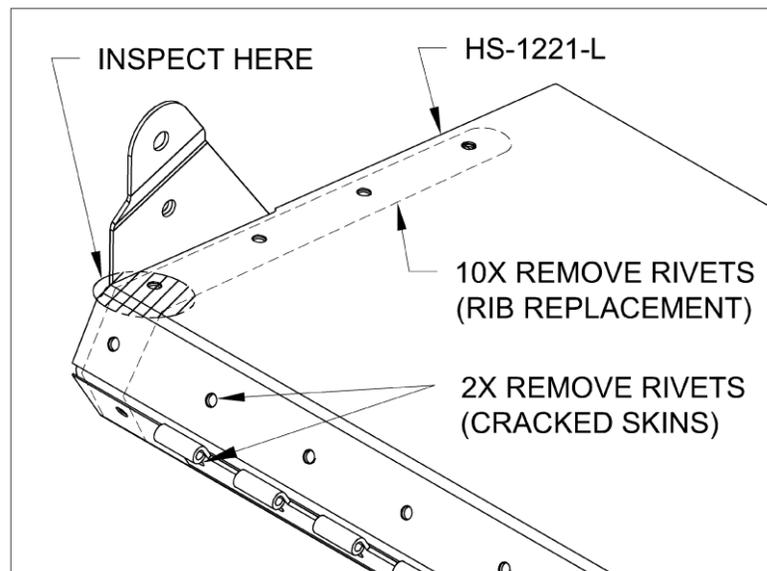
FIGURE 1: INSPECT FOR CRACKS

Three reported cracked HS-1221 Anti Servo Tab Skins in aircraft with over 900 hours. This Service Bulletin provides procedures for the repair of cracked skins and for upgrading the sub-structure to prevent cracks from developing.

Step 1: Inspect the HS-1221-L/R AST Skins upper and lower surfaces for cracks in the area depicted in Figure 1. If no cracks are found skip to Step 4 or re-inspect during next annual condition inspection.

Step 2 (Cracked Skins): Stop drill cracks using a #40 bit. If cracks are very small, less than 1/8 in. long, stop drill at or just beyond the end of the crack.

Step 4 (Rib Replacement Only): Remove the 10 rivets called out in Figure 1. For more instruction on removing rivets see Section 5. Remove the Horn Assembly(rib & horn).

Step 5 (Cracked Skins): Remove all rivets called out in Figure 1. Remove the Horn Assembly(rib & horn).
