VAN'S AIRCRAFT
TOTAL PERFORMANCE

SERVICE LETTER 19-09-23

Date Released: December 2, 2019
Date Effective: December 2, 2019
Subject: RV-12 Rotax 912ULS High Fuel Flow Indication
Affected Models: RV-12 Rotax 912ULS powered aircraft with fuel flow
Affected Serial Numbers: All
Required Action: None
Time of Compliance: None
Supersedes Notice: None

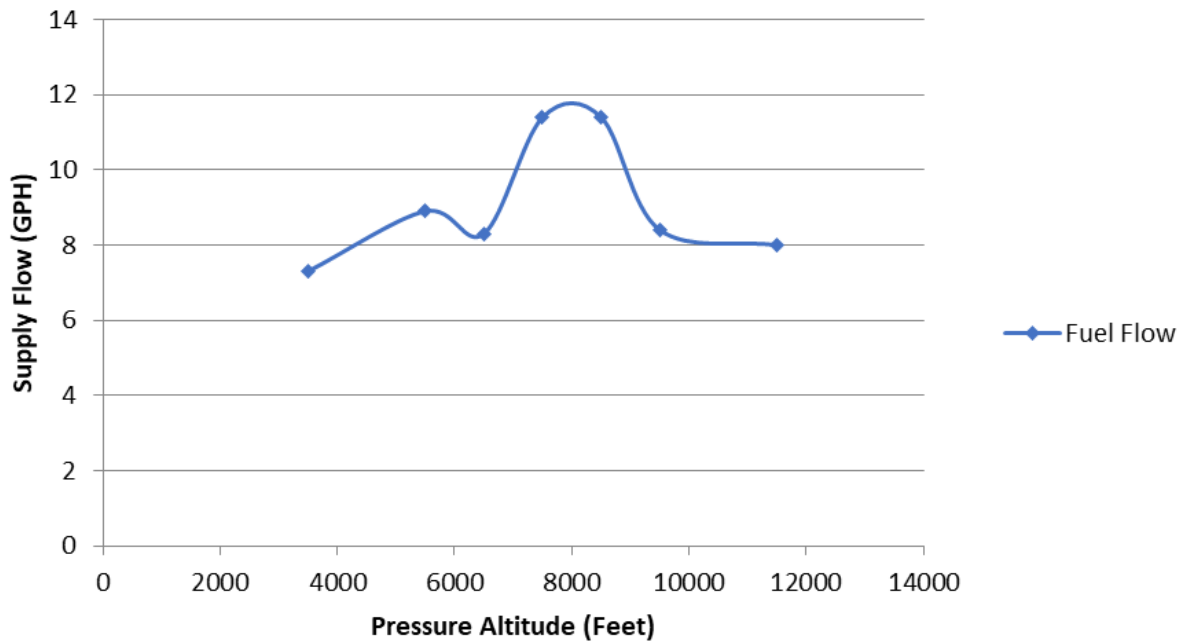
Fuel Flow

For the purpose of testing and evaluation, Van's Aircraft equipped an RV-12 with fuel flow sensors on both the supply and return lines. Several altitudes were flown at a planned set RPM. The results are shown in the table and graph below. The graph shows

the fuel flow values form a bell-shaped curve, which is indicative of a harmonic effect occurring in the fuel system. Note that after the aircraft climbs above the affected altitude range the fuel flow returns to normal. This affect at various levels of magnitude has been observed on a number of RV-12 aircraft, all within the same altitude band.

Observed and recorded engine operating parameters indicated in these cases that the engine was not actually exceeding normal rates of fuel consumption. The return line flow rate remained constant during all tests (the return line is not affected by the pulses from the fuel pumps). Also note that fuel pressure remained constant, indicating that vapor in the fuel line was not a factor. This is important: the reason the electric pump is placed at the beginning of the fuel system and operates continuously is to prevent vapor-related issues; this is an important safety aspect of the system design, and the electric fuel pump should always be used in a continuously-operating mode).

High fuel-flow alarms (especially repeated erroneous, false alarms) can be distracting to a pilot. Since fuel flow is neither a mandatory or critical indication, we recommend that aircraft that exhibit erroneously high fuel flow indications should at minimum turn off the high-pressure warning via the setup menu of the SkyView EFIS system (reference the SkyView installation guide available on the Dynon website). Note that Garmin systems do not indicate fuel flow even if the sensor is installed (when the Van's RV-12 configurations are applied). Alternately, owners of aircraft with the erroneous fuel flow indications may wish to disable the fuel flow indication completely.
