SERVICE BULLETIN 19-09-09

Subject: Cracking of RV-10 nose gear leg inboard attach lug

Affected Models: RV-10 flying aircraft and/or Finish Kits shipped prior to October 1, 2019

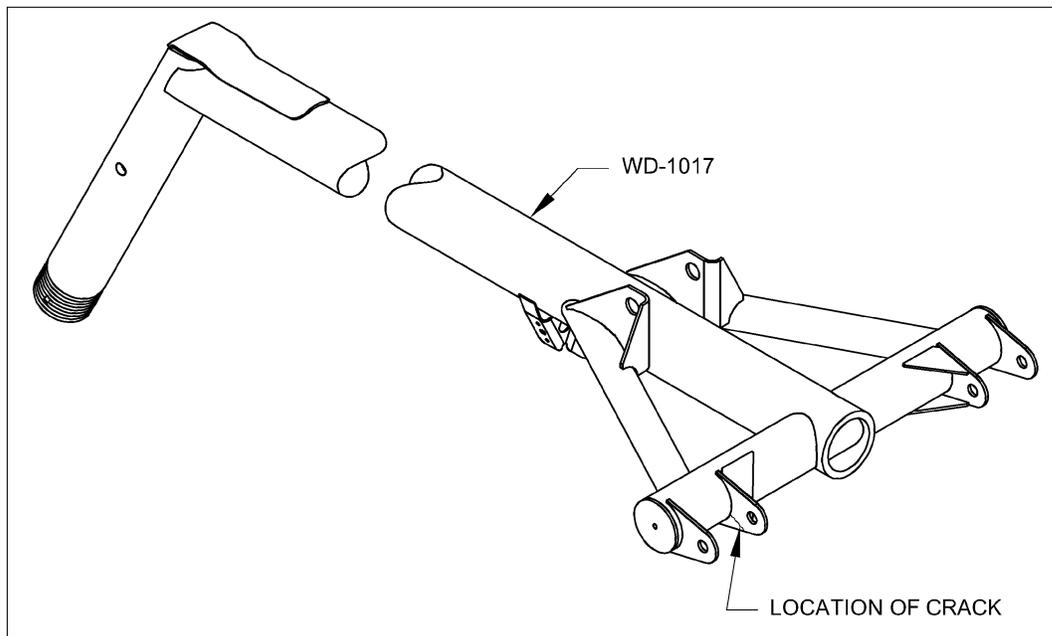
Required Action: Inspect the inboard attachment lugs of the WD-1017 Nose Landing Gear for cracks (see Figure 1). If cracks are discovered, replace the WD-1017 Nose Landing Gear with the WD-1017-1 Nose Landing Gear as described in this document. If no cracks are discovered, annual inspections are required.

FIGURE 1: INBOARD LUG CRACK LOCATION

A crack was discovered in the inboard attachment lug of the nose landing gear on an aircraft that operates from a grass field and which had acquired more than 1700 hours of flight time. Only a single instance has been reported.

NOTE: This gear leg is heat treated. Welding as a method of repair is not approved.

Inspect at or before the next annual condition inspection. If no cracks are detected, re-inspect at every annual condition inspection, or until the modification described in this document has been completed.
