**VAN'S AIRCRAFT**  
TOTAL PERFORMANCE

## SERVICE BULLETIN 18-03-06, REVISION 1

**Subject:** Replace the throttle return springs

**Affected Models:** RV-12 (Powered with Rotax 912ULS)

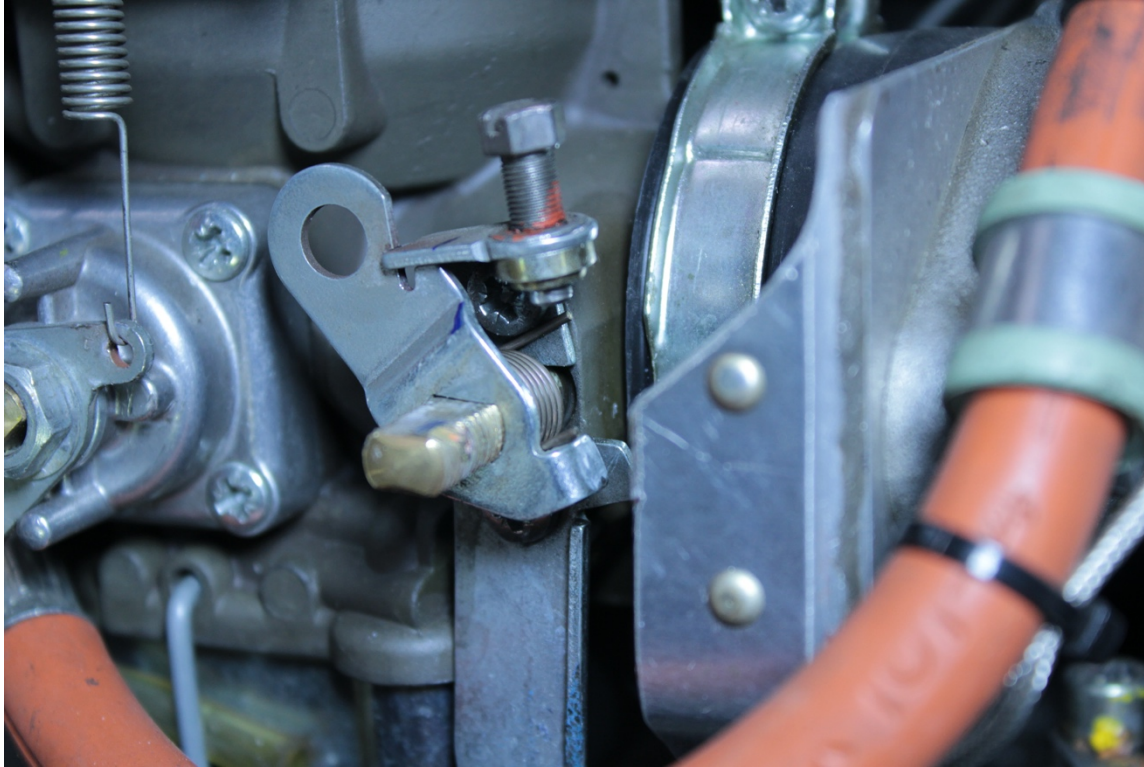
**FIGURE 1:** SPRING INSTALLATION (THROTTLE ARM NOT INSTALLED)

Replace the existing throttle springs with SPRING-00002-L/R-1. The previous spring was failing prematurely (before the recommended 100-hour replacement interval) on some aircraft.

Step 1: Remove SPRING-00002 as shown in KAI Section 50. See Figure 1 for reference.

Step 2: Complete SB-00026 and install SPRING-00002-L/R-1 as shown in KAI Section 50.
