## SERVICE BULLETIN 00023 - REV 1

**Subject:** WD-1221 Engine Mount Standoff inspection/replacement

**Affected Models:** RV-12/12iS

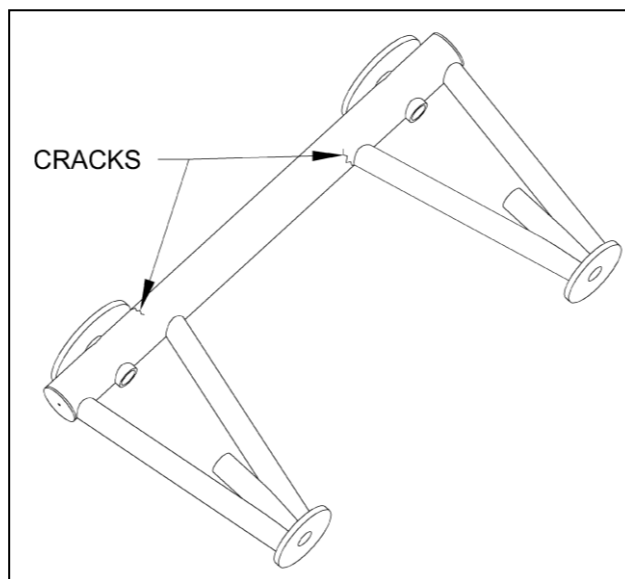
Remove the top cowl. Inspect the WD-1221 Engine Mount Standoff for cracks in the main cross tube (refer to Figure 1 for specific location).

**FIGURE 1:** WD-1221 CRACK LOCATIONS

Cracks have been discovered in the WD-1221 Engine Mount Standoff. These cracks have been reported/observed on two aircraft. Note that primary potential causes of vibration on the RV-12/12iS are carburetor sync and propeller balance issues.

Step 1: Remove the top engine cowling. Inspect the WD-1221 Engine Mount Standoff for cracks at the locations indicated in Figure 1, above. If no cracks are found, log the inspection (as per Step 9 below) and reinspect every 100 hours until such time as the WD-1221 has been replaced per the below steps.

If cracks are discovered in the standoff, notify Van's Aircraft support at [support@vansaircraft.com](mailto:support@vansaircraft.com) and replace it with a WD-01221-1 Engine Mount Standoff as described in this document. If no cracks are discovered, 100-hour inspections are required until the standoff is replaced.

Step 6: Replace the standoff with the new WD-01221-1 Engine Mount Standoff, and secure with the original bolts.

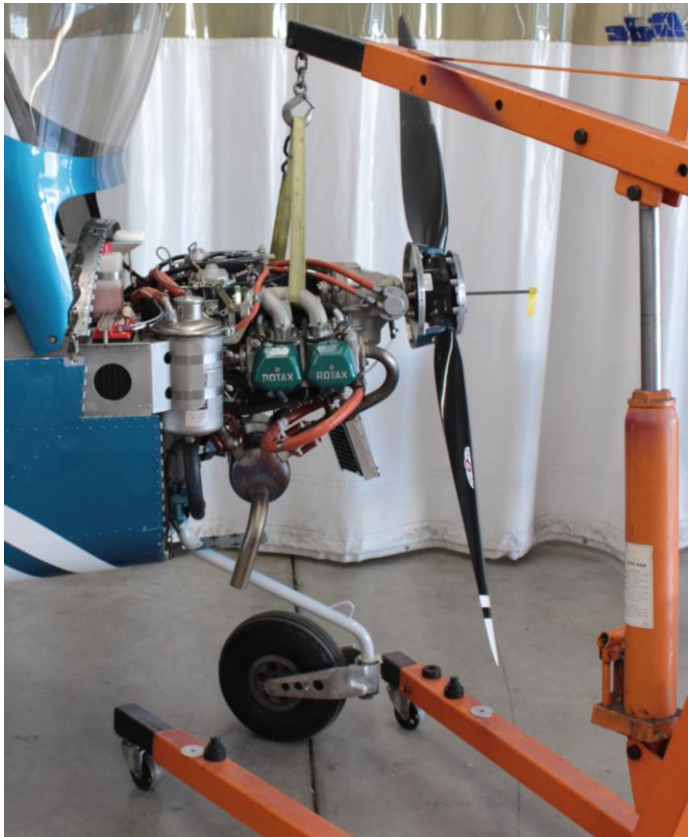
**FIGURE 2:** ENGINE HOISTING

Step 4: Attach a tail stand, or place an appropriate padded sawhorse under a tail cone bulkhead, to ensure the aircraft tail will not strike the ground when lifting the engine. With straps wrapped around the intake manifolds (see Figure 2), hoist the engine just enough to unload the bolts securing the engine mount standoff.
