## SERVICE LETTER 00022

**Subject:** Short WD-01214-L/R-1 Flaperon Torque Tubes

**Affected Models:** ELSA RV-12iS Finish Kits shipped between March, 2018 and October 12, 2020

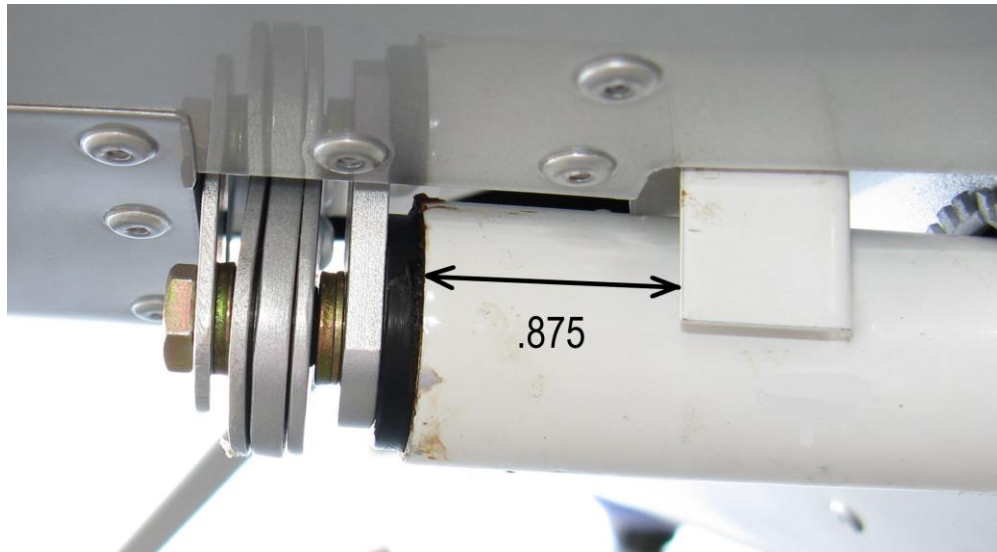
Builder feedback indicated several WD-01214-L/R-1 Flaperon Torque Tubes were fabricated using tubes with insufficient length which resulted in reduced engagement between the torque tube and the A-1211 Pivot Guide. Complying with this service letter adds a spacer to reestablish correct torque tube to pivot guide engagement.

Step 1: Compare WD-01214-L-1 and WD-01214-R-1 torque tubes to the dimension shown in Figure 1. If the measurement is 0.75 in. [19 mm] instead of the 0.875 in. [22 mm] dimension shown, WASHER-00022 should be installed.

**FIGURE 1: WD-01214-L/R-1 SHOULD MEASURE .875 IN.**

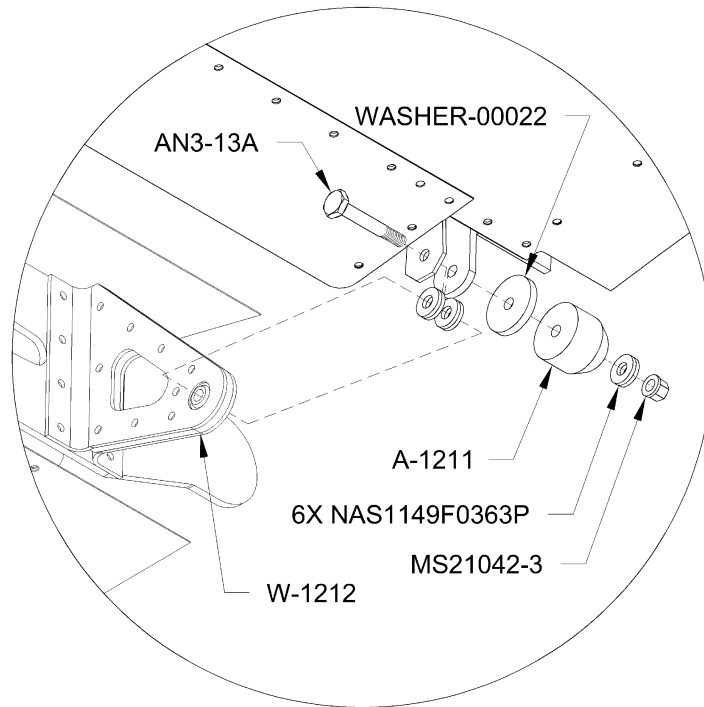
**FIGURE 2: INSTALL WASHER-00022**

Step 4: Install the AN3-13A bolt, washers, WASHER-00022, A-01211 Pivot Guide, and remaining hardware shown in Figure 2. Torque the MS21042-3 nut to 25 in-lbs.
