SERVICE BULLETIN SB-00027

Subject: Changes to RV-14A Nose Gear Attach Opening/Washer

Affected Models: RV-14A
Affects the nose gear on all RV-14A Finish Kits delivered prior to November 4, 2020

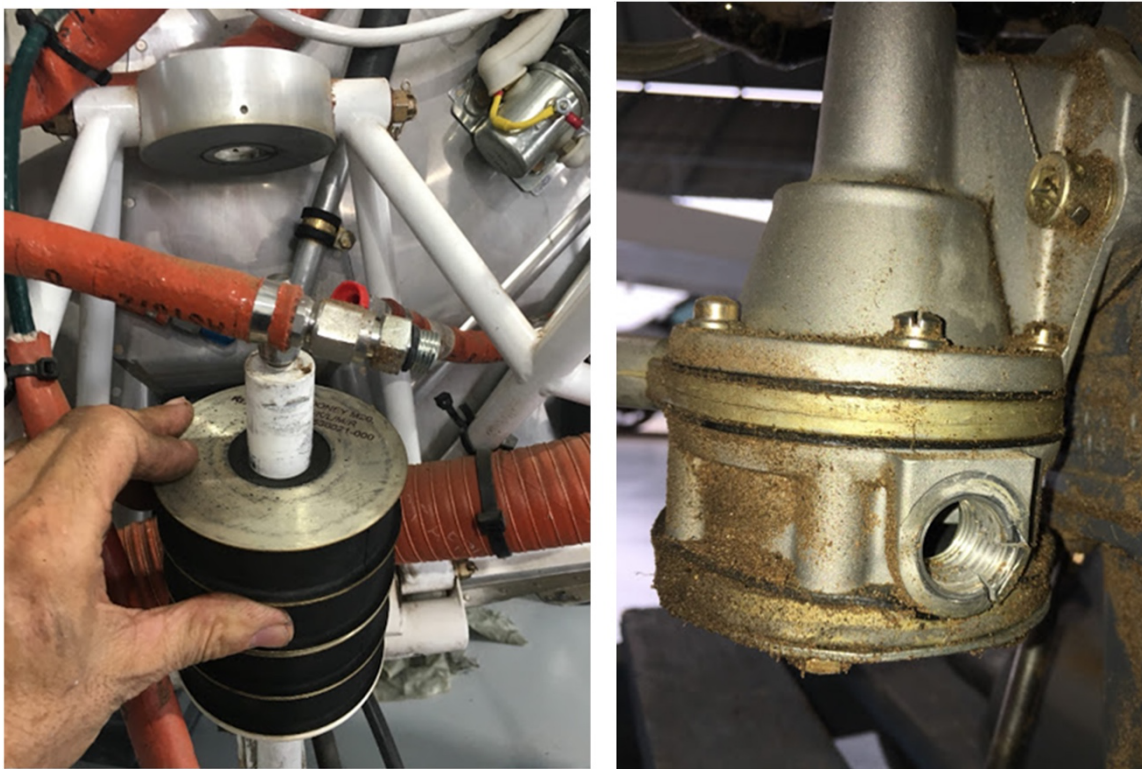
Data from the field suggests that, during a nose gear collapse, the upper end of the U-01416 Nose Gear Link Assembly can strike the fuel pump inlet fitting that is directly ahead of it, severing the fitting from the fuel pump along with the attached VA-139 hose. Refer to Figure 1.

FIGURE 1: SEVERED FUEL PUMP INLET FITTING DUE TO NOSE GEAR COLLAPSE DURING EMERGENCY LANDING

Tests at Van's Aircraft have verified that after enlarging the opening on the U-01406 Nose Gear Leg where the U-01416 Nose Gear Link Assembly is attached, the possibility of this scenario is eliminated. This is the case because after the modification, the upper end of the of the U-01416 Nose Gear Link Assembly will pass beneath the fuel line when the nose gear is deflected aft.

In addition, the U-01420 Link Assembly Cap has been revised to a higher-strength version. Where the original part would fail at the cap itself, the new U-01420-1 cap causes the upper end of the Link Assembly (i.e. the threads) to break off during a gear collapse, giving sufficient clearance for the Link Assembly to pass beneath the fuel line. The same outcome is achieved by replacing the NAS1149F0632P washer by the larger-diameter WASHER-00023. Therefore, builders/owners may choose either to add the new washer, or to replace the original cap with the new version.

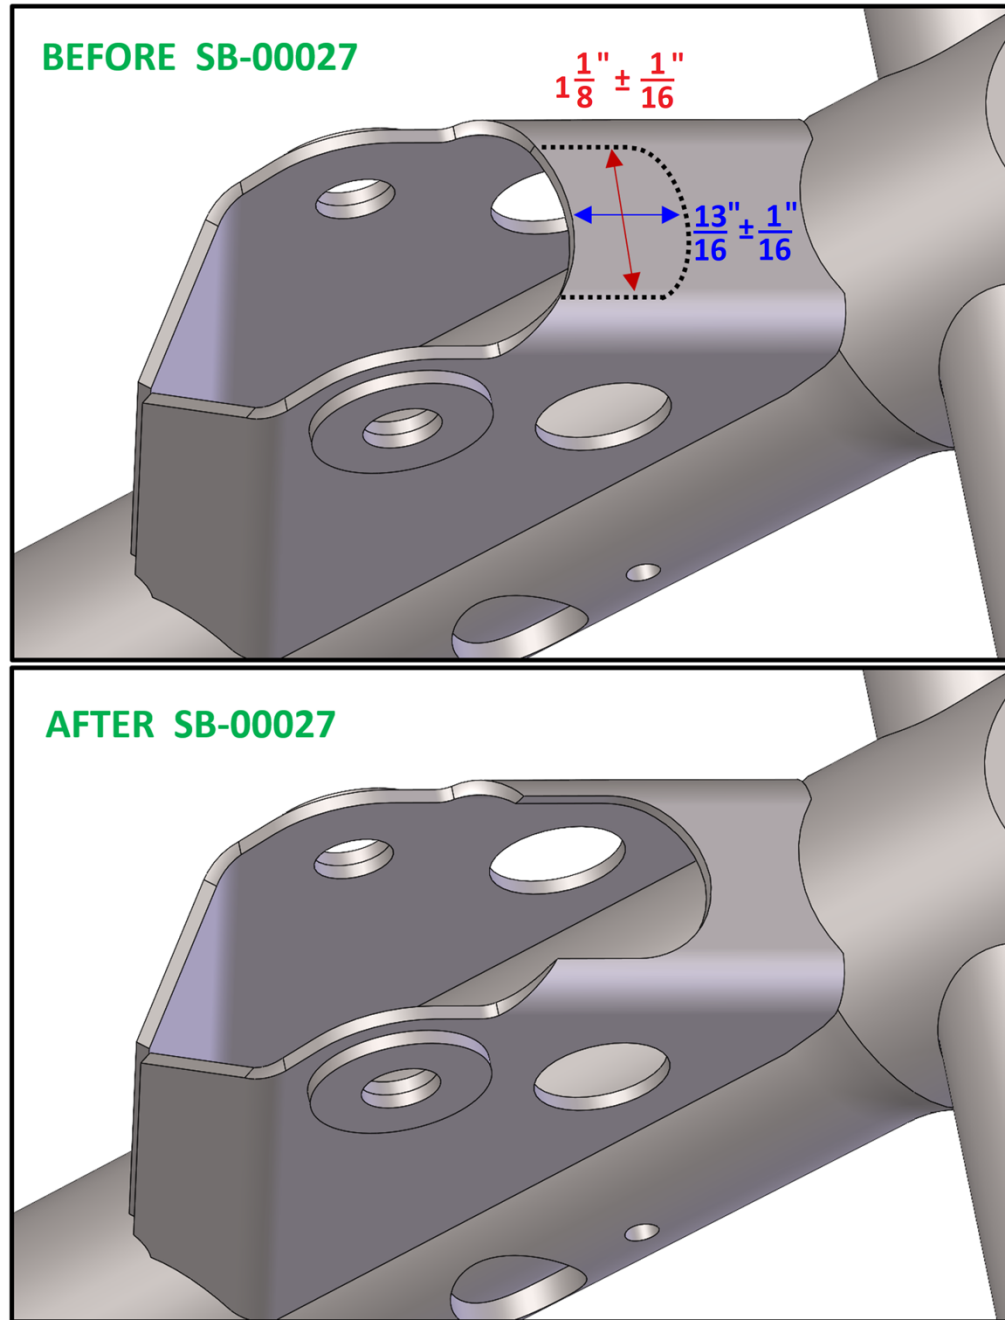
FIGURE 3: ENLARGING THE OPENING ON U-01406.

Step 5: Cut and/or grind material from the aft end of the opening on the Nose Gear Leg where the Nose Gear Link is attached. Sand the surface of the cut until it is smooth. Refer to Figure 3.

Step 6: Apply a coat of paint onto the exposed steel along the new edge of the opening, for corrosion prevention. Van's recommended paints for powder-coated parts can be found in our web-based FAQ, at:
