## SERVICE LETTER 00033, REV 1

**Subject:** RV-10 Landing Gear Component Field Assessment

**Affected Models:** RV-10

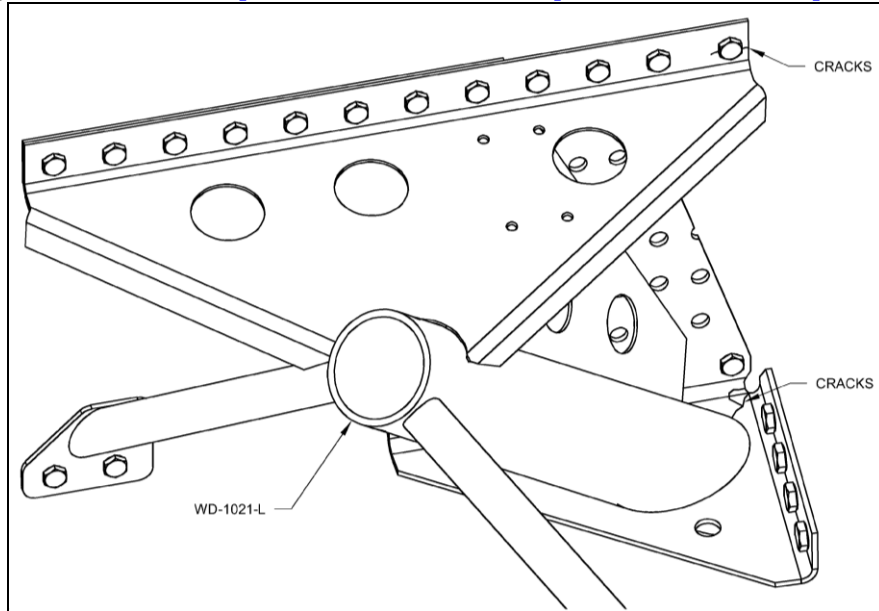
**FIGURE 1:** LANDING GEAR MOUNT POTENTIAL CRACKS

The Van's Aircraft factory prototype RV-10 developed cracks in the WD-1021 Landing Gear Mounts (see Figure 1) and in the F-1050 Fwd Cabin Floor Panels (see Figure 2). The Van's Aircraft engineering team has determined that these cracks may develop in aircraft with a high number of hours, or aircraft operated frequently on unimproved runways, such as is the case with the prototype RV-10. Initial feedback from the field after the publication of this service letter has shown that a while a number of aircraft have cracking in the floor, only a small number of cracks in customer landing gear weldments have been reported to Van's Aircraft.

The presence of cracks in the weldments is not necessarily an indication of imminent failure. These cracks will be slow-growing. There is some concern that a cracked weldment could fail during a very-high-impact landing, hence the request for owners to ground aircraft with cracks in the landing gear weldments, and then complete the described inspection and submit photos/results to Van's using the web form linked

Step 1: Inspect the WD-1021 Landing Gear Mounts for cracks in the corner plate of the gear mounts, and for cracks propagating from the top, outboard attachment bolt hole (refer to Figure 1). The front seats and underlying F-1067B Seat Floor Covers must be removed for this inspection.

Aircraft with cracks in the WD-1021 Landing Gear Mounts shall be grounded and the owner/operator is directed to contact Van's Aircraft Support for further assistance.

below. Upon verification of cracked weldments, Van's Aircraft will provide individual assistance, replacement parts and specific guidance to customers with cracks in landing gear weldments.

Note that apparent cracking may only be in the powder coat material and not in the part itself. If cracking is suspected, remove the powder coat from the area as required to determine if cracking is in the metal part itself. If no cracking is found in the metal part be sure to recoat or cover the exposed area to prevent corrosion.

If cracks are found in the metal weldment(s), take pictures of the affected area(s) and submit them to Van's Aircraft using the form linked below. Please include your aircraft total time, serial number and registration number in your submission.
