## SERVICE BULLETIN 19-10-10 REV 1

**Subject:** Fuel System double banjo bolt

**Affected Models:** RV-12iS using a Rotax 912iS Sport Engine

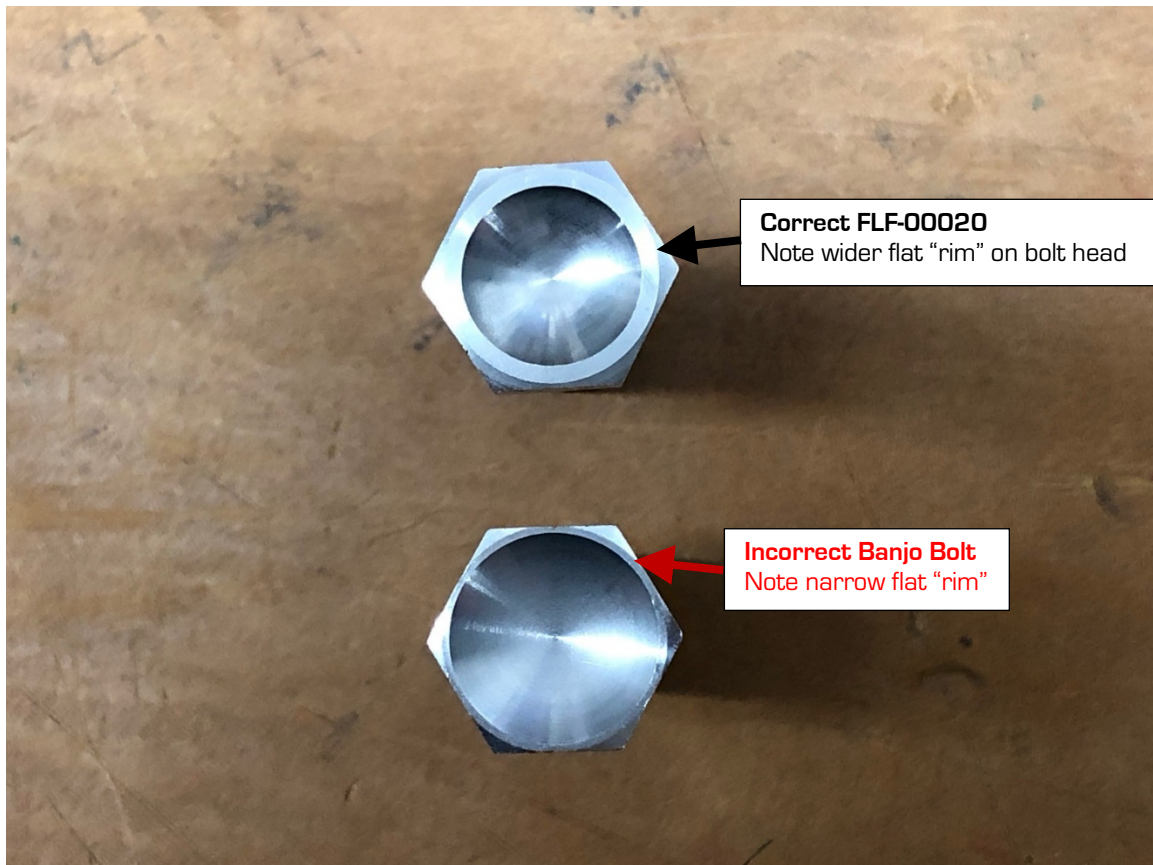
**Figure 1: Banjo Bolt Head Details**

Step 2: Visually inspect the head of the FLF-00020 Double Banjo Bolt to see if the correct hardware is installed. See Figures 1 and 2.

Step 3: Remove incorrect FLF-00020 Double Banjo Bolt and the three FLF-00024 Crush Washers. See the RV-12iS Maintenance Manual Section 13 and KAI Section 27iS/U.

Step 4: Install the new FLF-00020 Double Banjo Bolt and three FLF-00024 Crush Washers. See the RV-12iS Maintenance Manual Section 13 and KAI Section 27iS/U.
