SERVICE BULLETIN 99-06-01

Date Released:	October 21, 2021 October 21, 2021 (Rev 2, made SB mandatory; removed the original option for ongoing inspections) June 30th, 1999 (Rev 1)
Date Effective:	October 21, 2021
Subject:	Overhead (“suspended”) rudder pedals for the RV-6 and RV-6A are cracking and need to be replaced <u>or</u> reinforcement gussets need to be installed
Affected Models:	RV-6, RV-6A
Required Action:	Replace or reenforce all affected WD-655-L/R rudder pedals with gussets
Time of Compliance:	Before further flight
Supersedes Notice:	Revises and replaces SB 99-06-01 Rev 1
Labor Required:	6.0 Hours (Note this number is highly dependent on the configuration of the RV-6, the presence of a center console, or other unique features that may inhibit the removal and subsequent installation of WD-655-L/R)
Level of Certification:	Check the rules of the local controlling authority/agency and the operating limitations for your aircraft

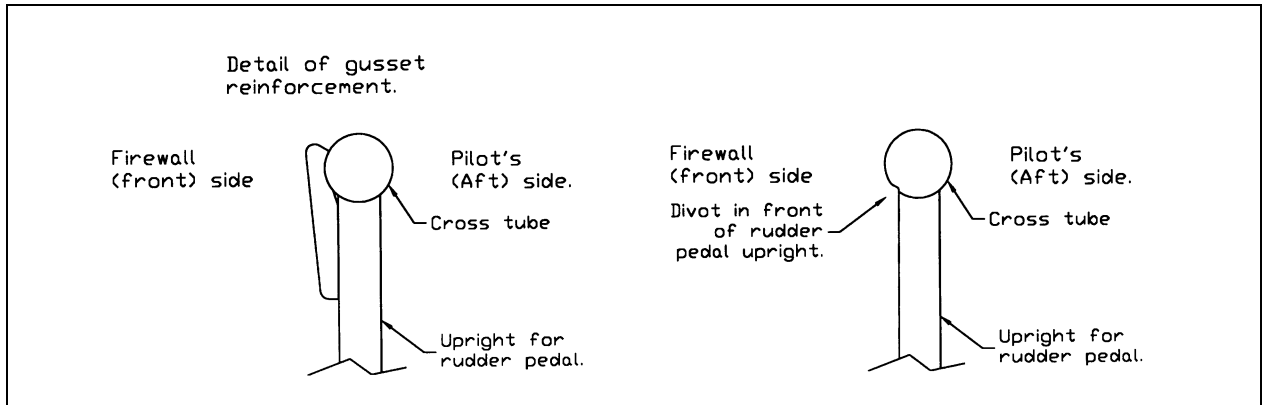
FIGURE 1: GUSSET DETAIL

There have been several cases of welds breaking on the overhead-style rudder pedals (WD-655L and WD-655R) used in the RV-6/6A. These breaks usually occur where the upright tubes from the pedal connect to the torque tube that runs across the fuselage. The forward side of the torque tube fails in compression, allowing the aft side of the torque tube to tear.

Step 1: Check that your rudder pedals have gussets installed, as shown in Figure 1. Also refer to KAI drawing 43A.

Step 2: If no gussets are present, remove the WD-655-L/R Rudder Pedals from the aircraft. Reference KAI drawing 43A.

Step 3: Repair or replace the pedals using one of the methods described in the materials required section, above.
