## SERVICE BULLETIN 00036 - REV 3

<b>Date Released:</b>	February 28, 2023 (Revision 3 – Corrections made) February 25, 2023 (Revision 2 – New parts and method of compliance) February 2, 2023 (Revision 1) January 23, 2023 (Initial release)
<b>Date Effective:</b>	January 23, 2023
<b>Subject:</b>	Cracking in horizontal stabilizer rear spar at outboard elevator hinge brackets
<b>Affected Models:</b>	RV-3, RV-4, RV-6/6A, RV-9/9A, RV-10, RV-14/14A  RV-7/7A and RV-8/8A Empennage Kits shipped prior to November 2022
<b>Required Action:</b>	Inspect the rear spar web at the outboard elevator hinge bracket for cracks. If cracks are present in the spar web, replace the spar or stop drill the cracks, install doublers, and replace the elevator hinge brackets with updated parts.
<b>Time of Compliance:</b>	Inspect within 25 flight hours or at the next annual inspection, whichever is earlier.  If cracks are <u>not</u> present, you may continue to comply with this Service Bulletin via the prescribed inspection no less than every 12 months, or you may complete the modifications described in this service bulletin for aircraft without cracks.  If cracks <u>are</u> present, the modifications required by

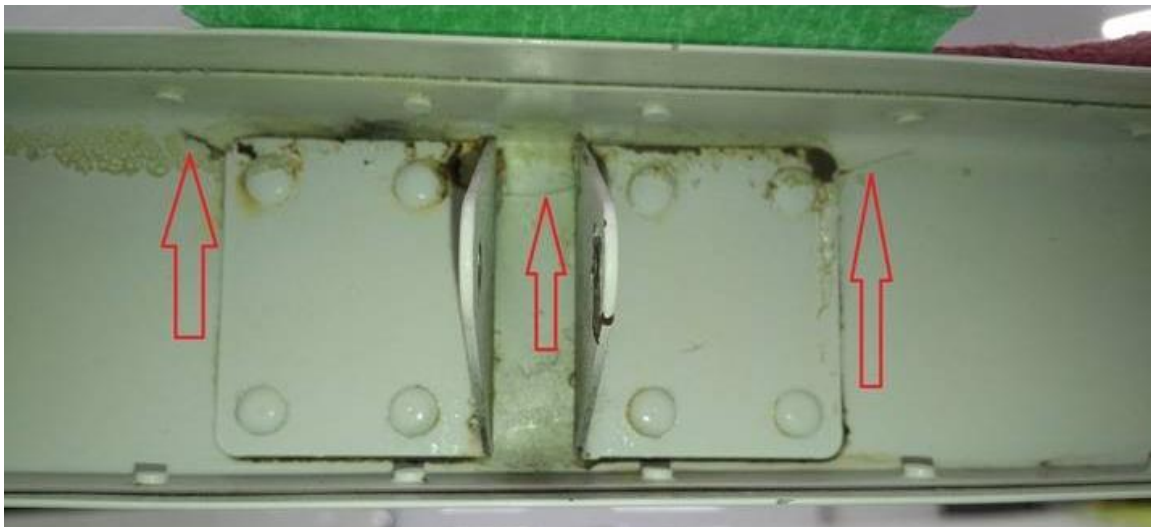
Van's Aircraft has received reports of cracks forming in the outboard elevator hinge bracket areas of the horizontal stabilizer rear spar. See Figures 1 through 4 below for visual examples of cracks.

Formation of these cracks is caused by loads from the elevator hinge pushing and pulling on the web of the rear spar. This has been observed and reported on multiple RV-3, RV-4, RV-6, RV-7 and RV-8 aircraft, in many cases where aerobatics were performed and the airframe total times were near 2,000 hours, although cracks have since been reported on aircraft with a variety of total times and operations.

**FIGURE 1: EXAMPLE 1 - CRACK LOCATIONS – AFT SIDE OF SPAR**

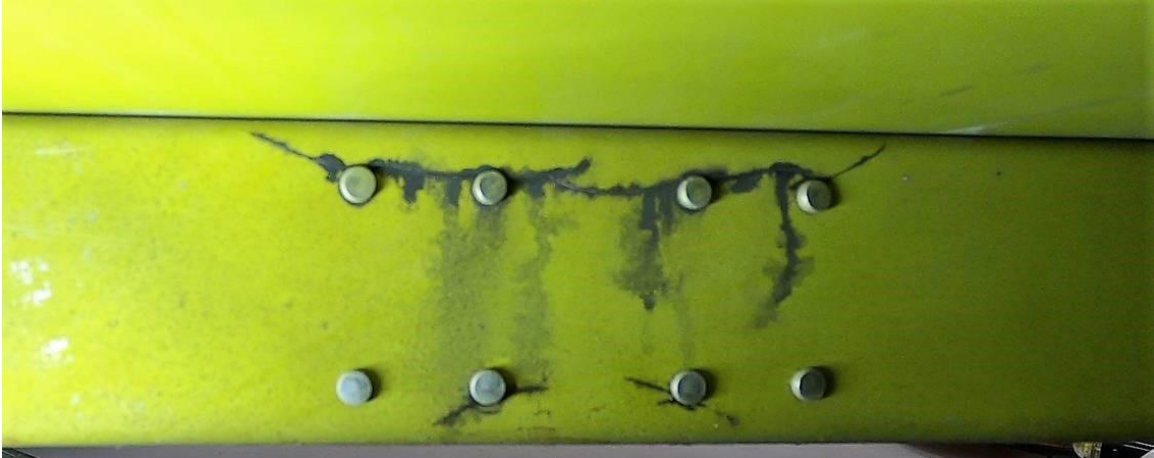
**FIGURE 2:** EXAMPLE 1 - CRACK LOCATIONS - FWD SIDE OF SPAR

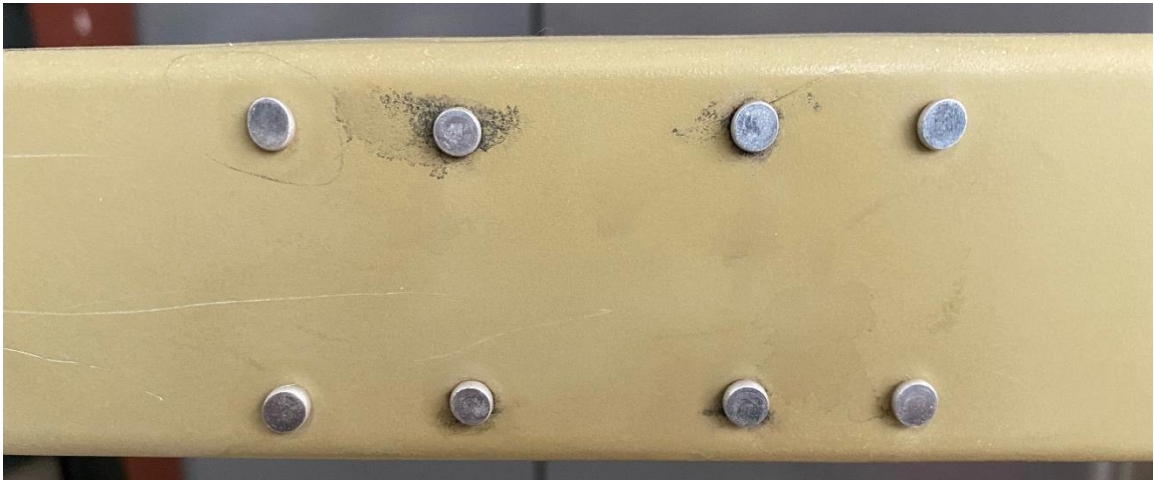
**FIGURE 3:** EXAMPLE 2 - CRACK LOCATIONS - FWD SIDE OF SPAR

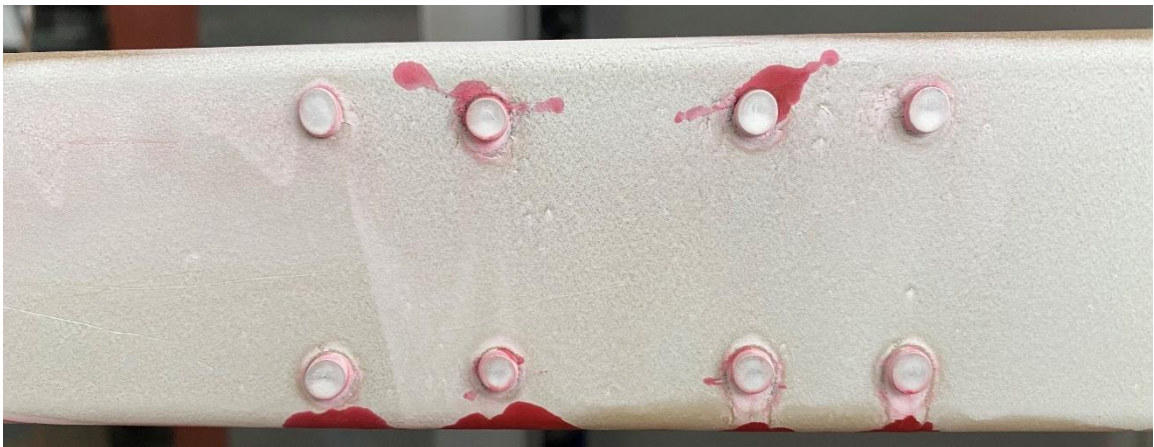
**FIGURE 4:** EXAMPLE 2 - CRACK LOCATIONS - FWD SIDE OF SPAR
