SERVICE BULLETIN 00080 REV 2

Subject: Inspection of EA-00002 Oil Cooler for Possible Leaks

Affected Models: RV's using EA-00002 Oil Coolers

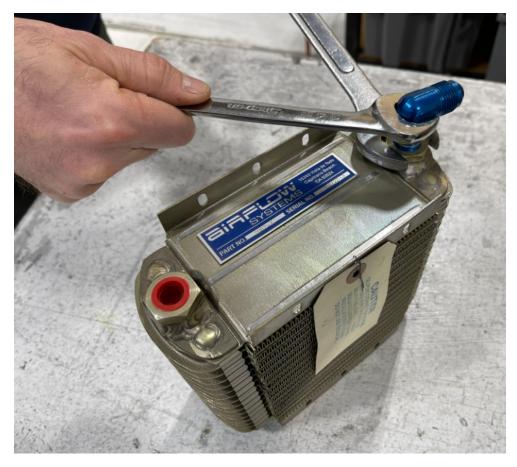
WARNING! Some coolers in which the fluid fittings were torqued improperly have shown leaks outside the affected serial number range given in Airflow Systems Oil Cooler Service Bulletin 0001. Always use wrenches on both the cooler and the fluid fitting! For further information watch the video linked here.

FIGURE 1: USE TWO WRENCHES WHEN TIGHTENING FITTINGS
