SERVICE LETTER 00072

Date Released:	June 19, 2023
Date Effective:	June 19, 2023
Subject:	Ignition Module Firmware Update
Affected Models:	RV-12iS with avionics kits shipped before June 2023 RV-12iS SLSA Serial Numbers 12003, 12076-12128
Required Action:	Install new ES-60016-7.3 microcontroller on AV-60007 Ignition Module
Time of Compliance:	Optional, upon indication of below-described start behavior
Supersedes Notice:	N/A (if applicable)
Labor Required / SLSA Warranty Allowance:	0.5 hours
Level of Certification:	SLSA: LSA Repairman Maintenance or A&P ELSA: Owner (certification not required) <i>Check the rules of the local controlling authority/agency and the operating limitations for your aircraft.</i>

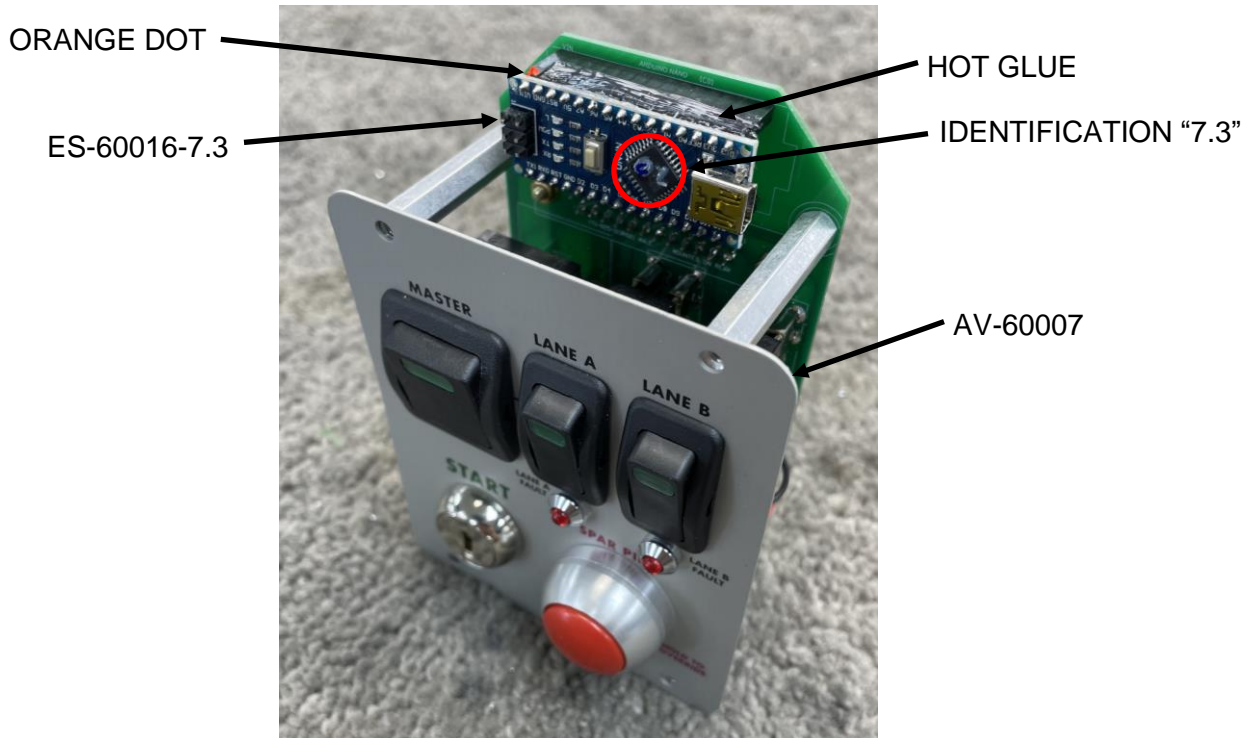
FIGURE 1: AV-60007 IGNITION MODULE

The AV-60007 Ignition Module includes an onboard microcontroller device that controls start power during the aircraft start-up sequence. After starting the engine, the Ignition Module automatically disconnects start power, and the Rotax 912iS directly powers the fuse box and fuel pumps. Van's aircraft has found that after completion of SB-00058, the Ignition Module may time out early and shut off the fuse box and fuel pumps before starting the engine.

NOTE: The ES-60016-7.3 can be identified by “7.3” written on the microcontroller chip, as shown in Figure 1.

Step 3: Remove the ES-60016 microcontroller from the AV-60007 Ignition Module. See Figure 1.

NOTE: The ES-60016 is retained by the friction of the pins and a strip of hot glue on the top. It can simply be pulled from the AV-60007.

Step 4: Install the ES-60016-7.3 microcontroller on the AV-60007 Ignition Module with the orange dot facing up. See Figure 1.

Step 5: Apply a strip of hot glue across the top of the ES-60016-7.3 and AV-60007 as shown in Figure 1. The hot glue must bridge across both components to retain the ES-60016-7.3.
