SERVICE LETTER 00096

Date Released:	June 17, 2024
Date Effective:	June 17, 2024
Subject:	Laser Cut RV-10 Rear Spar Bulkhead Remediation
Affected Models:	RV-10 fuselages constructed with a laser cut F-1005A Rear Spar Bulkhead
Required Action:	<p>Inspect the F-1005A for fatigue cracks propagated from fastener holes. In many places, cracks will not be visible until they have propagated beyond the flanges of overlapping parts. If cracks are present, replace the laser-cut F-1005A with a punched part. If cracks are not present, install the alternate fix detailed below.</p>
Time of Compliance:	<p>Inspect within 200 flight hours or at the next annual inspection, whichever is earlier.</p> <p>If fatigue cracking is not present, you may continue to comply with this Service Letter via ongoing inspection no less than every 12 months or 200 flight hours, whichever is first.</p> <p>Upon or before reaching 1000 flight hours, the alternate fix must be conducted as outlined in this Service Letter, at which point compliance has been met without need for ongoing inspection.</p> <p>If fatigue cracking is present, replace the F-1005A before further flight, or contact Van's Aircraft to discuss alternati

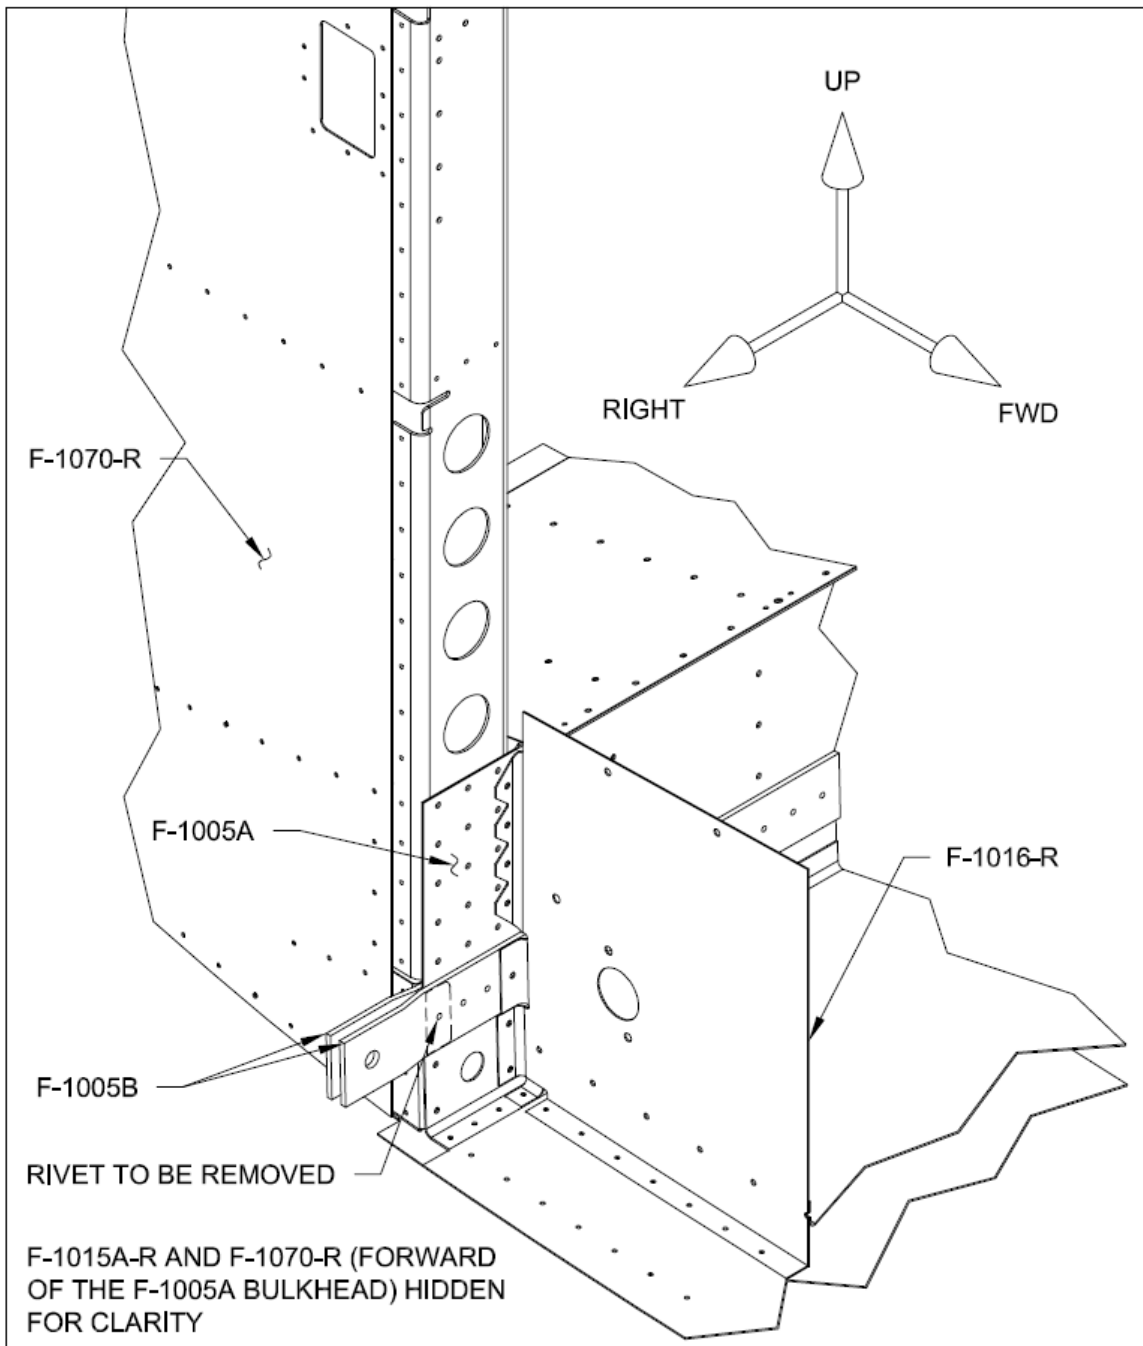
FIGURE 1: RV-10 MID FUSELAGE AS VIEWED FROM THE FRONT RIGHT

The Rear Spar Bulkhead Assembly is a highly-loaded section of the fuselage structure built upon the F-1005A Rear Spar Bulkhead; classified as Recommended for Replacement. The outboard-most rivet in the bulkhead assembly that attaches to the F-1005B Rear Spar Attach Bar sees particularly high loads, and is the sole area of concern for the assembly with regards to laser cut part fatigue. Replacement of the F-1005A would be very involved on a flying aircraft, a QuickBuild Kit, or a Standard Kit that has progressed past Section 25 of the KAI (Kit Assembly Instruction). However, an alternate fix has been developed, restoring the structure to as-good or better structural strength and durability in service, with a drastically reduced workload.

The alternate fix requires the outboard-most rivet to be drilled out, the hole upsized, and an AN3 bolt installed in the original rivet's place as shown in Figure 1. Given the curvature of the side skins and existing structure in the area, drilling this rivet out from inside the fuselage would be nearly impossible while maintaining proper drill alignment. Fortunately, an existing hole in the fuselage side skin can be altered, allowing easy access to the rivet from outside of the fuselage. This modification to the side skin does not negatively affect the strength of the area, and will be covered by the wing root fairing.
