SERVICE BULLETIN 00116

Subject: Autopilot Roll Servo Bracket Attach Rivets

Affected Models: RV-12 or RV-12iS with an autopilot

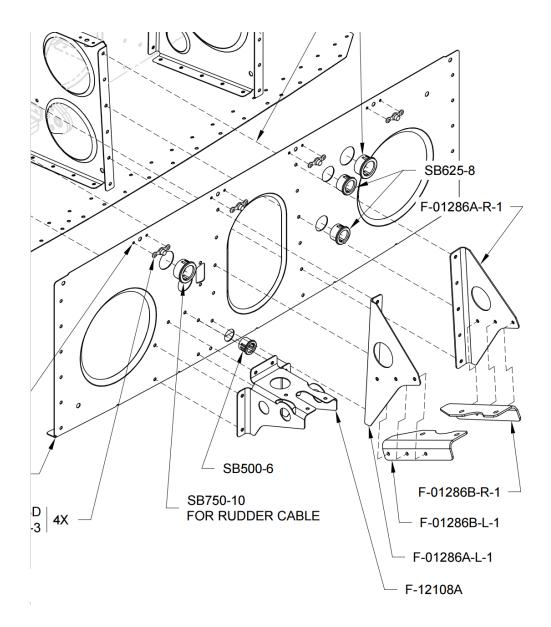
FIGURE 1: RV-12iS SERVO ANGLE INSTALLATION (SEE KAI 21iS/U)

A report from a RV-12 aircraft equipped with a Dynon autopilot indicated that rivets had failed that attach the F-1286B-L & -R Servo Angles to the F-1286A-L & -R Servo Brackets. The current attach rivets should be updated to solid rivets.

<u>Step 2:</u> Inspect the rivets that attach the F-1286B-L & -R Servo Angles to the F-1286A-L & -R Servo Brackets (for RV-12) or F-1286-B-L-1 & -R Servo Attach Angles to the F-1286A-L & -R Servo Brackets (for RV-12iS).

Step 3: Drill out the six rivets that attach the servo angles to the servo brackets.

<u>Step 4:</u> Replace the six rivets removed in Step 3 with AN470AD4-4.5 rivets or CherryMax CR3213-4-02 rivets.
