# **SERVICE BULLETIN 19-08-16**

Subject: AV-60000 and AV-60009 Recall

Affected Models: RV-12iS

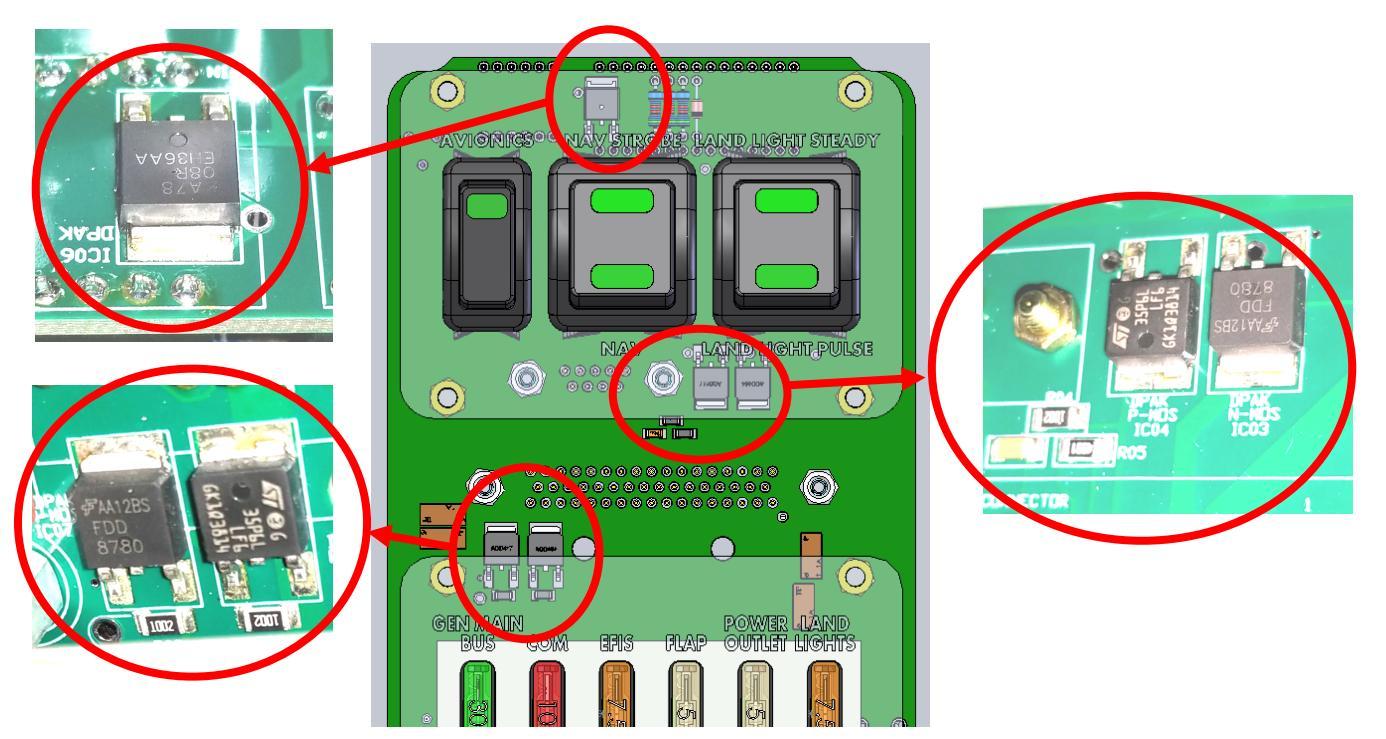
Take clear, in focus, well lighted, pictures of the 3 locations noted in Figure 3 on the AV-60000 and the location in Figure 7 on the AV-60009. Send these photos to <u>servicebulletins@vansaircraft.com</u>.

**FIGURE 3:** The AV-60000 components to be photographed are located at the top of the AV-60000 (shown here with transparent faceplates).

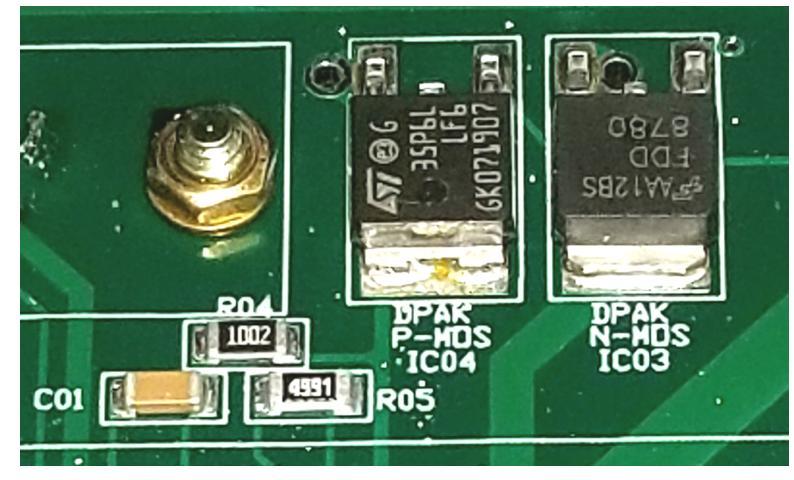
FIGURE 4: Example of in-focus closeup of IC03 and IC04 needed for photo analysis.

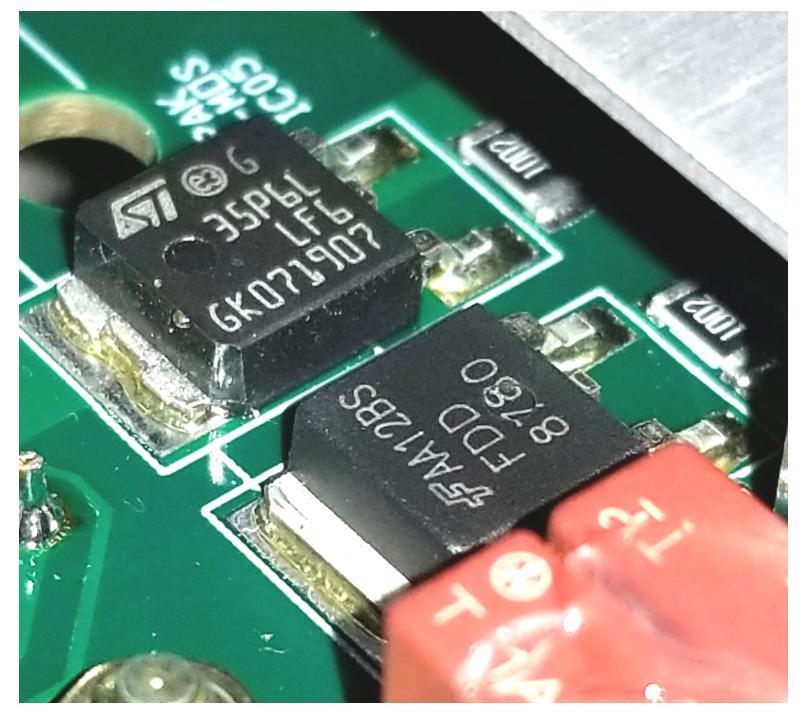
FIGURE 5: Example of in-focus closeup of IC05 and IC07 needed for photo analysis.

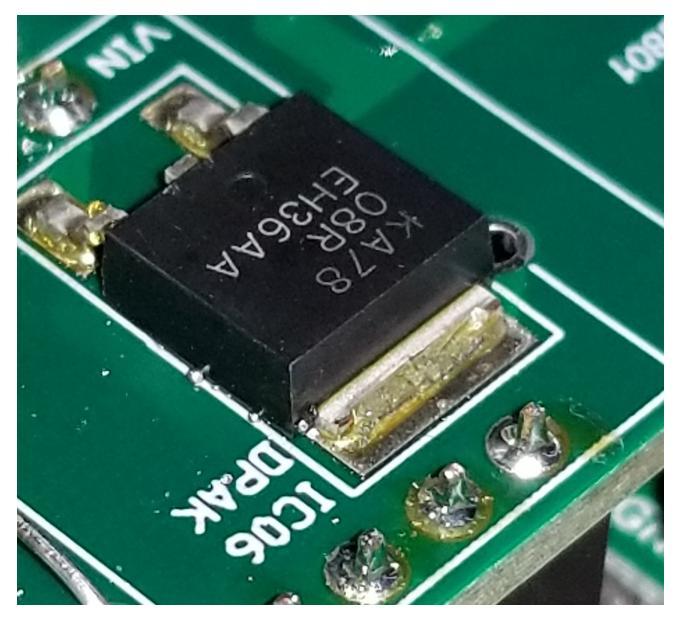
FIGURE 6: Example of in-focus closeup of IC06 needed for photo analysis.

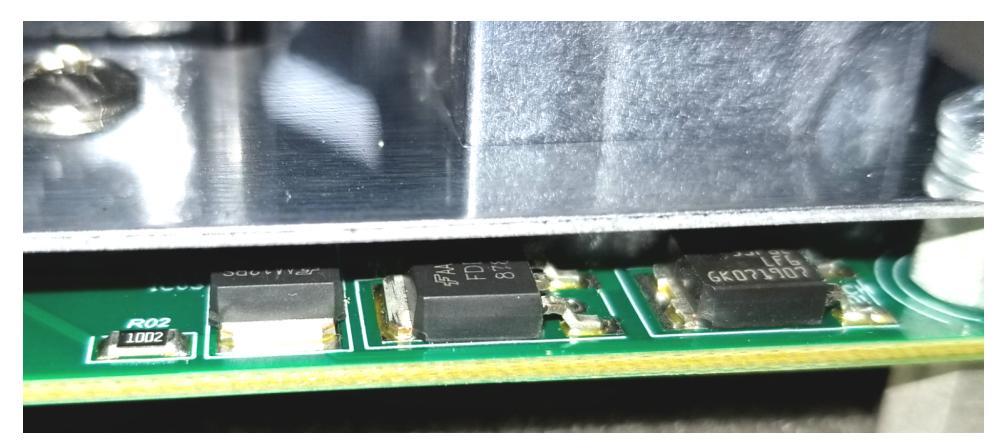
FIGURE 7: Example of in-focus closeup of the AV-60009 components needed for photo analysis. View is looking at the aft end of the assembly nearest the square 8-pin Molex connector.

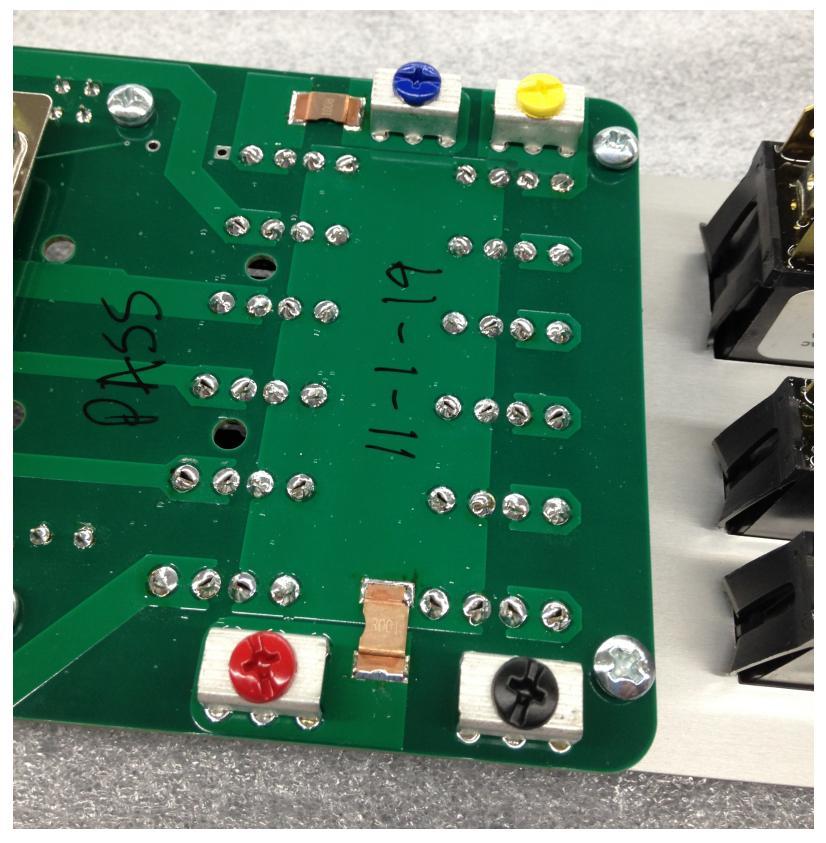
FIGURE 11: AV-60000 Production Date Location

<u>Step 12:</u> Use Figures 11 and 12 below to determine if the production date of your modules is affected and in scope for this Service Bulletin. If not affected, proceed to Step 13. If affected complete the remainder of this Step.
