## **SERVICE BULLETIN 00026**

| Date Released: | October 5, 2020 |
|---|---|
| Subject: | Addition of retaining plates for throttle springs |
| Affected Models: | SLSA: RV-12 (Powered with Rotax 912ULS) with Serial<br>Numbers 12001 through 120074<br>ELSA: RV-12 (Powered with Rotax 912ULS) shipped<br>before October 2020 |

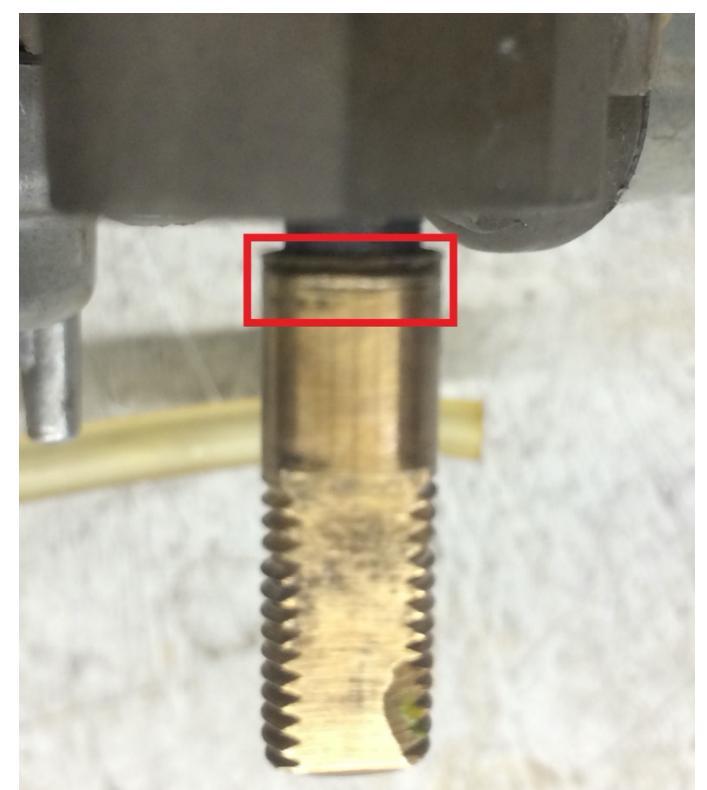
The SPRING-00002-L/R-1 can possibly cause wear to the throttle shaft, as the spring rests against the throttle shaft. This potential wear is located at the base of the throttle shaft. To prevent this, a retaining plate has been designed for the spring to be captured in, and serve as a bearing surface for, the inboard leg of the spring.

Wear caused by the spring to the throttle shaft does not require replacement or modification of the throttle shaft, as long as the wear has not reduced the diameter of the shaft below the existing minimum diameter of the shaft (the minimum diameter of the shaft is located at the base of the shaft, where the shaft enters the carburetor housing).

FIGURE 1: Wear on throttle shaft from throttle return spring

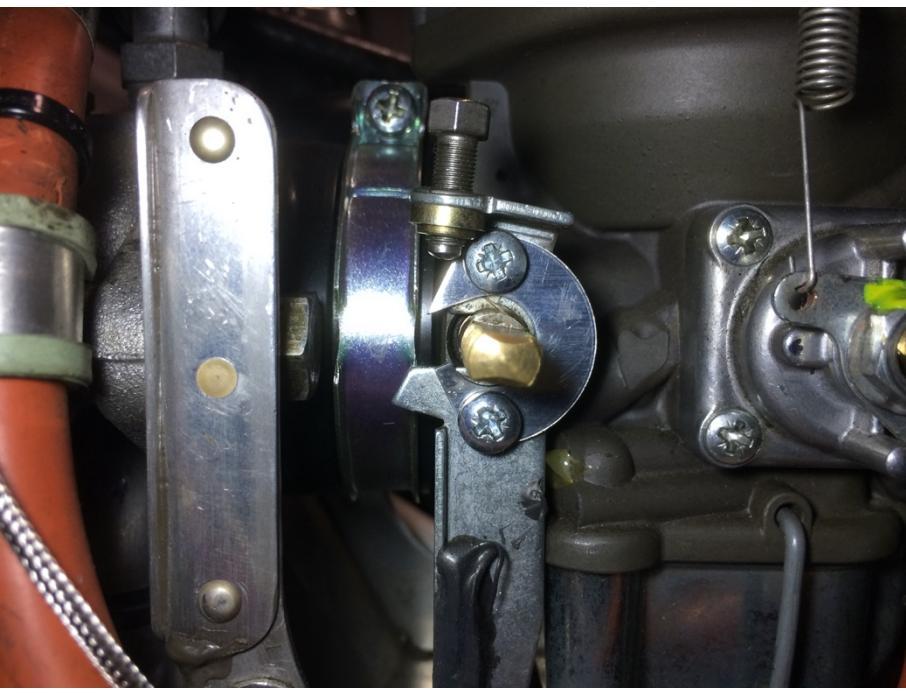
FIGURE 2: VA-00276 installed (SPRING-00002-L-1 not installed)

Step 1: Remove 942290 NUT, 845035 SPRING WASHER, THROTTLE ARM, and SPRING-00002-L/R-1. Refer to KAI 50-05 Figure 1 for detailed parts diagram.

Step 2: Install VA-00276. Refer to KAI 50-05 for the installation process.
