SERVICE BULLETIN 12-11-09

Subject: Loose U-1202 Attach Bolts, Cracking in F-1204 Center Section Assembly, Damage to side skin structure near landing gear attach.

Affected Models: All RV-12 Models

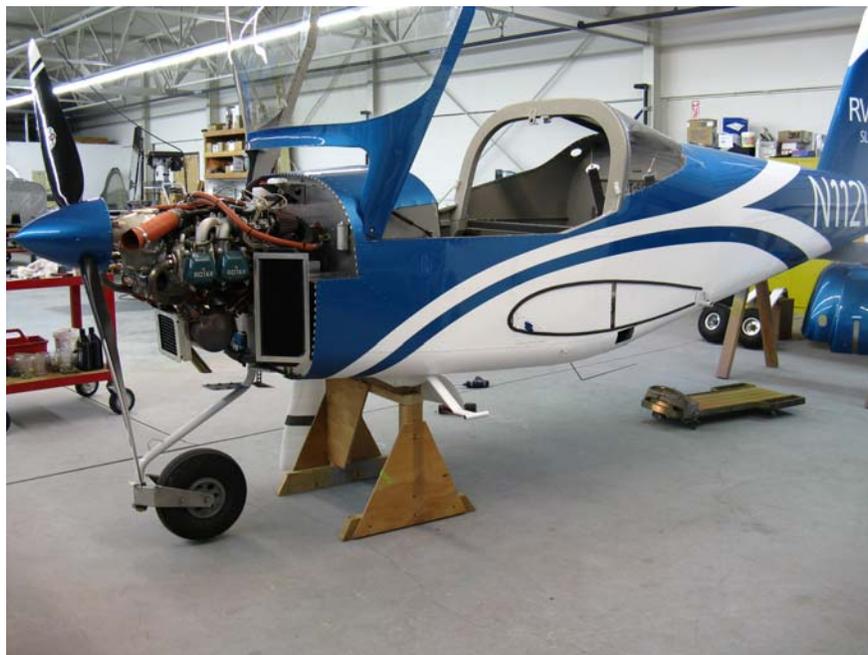
FIGURE 1: AIRCRAFT SUPPORT

Step 8: Support the aircraft using sawhorses such that both main landing gear are no longer touching the ground. See "Lifting and Supporting the Fuselage" in the Maintenance Manual. Note an alternative aft sawhorse position is shown in Figure 1.

A height that positions the tires approx. 1 inch off the floor makes it easier to hold the legs in the proper position during removal and re-installation.

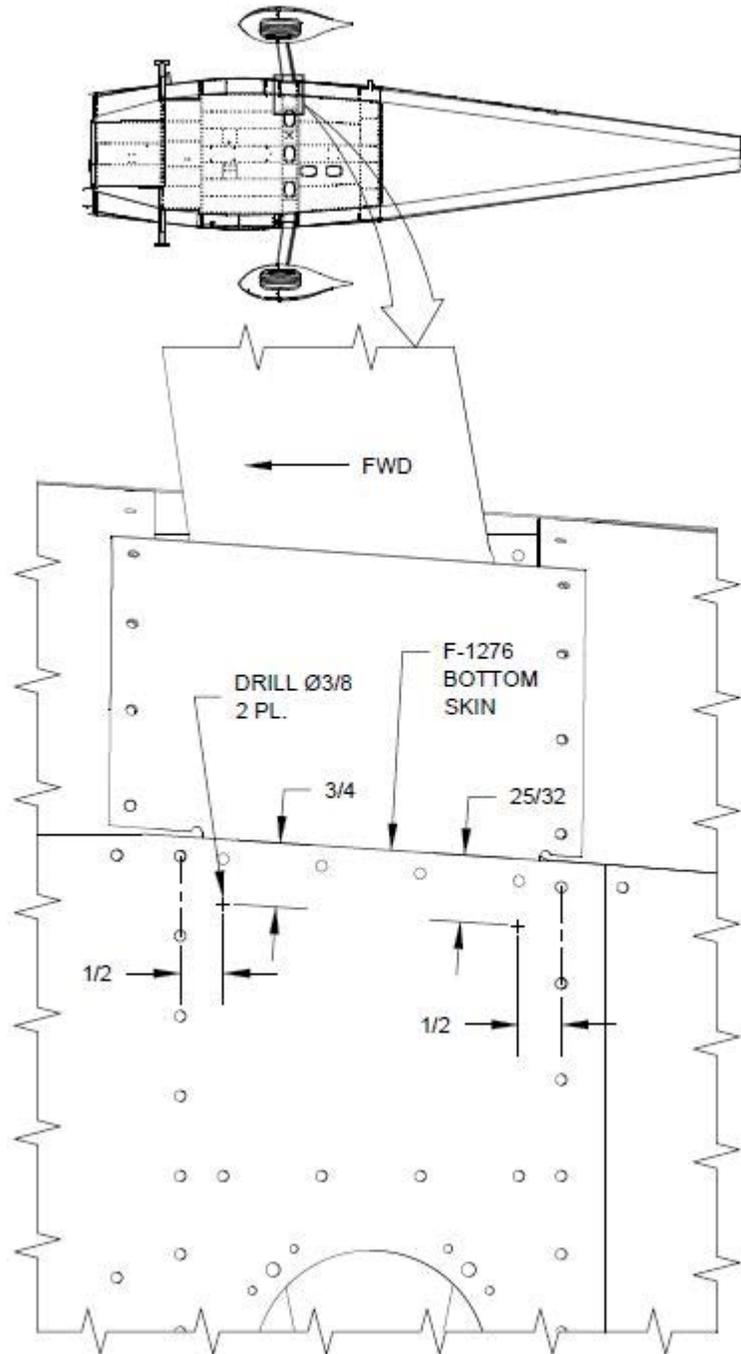
FIGURE 2: DRIFT AND SOCKET ACCESS HOLES (BOTTOM VIEW - LEFT SIDE)

Step 12: Use a Step-Drill (Uni-bit™) to drill 3/8 dia. [9.5mm] holes in the F-1276 Bottom Skin to allow for insertion of a drift (for seating the bolt hardware) or a socket extension before the socket itself is attached.. See Figure 2. This will permit torque to be applied to the head of the U-1202 attach bolts.

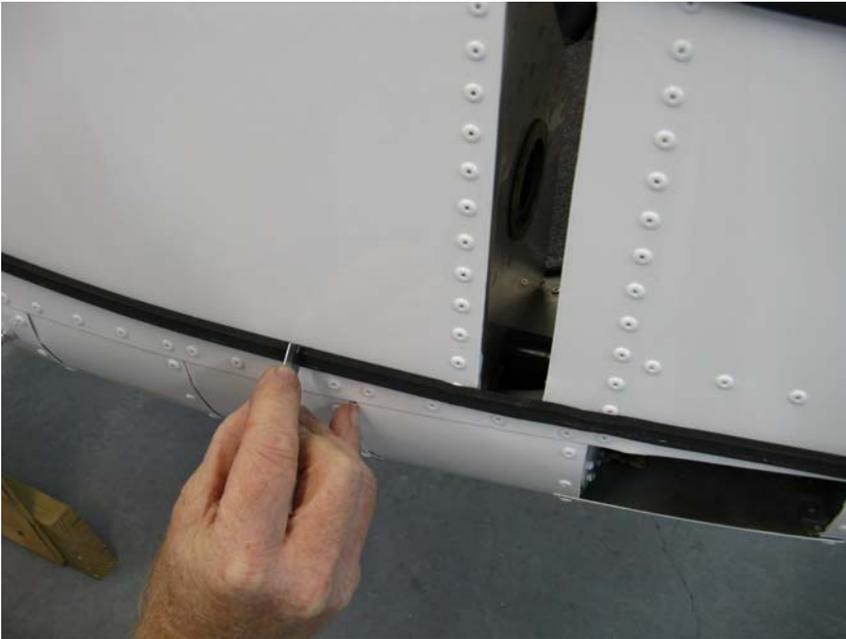
FIGURE 3: CUTTING SEAL STRIP

Step 14: Cut the wing root seal with a razor blade at the location shown in Fig 6. Remove the portion of the wing root seal strip aft of the cut point by using a sharpened wood Popsicle type stick to lift the seal away as you pull it with your opposite hand. See Figures 3 and 4.

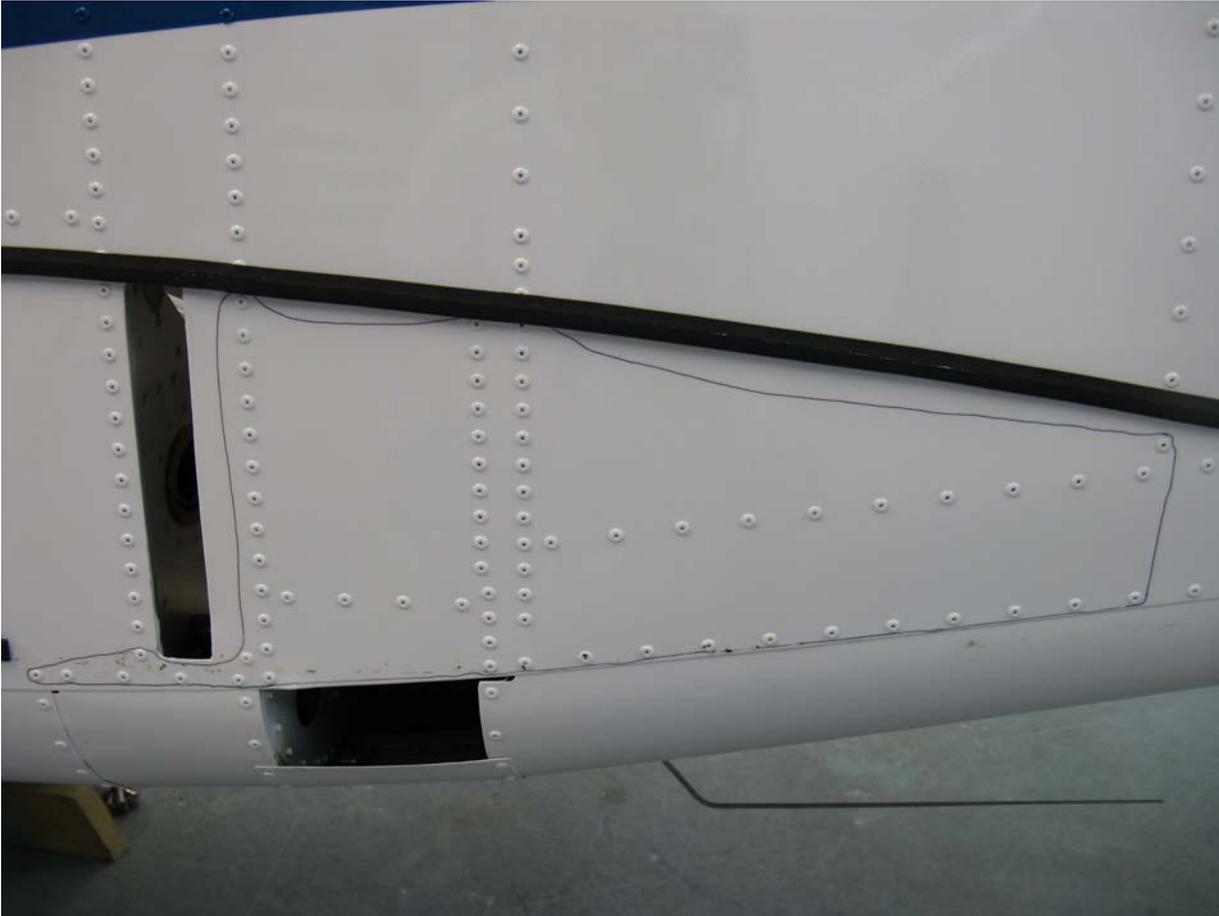
FIGURE 5: MARKING RIVET
REMOVAL AREA

Step 15: Reference Figures 5, 6 and the F-1270A Doubler to mark the zone on the fuselage side for rivet removal. See Figure 5.

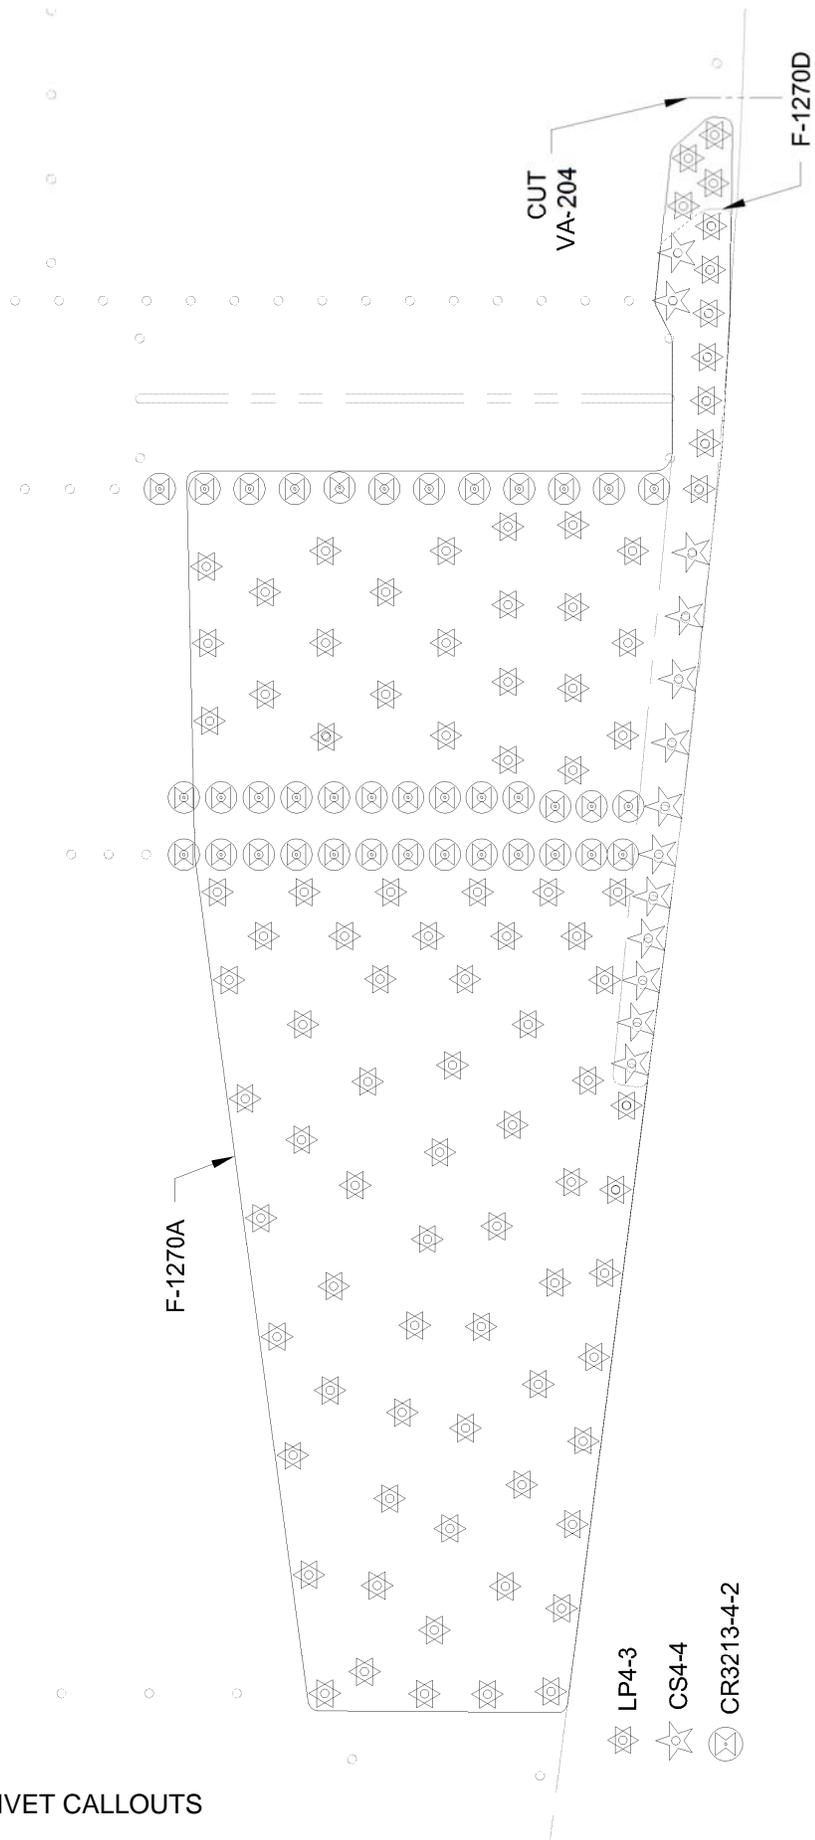
FIGURE 6: RIVET CALLOUTS

Remove all rivets that have rivet callouts depicted in Figure 6

Step 31: Rivet the F-1270A and F-1270D Side Skin Doublers to the fuselage structure using the rivet callouts in Figure 6.

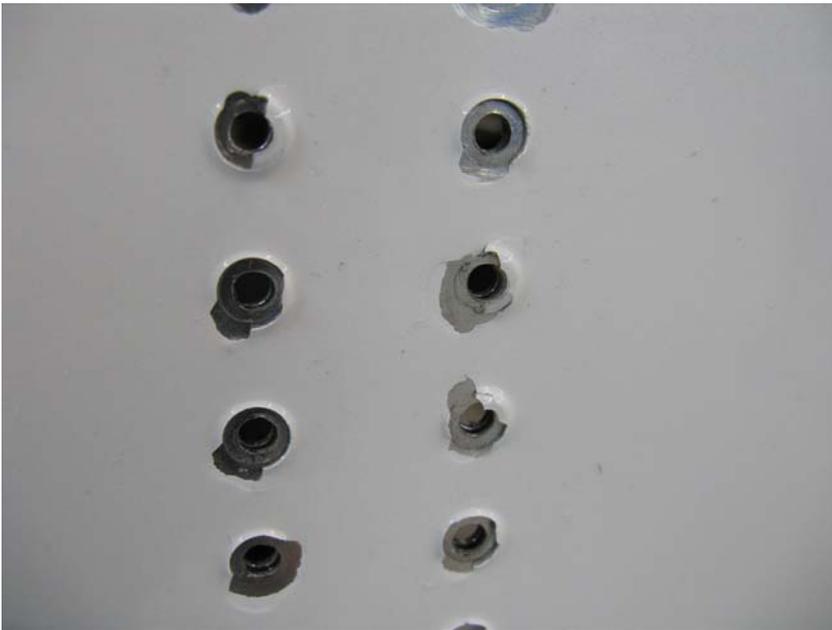
FIGURE 7: RIVET HEAD
PAINT BUILDUP

Step 17: Once the rivet heads are all removed, any paint ridge caused by the rivet heads that is present must be removed. This can be done by shaving them flush with a sharp wood chisel, sanding them with a small sanding block, etc.. See Figure 7 and Figure 8.

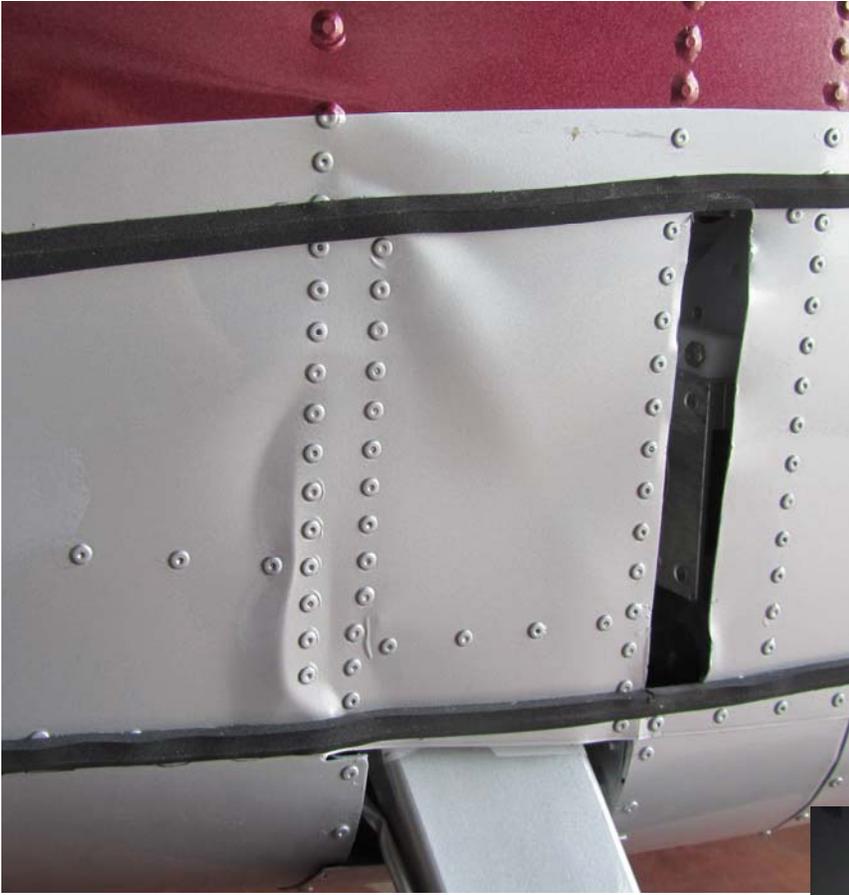
FIGURE 9: SIDE SKIN DAMAGE

Step 19: Inspect for damage in fuselage structure including skins and internal bulkheads near the gear leg opening. See Figures 9 and 10.

Flatten any damage in the F-1270 Fuselage Side Skin, F-1253-L & -R Seat Floor Supports, F-1273-L & -R Baggage Corner Skin and F-1275-L & -R Fuselage Corner Skins. See Sections 21,23 and 25.

When flattening creases or ripples in skins, first evaluate the sharpness of the bend. At locations where there is a sharply defined crease apply localized pressure along the raised portion of the crease, forcing it back in the opposite direction. A hardwood (Oak or Maple) block with a 6 inch radius sanded on the end, and the sharp corners radiused slightly (about 1/16" radius) works well as a tool. The large radius on the end of the tool allows you to rock it along the crease. It is more of a massaging process than a one time bending process. Work slowly a little at a time, starting at the worst point, then working your way out from there.

On large radius creases or ripples, a tool with a bigger radius is needed. A general rule to follow for removing large radius creases is find a hard round object of similar radius (hard ball shapes work well) to the damaged area. Once again it is a massaging process... don't try and straighten the damage in just one pass.

Most of all, resist getting out a big hammer and dolly. This process is faster, but localized hammering thins/stretches the metal, causing big oilcans and ripples that can only be resolved by replacing the skin.

If unable to flatten and straighten damaged parts/skins, replace the parts or contact Van's Aircraft for further support. Van's will determine if the damage may be flattened out or if part replacement is necessary. Photos and description of damage can be e-mailed to engineering@vansaircraft.com.

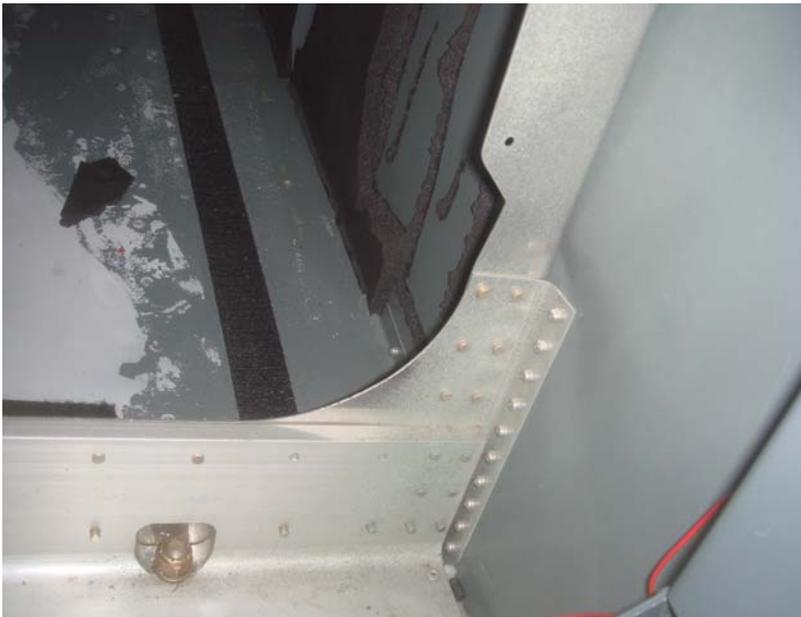
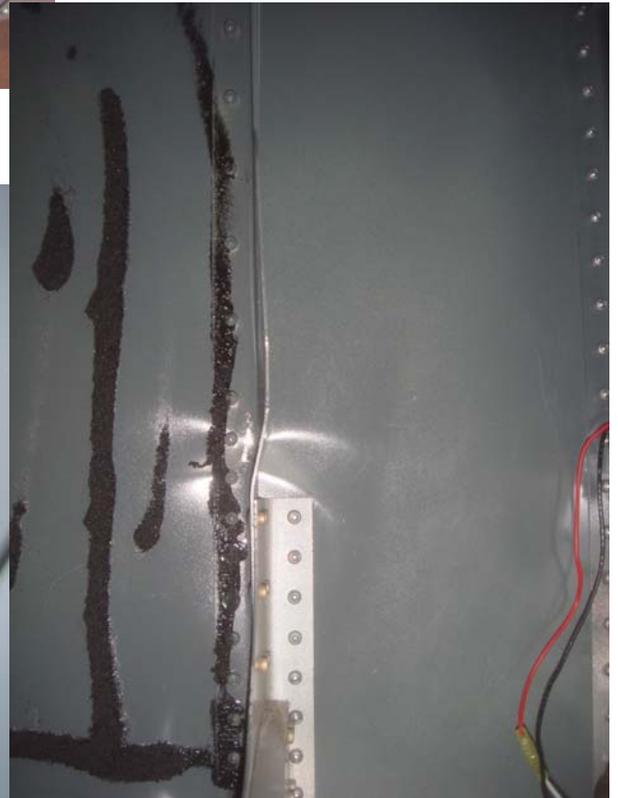
FIGURE 10: BULKHEAD DAMAGE
EXAMPLE

Straighten any buckling in the F-1204F-R Aft Side Bulkhead. This especially may be prevalent just above the upper edge of the F-1204D Center Section Aft Bulkhead. See Construction Manual Page 20-04, Fig. 1.

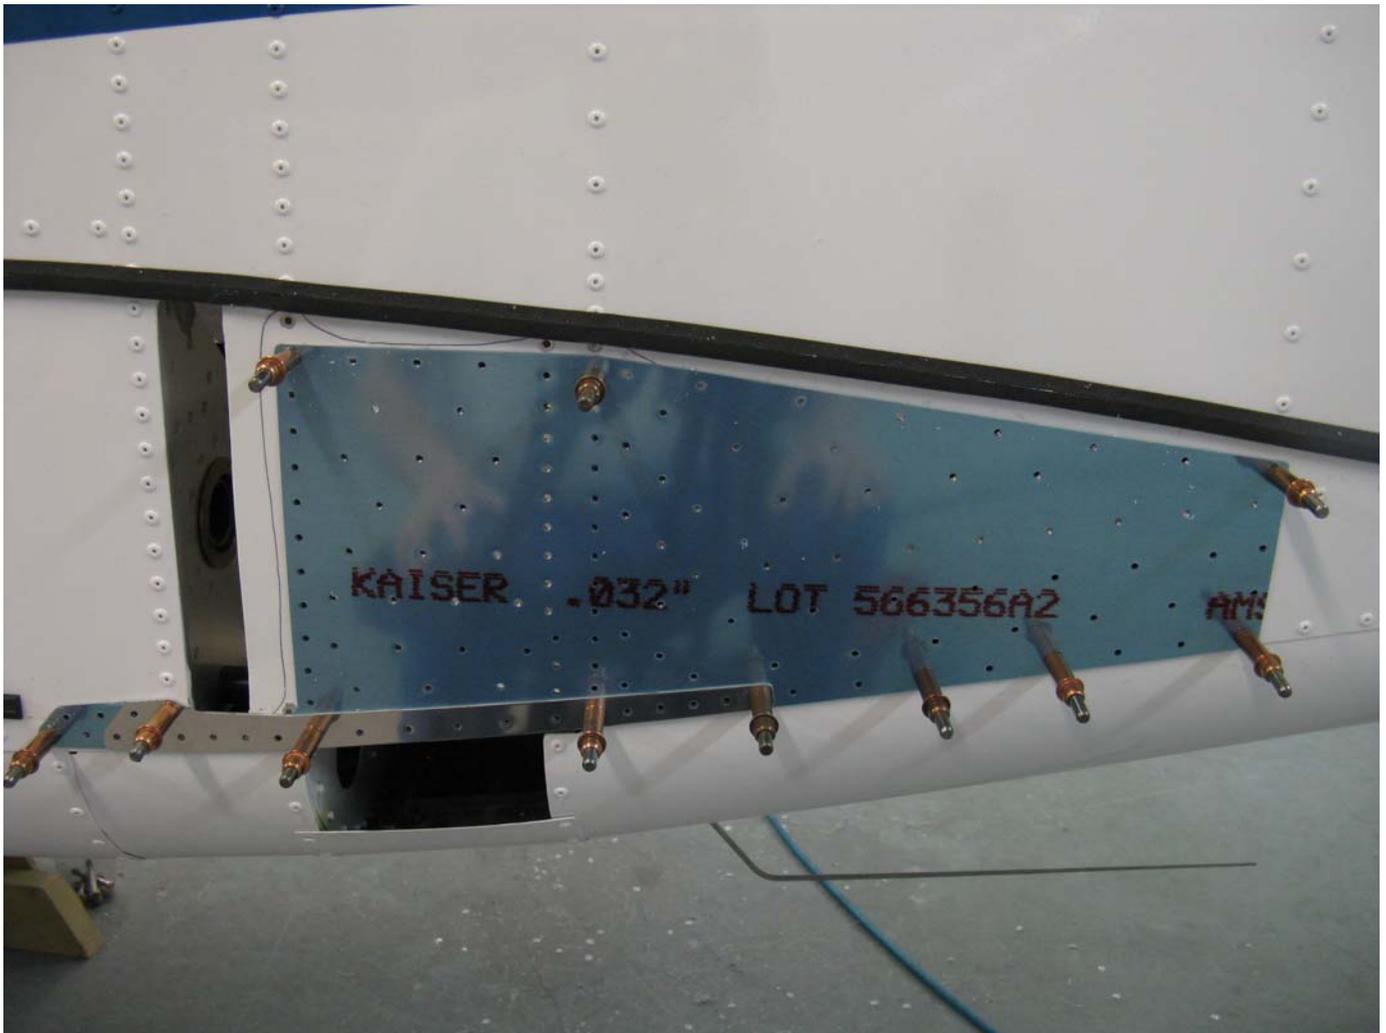
FIGURE 11: ADDING SIDE SKIN DOUBLERS

Step 20: Remove the blue vinyl plastic from the F-1270A and F-1270D Side Skin Doublers, and cleco them to the sides of the fuselage. See Figure 11.

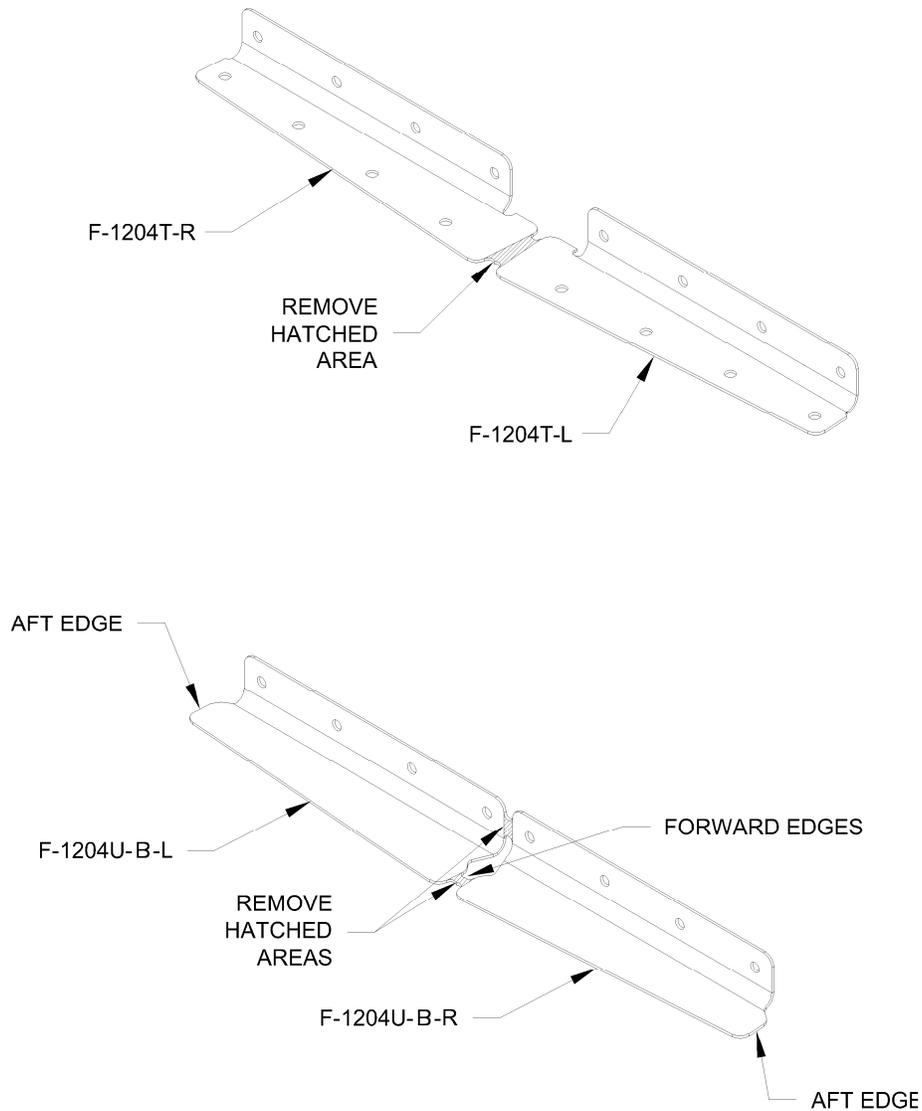
FIGURE 12: SKIN ATTACH FLANGES

Step 23: Separate the F-1204U-B L & R and F-1204T-2 L & R from each other by cutting as shown in Fig. 12

Step 24: Bend a slight upward angle on the flange extensions on the bottom flange forward and aft edges of the F-1204U-B Angles. A pair of pliers with tape applied to pad the jaws can be used. See Figure 12.

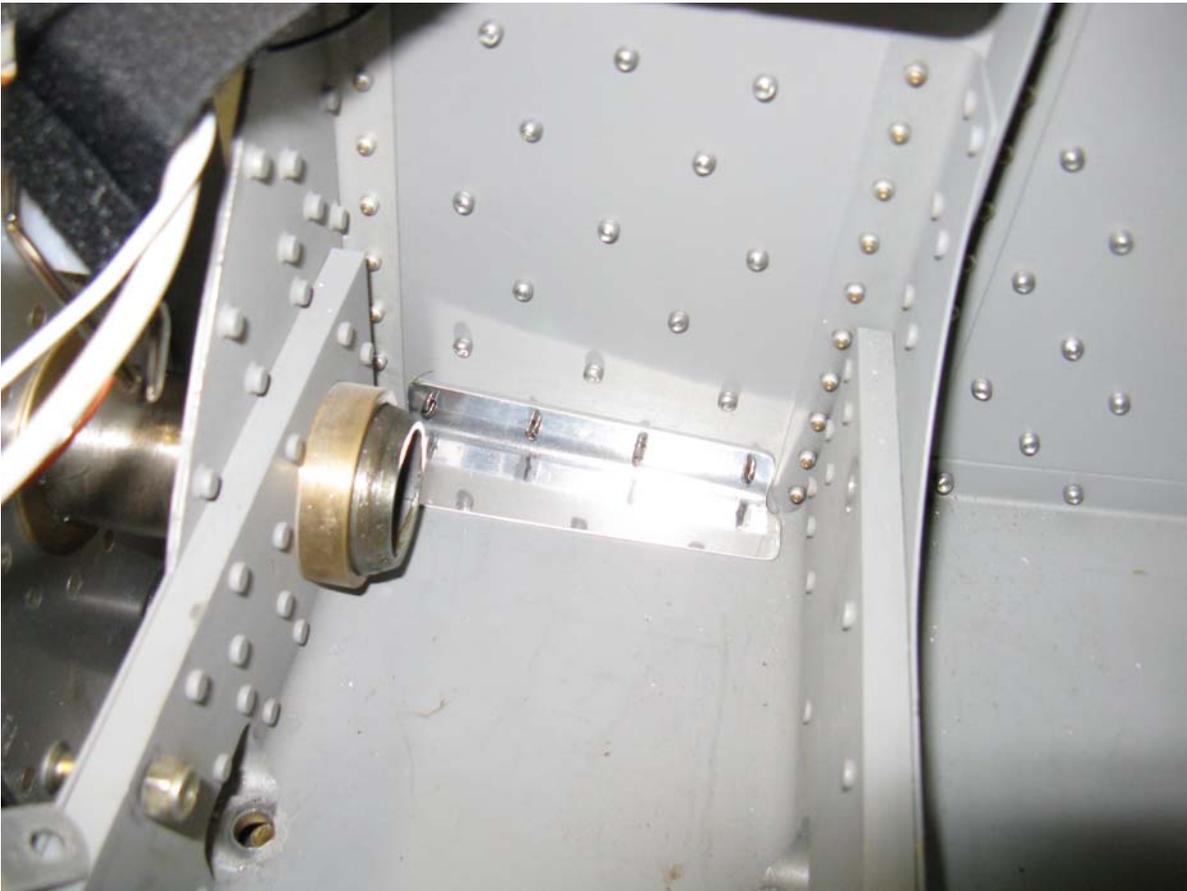
FIGURE 13: CLECOING THE SKIN
ATTACH FLANGES

Step 25: Cleco the F-1202U-B L & R into position (cleco all holes). Use a 12" #30 drill, and match drill from below up through the four holes in the F-1204 Center Section (cleco each hole as you drill). See Figure 13.

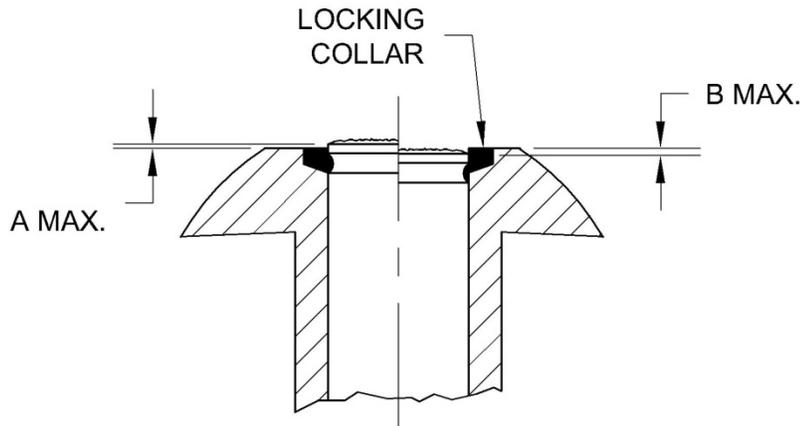
FIGURE 14B: RIVET CROSS SECTION

Typical fastener flushness acceptance criteria is shown in Figure 14B and listed in Table 2 below. Locking collar is to be flush with top surface of rivet head. Collar flash permissible is .020 max. Stem flushness shall be as indicated.

RIVET DIAMETER	A MAX.	B MAX.
-4 (1/8") [3.2mm]	0.010 [.25mm]	0.015 [.38mm]

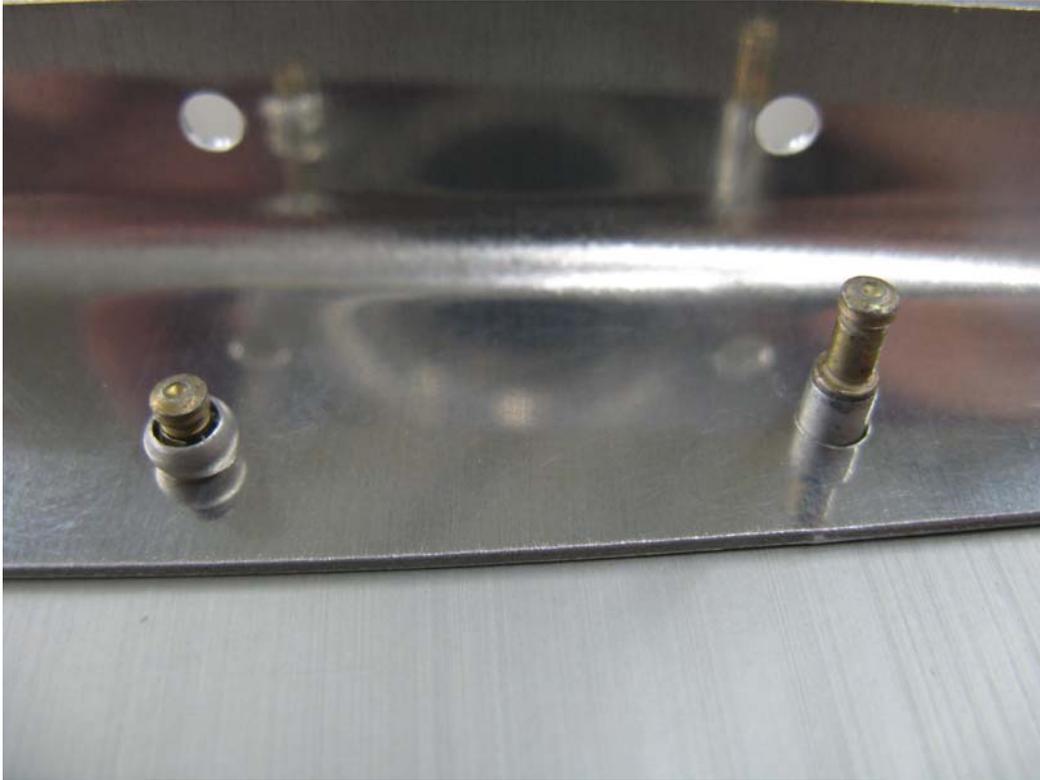
FIGURE 14C: CR32XX
SHOP HEAD EXAMPLE
(after and before installation)

- iii. Stem will not be pulled fully into rivet body at shop head end, but rivet body should have formed (closed up) around stem as shown in left-hand side of Figure 14C. See Figure 14D for acceptable blind head formations.

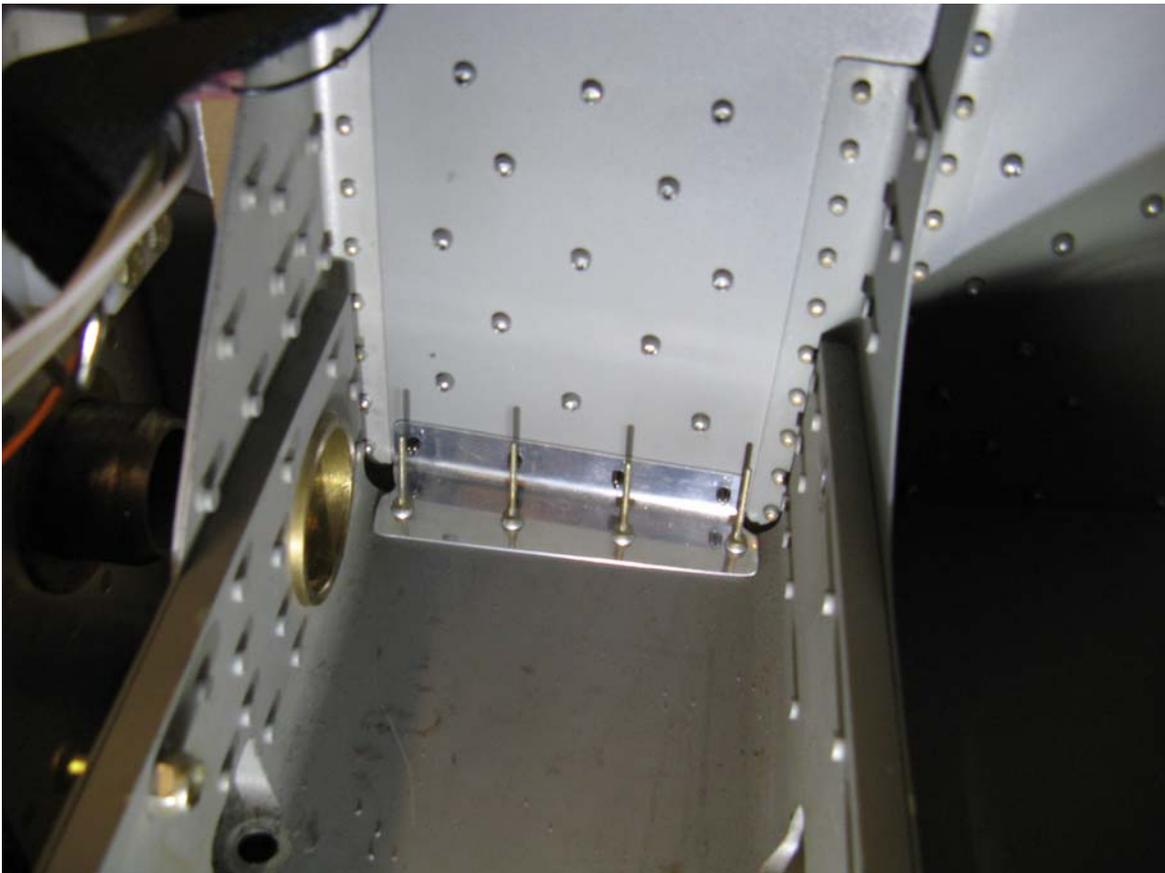
FIGURE 14E: ATTACHING SKIN STIFFENER ANGLES TO CENTER SECTION CHANNEL USING CHERRYMAX CR32XX RIVETS
(NOTE: RIVETS ARE SHOWN INSTALLED FROM THE UPPER SIDE)

Rivet the F-1204U-B L & R and F-1204T-2 L & R to the F-1204 Center Section Assembly using CR3213-4-5 rivets as shown in Figure 14E.

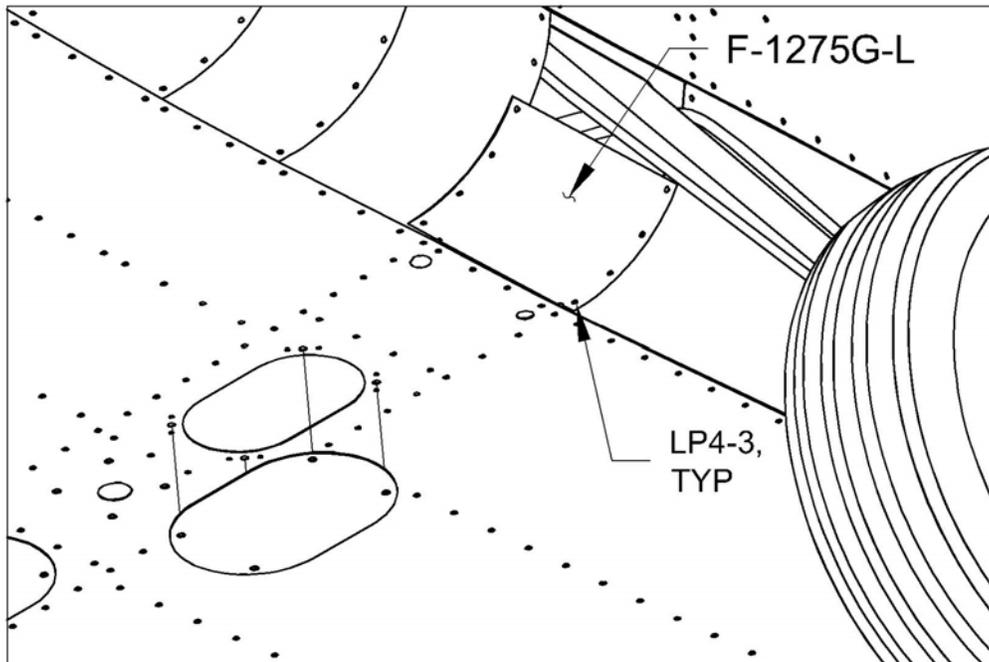
FIGURE 14F: COVER PLATE REMOVAL

[Step 3]: Cleco then rivet the Cover Plates back into place using the rivets called out in Figure 14F.

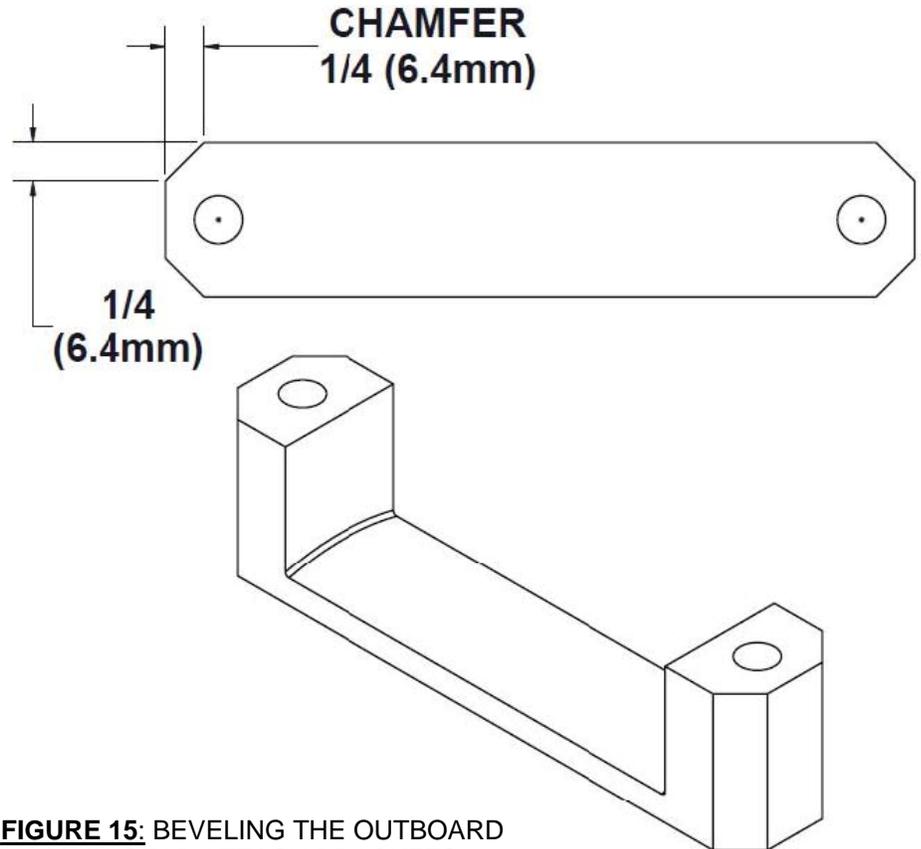
FIGURE 15: BEVELING THE OUTBOARD MAIN GEAR ATTACH BRACKETS

Step 32: Add bevels to the four corners of the U-1202 Outboard Main Gear Attach Brackets as shown in Figure 15, and detailed in RV-12 SB 12-09-2.

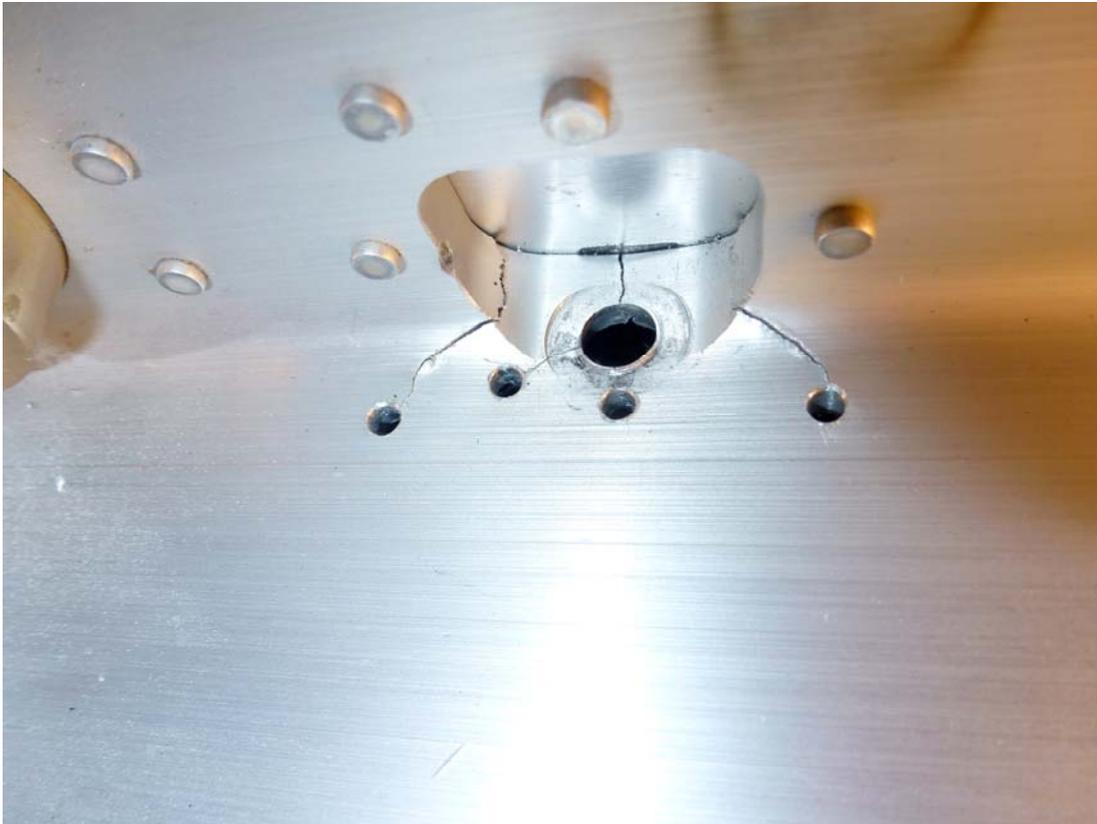
FIGURE 16: CENTER SECTION CRACKING

Step 33: Thoroughly clean the area and remove any primer or paint around the cracked region shown in Figure 16. Inspect the areas around the forward U-1202 Outboard Main Gear Attach Bracket hole in the F-1204 Center Section Assembly.

If cracks are present find the end of the crack then mark the end with a center punch. Stop Drill #30 the end of each crack.

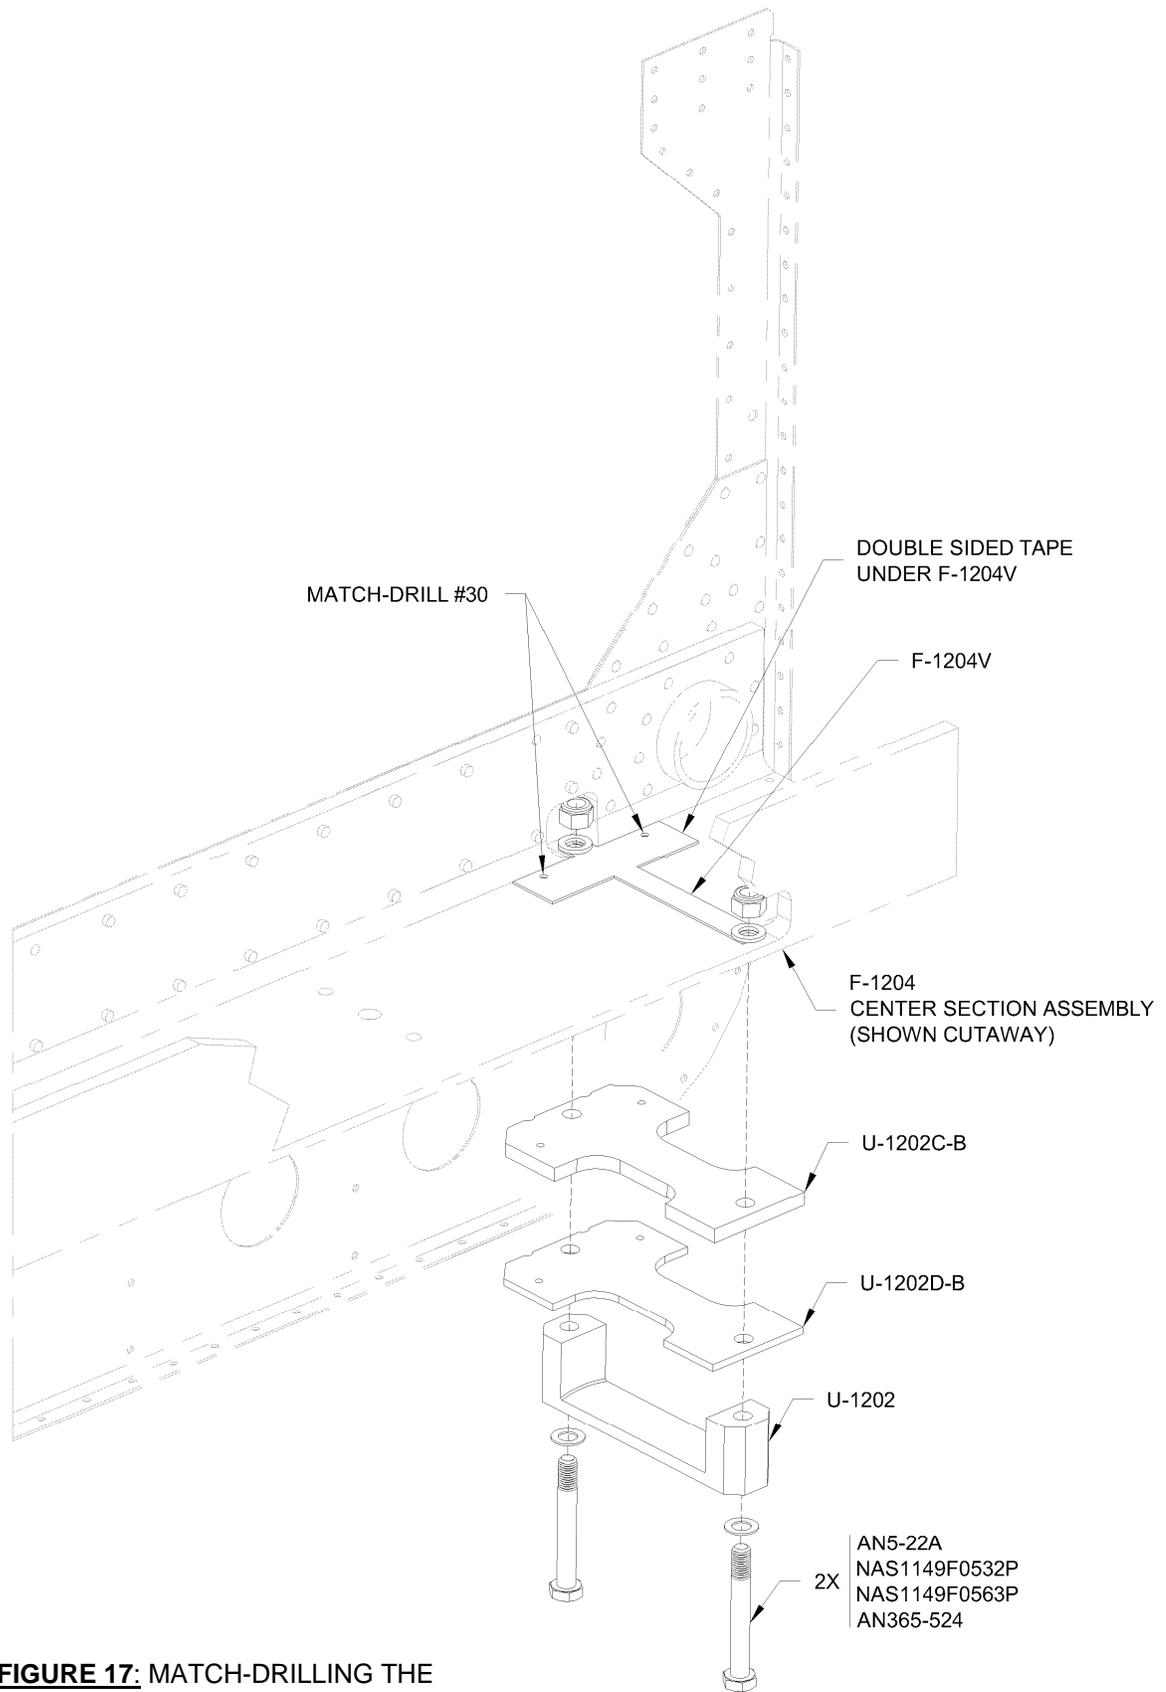
FIGURE 17: MATCH-DRILLING THE CENTER SECTION

Step 36: Attach the F-1204V Drill Template to the top side of the F-1204 Center Section Assembly with the U-1202 Outboard Main Gear Attach Bracket, U-1202C-B Outboard Doubler Plate and U-1202D-B Outboard Wear Plate to the lower side of the center section assembly at the attachment location for the right main gear leg. Note that the steel wear plate goes below the doubler plate. Use the old AN365-524 Nuts saved when

Step 39: Relocate the template back to the right side. Re-Tighten the hardware holding the attach bracket, doubler and wear plate, and drill template in place. The template is being reinstalled for it's reflective properties. Repeat the drilling process from the previous step for the two holes on the right side.

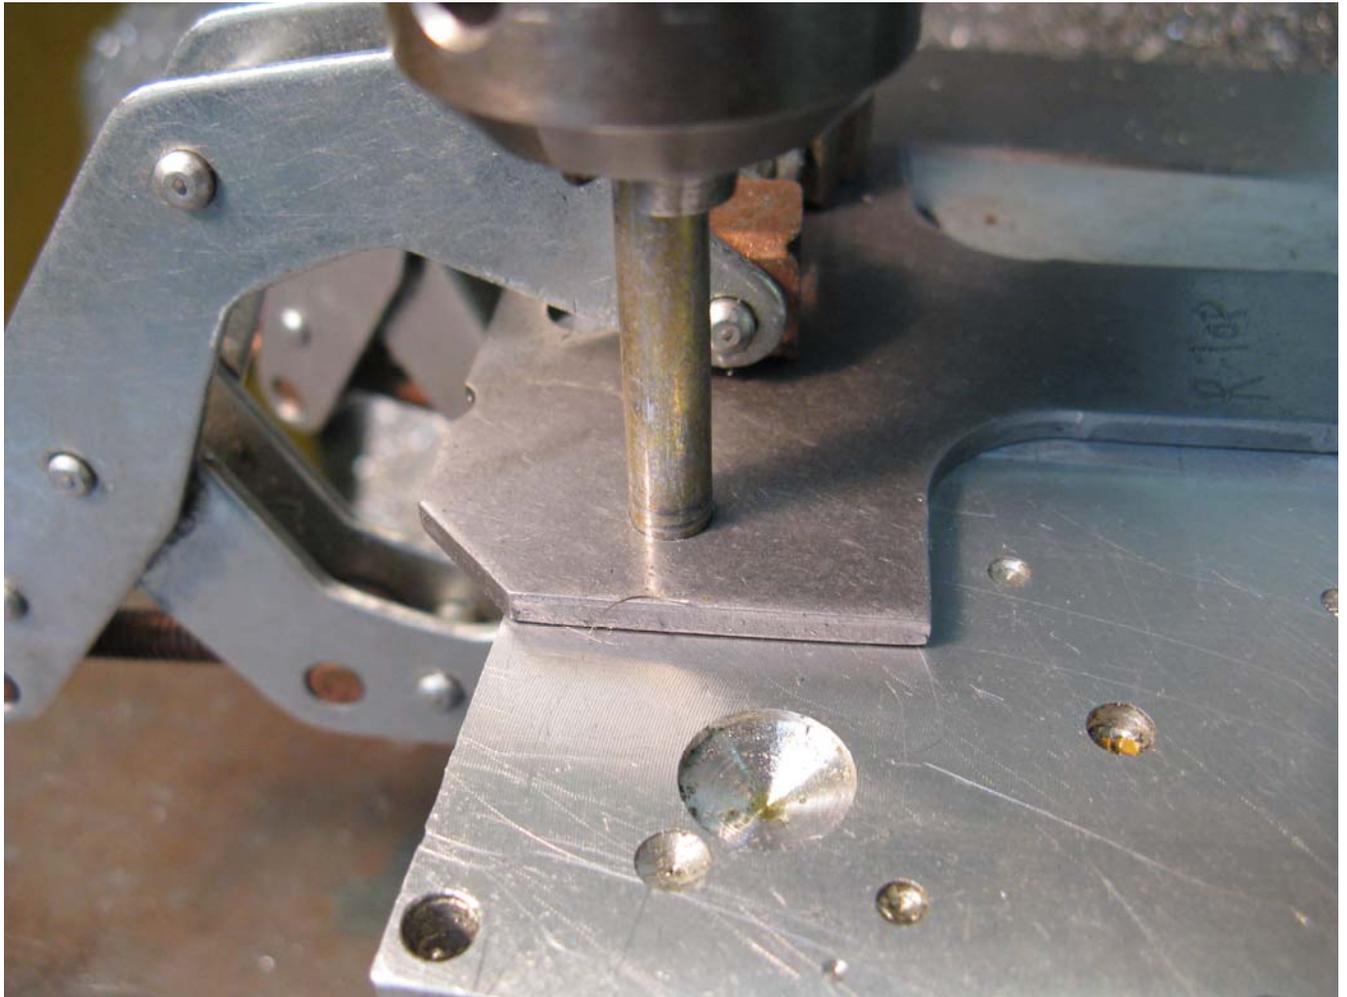
FIGURE 18: DRILL PRESS POSITIONING

Cut the head off of a scrap (but straight) 1/4" bolt. Fit the cut off bolt into the chuck of a drill press and use it as an alignment pin to center the wear plate under the drill chuck. See Figure 18.

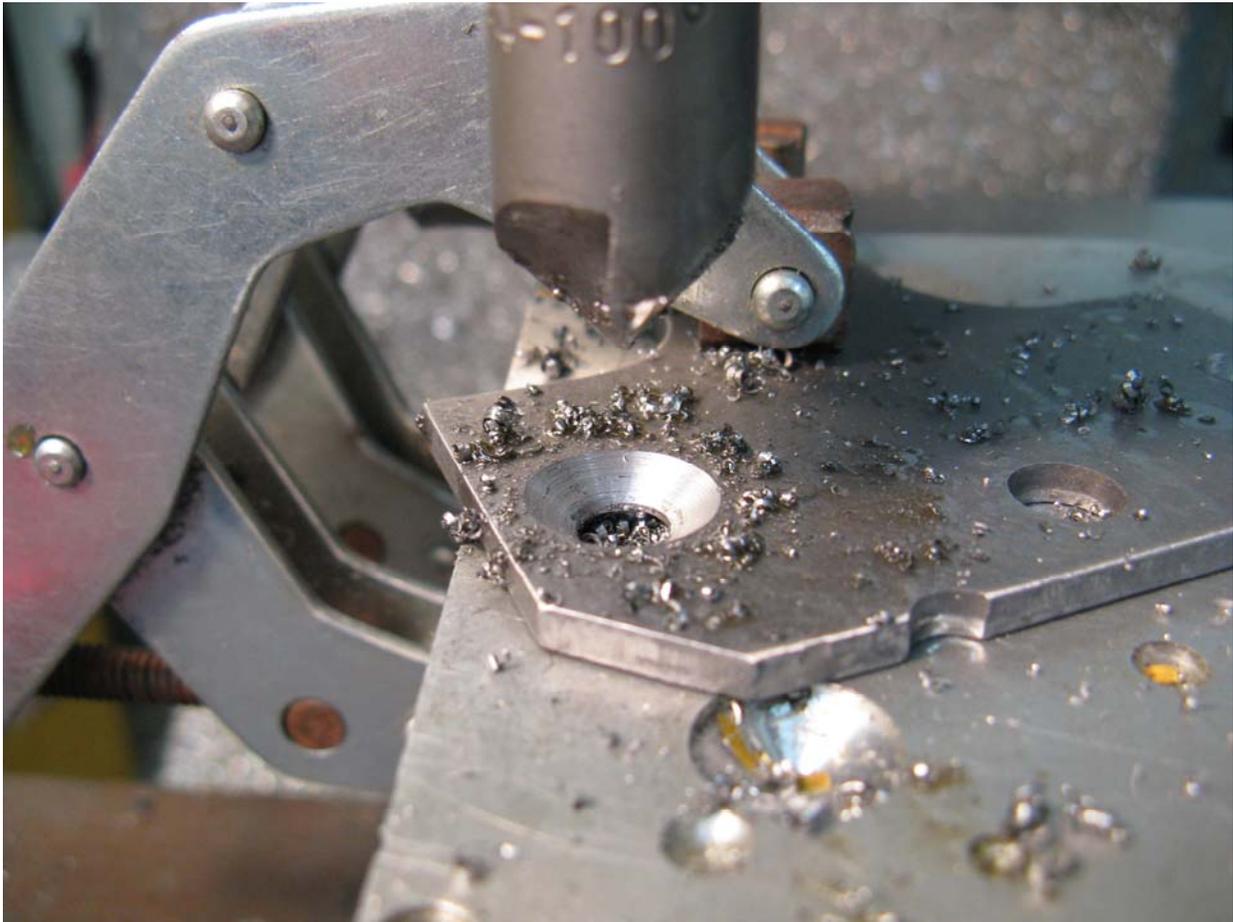
FIGURE 19: MACHINE-COUNTERSINKING
THE WEAR PLATES

The outside diameter of a proper depth countersink is 1/2". See Figure 19.

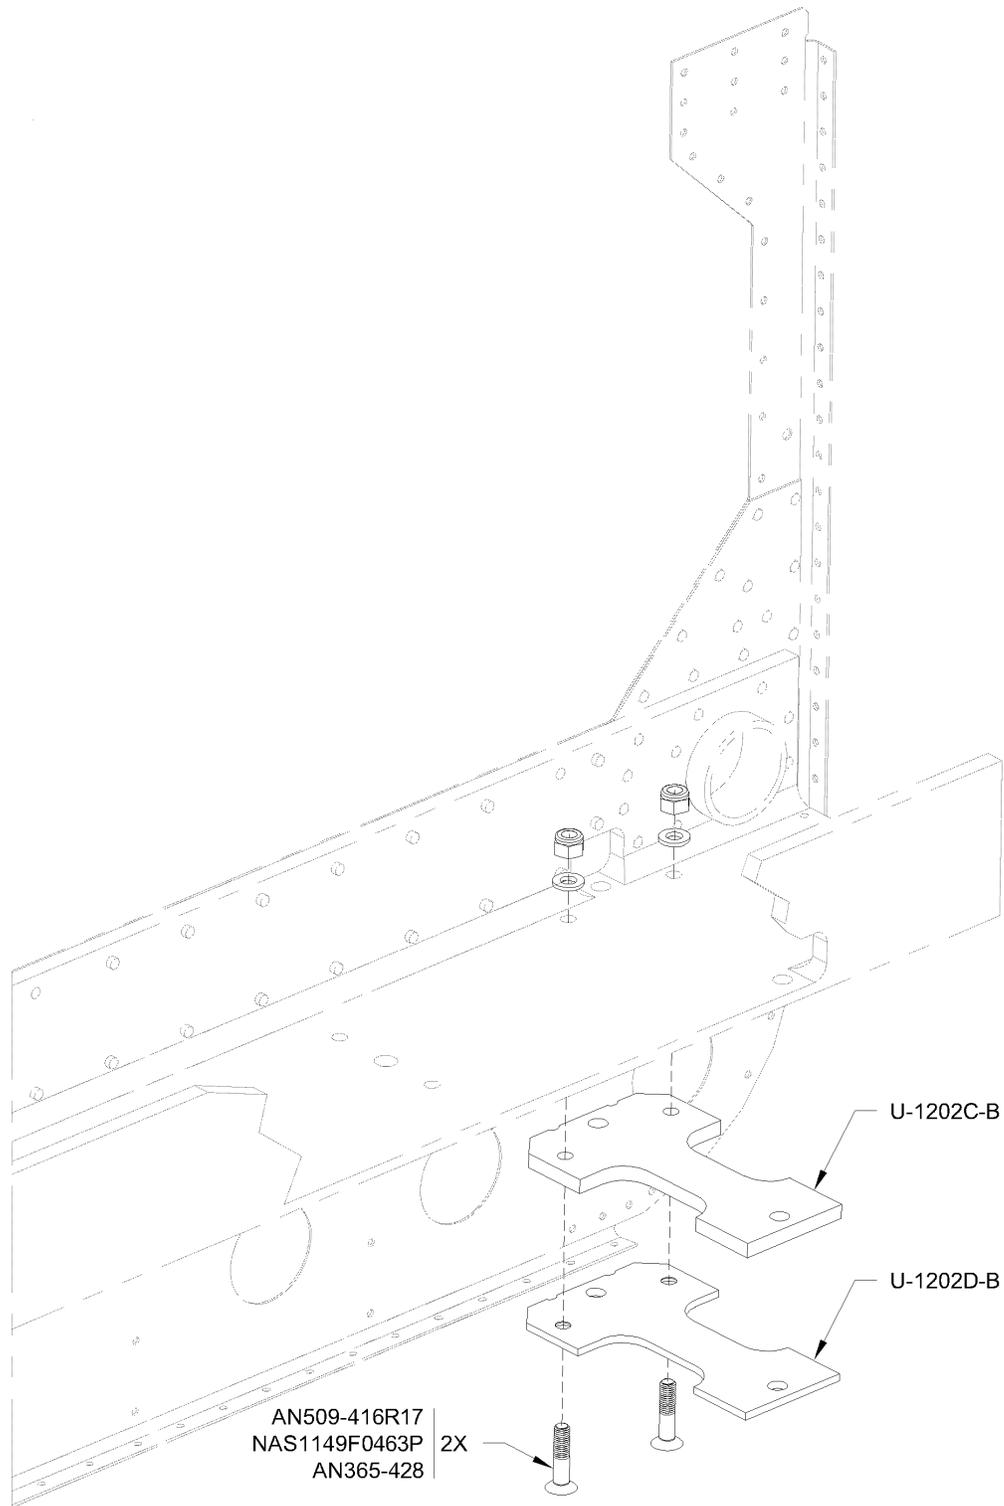
FIGURE 20: INSTALLING THE OUTBOARD DOUBLER AND WEAR PLATES

Step 45: Install the U-1202C-B Outboard Doublor Plate and U-1202D-B Outboard Wear Plate to the F-1204 Center Section Assembly as shown in Figure 20. Use 2 temporary AN5 bolts as alignment pins to assure alignment while torquing the nuts on the screws.
