SERVICE BULLETIN 12-11-09

Subject: Loose U-1202 Attach Bolts, Cracking in F-1204 Center Section Assembly, Damage to side skin structure near landing gear attach.

Affected Models: All RV-12 Models

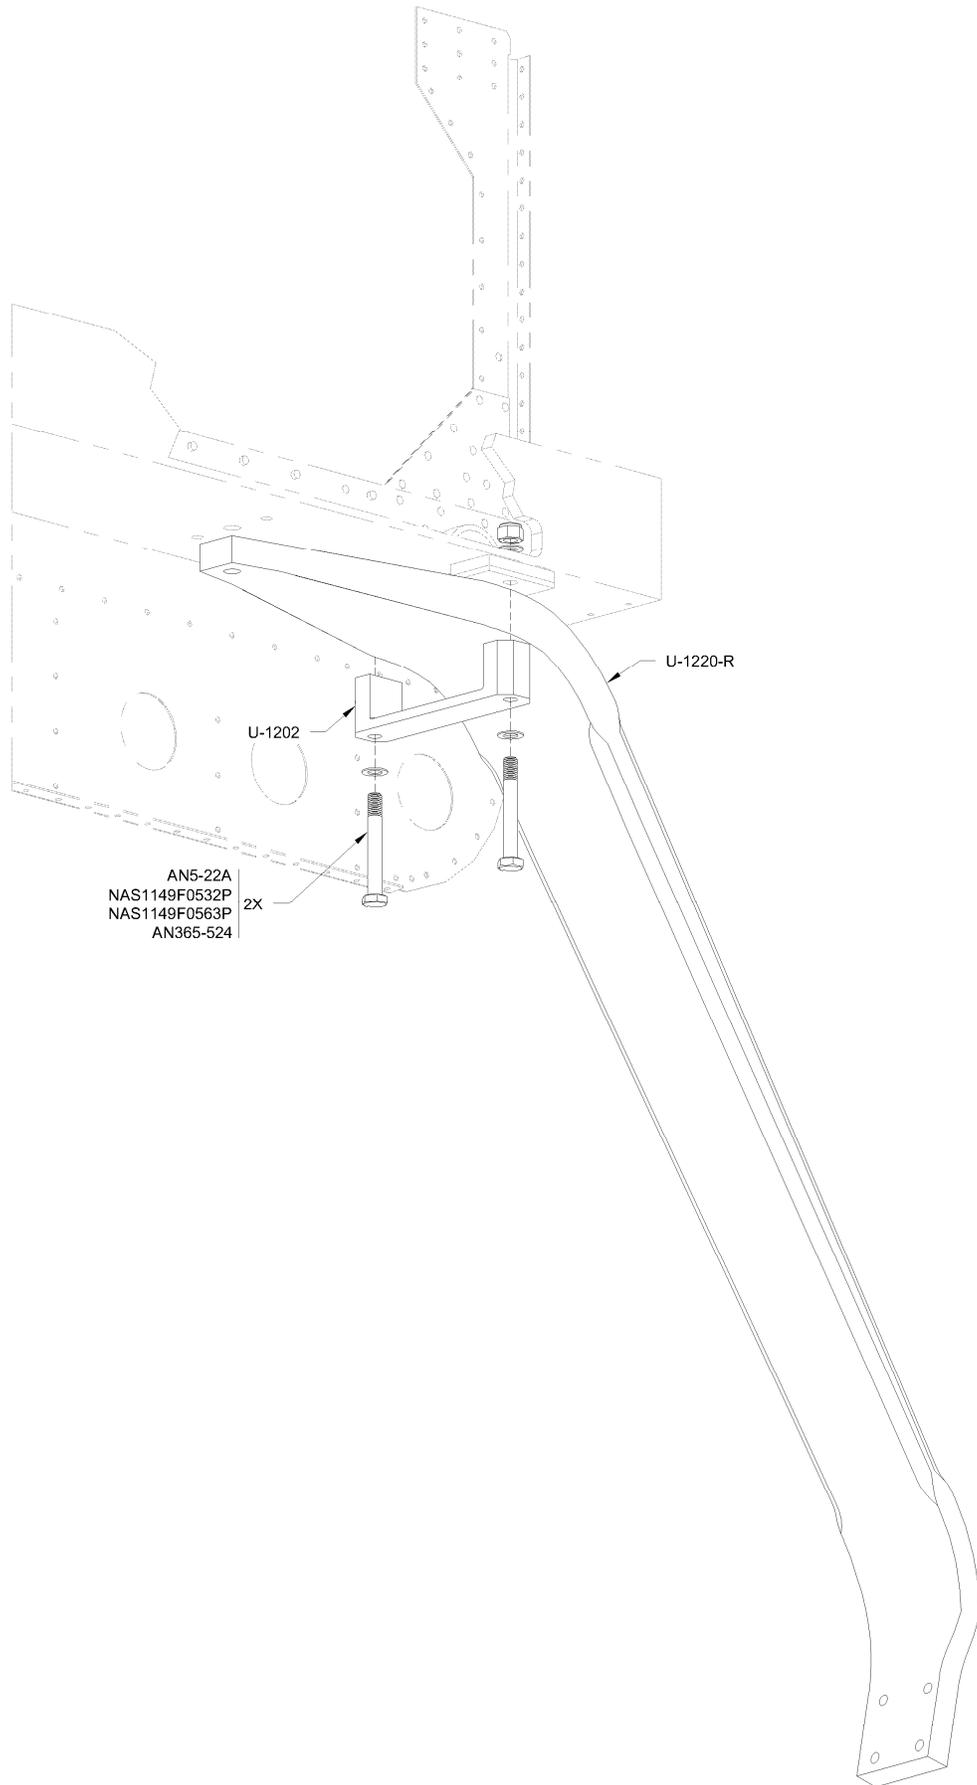
Step 46: Maneuver the U-1202-R Gear Leg and U-1202 Outboard Main Gear Attach Bracket into position at the same time as shown in Figure 21. Insert the two AN5 bolts with washers and nuts but don't fully tighten them yet.
