## **FLAKY FLAP MOTORS**

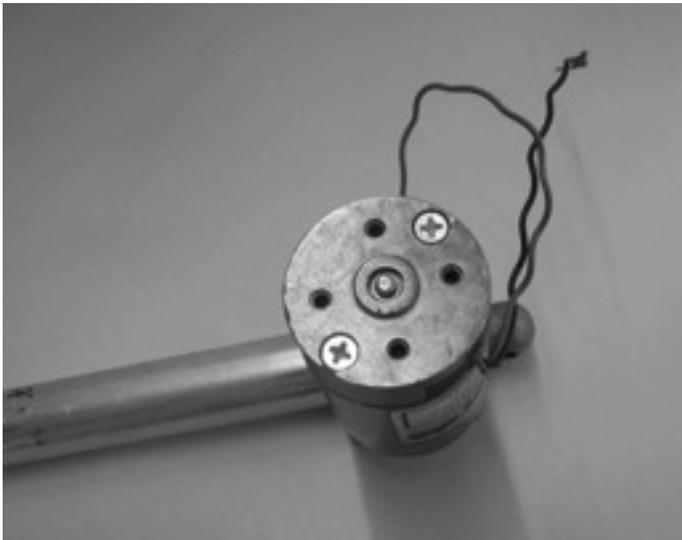
The motor unit and screws securing the housing to the gearbox.

Now use the allen key to remove the bolts holding the motor to the gear box. Pull the motor winding/shaft assembly out of the cylindrical housing (the magnets will resist, but it will come out) and inspect it for grease and corruption.

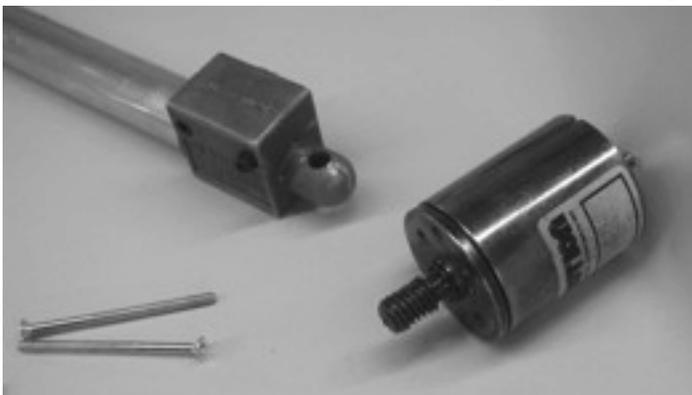
The long phillips-head and short allen-head screws have been removed or backed off and the motor separated from the gear box.

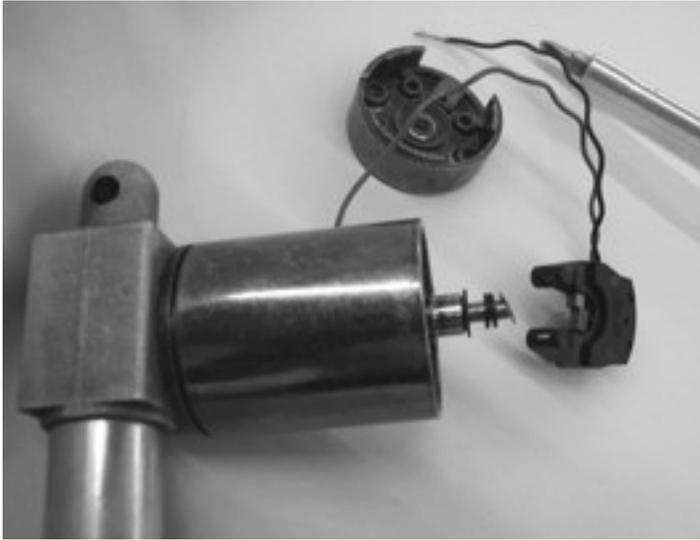
The motor cap and the horseshoe shaped brush housing have been removed. The brushes have popped out of the housing, and if you look closely, you can see the tiny spring that must be behind the brush when it is re-inserted. The springs keep the brushes up against the motor armature.

Slide the horseshoe gently off the motor shaft. A couple of little copper colored things are going to jump out (those are the brushes). They are retained by very thin wire springs.

Reassembling the motor can be more difficult than getting it apart. Begin by teasing the little springs that go behind the brushes back into their recess and tie them back with the wire ties. This may take some patience... When the springs are held back, use the tweezers to re-insert the brushes, taking care that curve worn on their contact surface matches the curve of the motor shaft. Tie the brushes back.

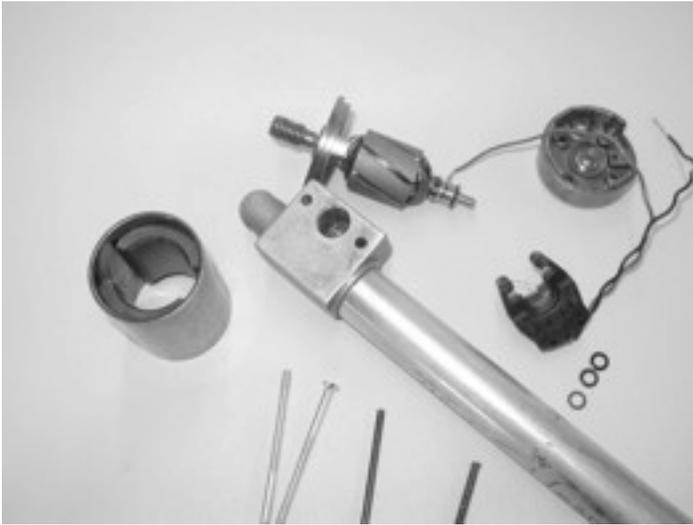
The motor armature has been removed from within the motor housing and the washers removed from the motor shaft.

There are several washers on the shaft. These must be reinstalled in the order they came out, so carefully note and preserve their orientation as you remove them.

Clean the commutator (the shiny part of the shaft that the brushes ride on) with the cotton swabs or even a bit of scotchbrite.

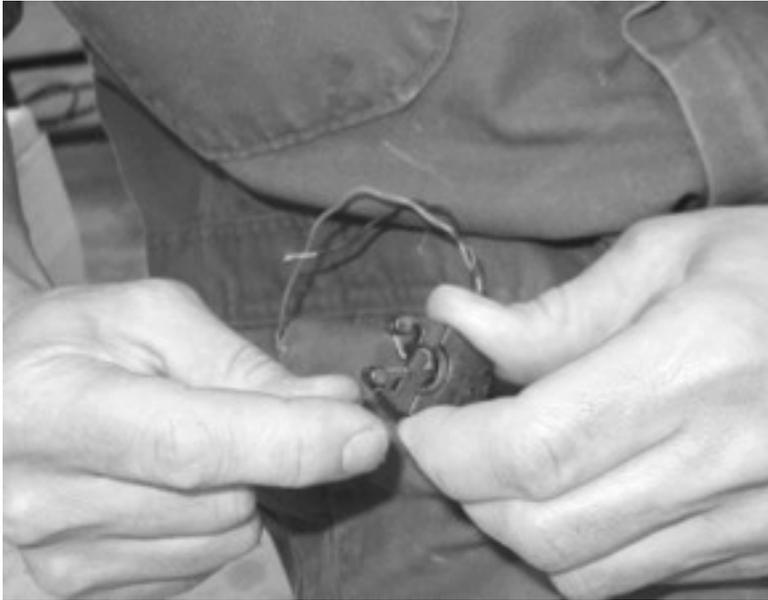
Tucking the springs and brushes back into their cubbyholes is the toughest part of the exercise. Be careful not to bend the springs. A small spacer made of any non-magnetic scrap, that keeps the brushes pushed back will help get the “horseshoe” back on the shaft.

Gently, carefully put the horseshoe back around the shaft and slide the wire ties out. The springs should force the brushes up against the commutator. Reinstall the washers.
