SERVICE BULLETIN SB-00040

Subject: RV-12 Landing Gear Beam Reinforcements

Affected Models: Original RV-12 (does not apply to RV-12iS)

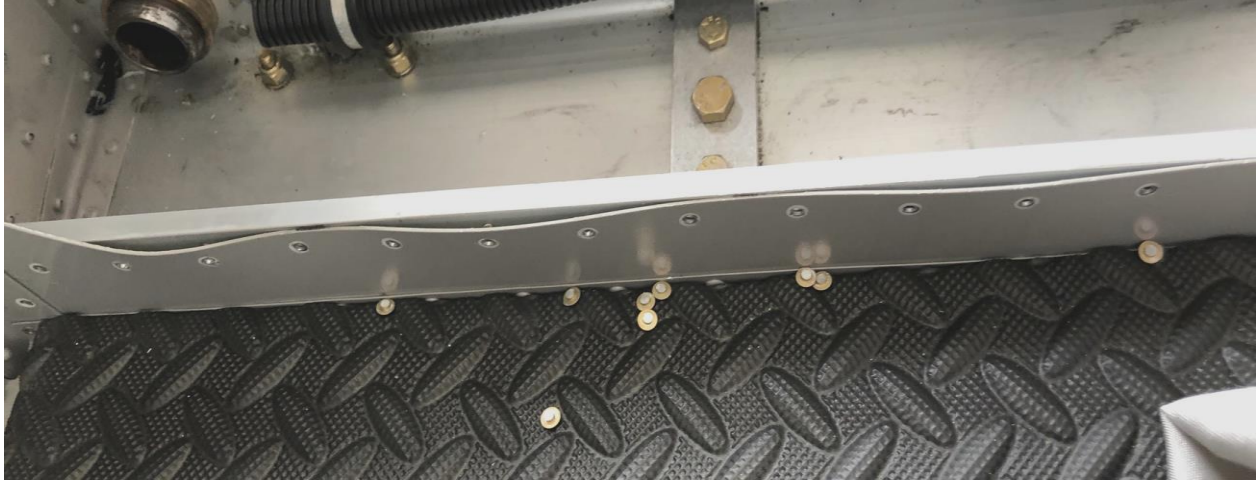
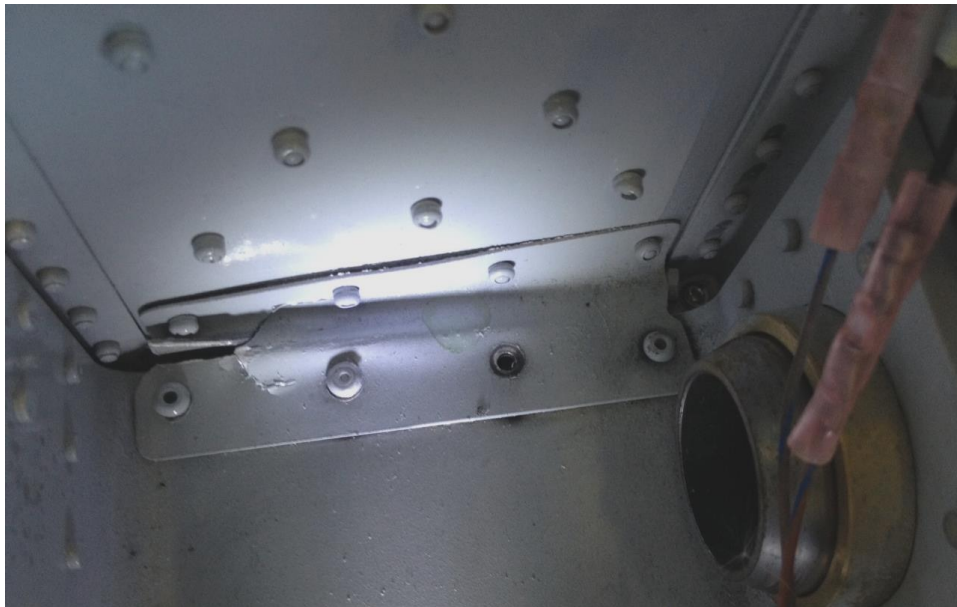
FIGURE 1: DAMAGE IN AND AROUND F-1204E LANDING GEAR BEAM

Although the RV-12 landing gear structure meets ASTM requirements for landing loads, data from the field indicates that repeated excessively hard landings may cause failure of rivets between the F-1204E Landing Gear Beam and the F-1204D Center Section Aft Bulkhead, and/or fracture the F-1204U Skin Stiffeners, and/or result in fatigue cracks in the F-1204E Landing Gear Beam. Refer to Figure 1 for illustrative examples.

The modifications described in this document add strength and durability to the original model RV-12 landing gear structure to prevent this type of damage. This service bulletin document does not apply to the RV-12iS.

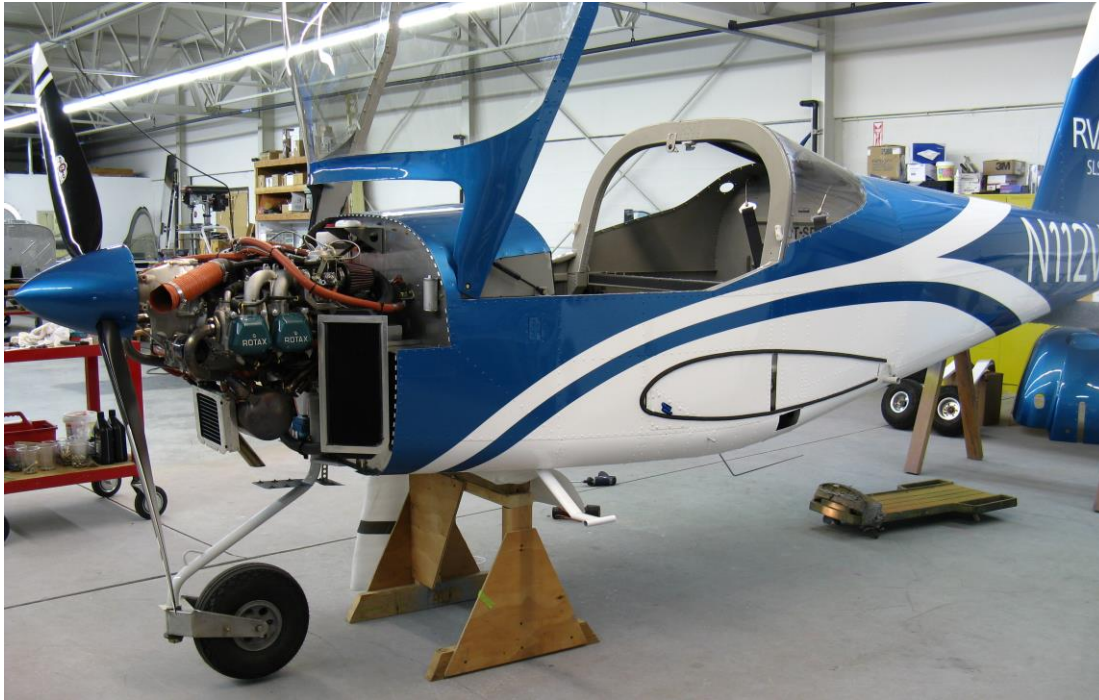
FIGURE 2: AIRCRAFT SUPPORT

Step 10: Support the aircraft using sawhorses such that both main landing gear are no longer touching the ground. Refer to "Lifting and Supporting the Fuselage" in the Maintenance Manual. Note an alternative aft sawhorse position is shown in Figure 2.

A height that positions the tires approx. 1 inch off the floor makes it easier to hold the legs in the proper position during removal and re-installation.

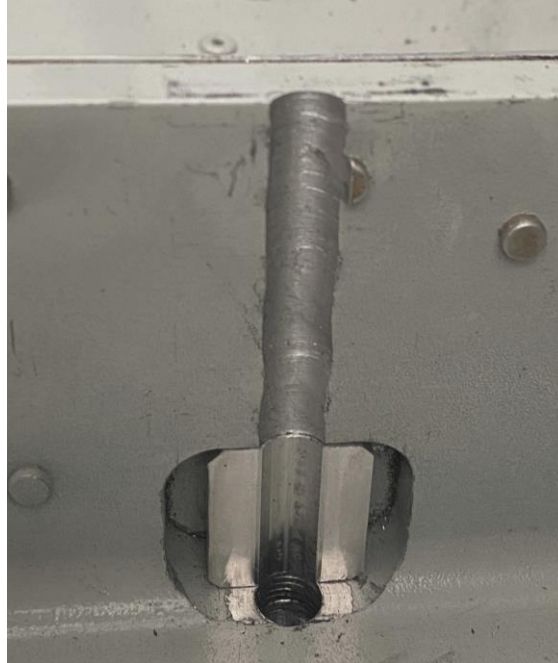
FIGURE 11: LOCATION OF F-00225 PLUGS

Step 46: Insert an F-00225 Plug into each of the four “mouseholes” on the F-1204E Landing Gear Beam, such that the channel on one side of the F-00225 lines up with the newly-drilled vertical channels on the inner wall of the F-1204E and with the 5/16 in. [7.9 mm] bolt holes at the bottom of the F-1204E. Refer to Figure 11.

Step 45: Remove material from the top and/or bottom of each F-00225 Plug so that it can be snugly inserted into one of the “mouseholes” on the F-1204E Landing Gear Beam.

If the F-00225 Plug can be inserted into a “mousehole” with no friction, then too much material was removed. Apply one or more coats of primer to the upper and lower surfaces of the F-00225 and wait for it to fully set, and/or fabricate a small shim out of thin sheet stock or foil. If this does not achieve a snug fit, discard the F-00225.
