# **SERVICE BULLETIN 19-08-16**

Subject: AV-60000 and AV-60009 Recall

Affected Models: RV-12iS

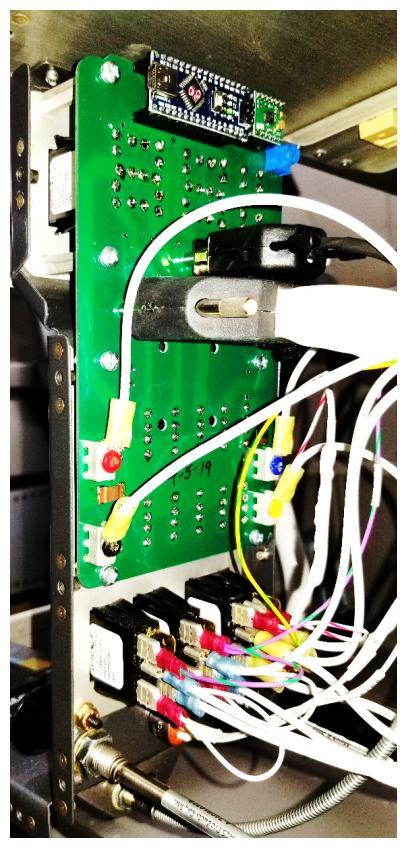
FIGURE 1: Rear of AV-60000 as installed, note colored screw terminal wire orientations.

<u>Step 6:</u> Refer to Figure 1 & 2 and Figures 8-10 (below), note the location of the 4 screw terminals that attach large wires to the back of the AV-60000 PCB and their respective colors. Also note the direction each wire is currently oriented (the orientation prevents interference with the tunnel side covers). Taking a couple photos before disassembly will be helpful during reassembly.

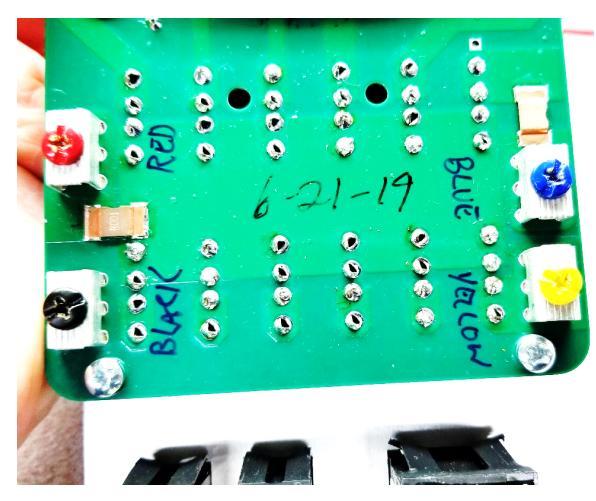
FIGURE 2: Label screw terminal colors on PCB if you remove the wires.

<u>Step 7:</u> Label each wire (with a masking tape flag) before disconnecting them from the AV-60000 screw terminals. Remove the 4 colored screws and labeled wires. Remove both D-sub connectors. Label the terminal colors on the back of the AV-60000 PCB as shown in Figure 2 below.
