#### **REVISION DESCRIPTION:**

# VAN'S AIRCRAFT, INC.

RV-14 PAGE 12-03

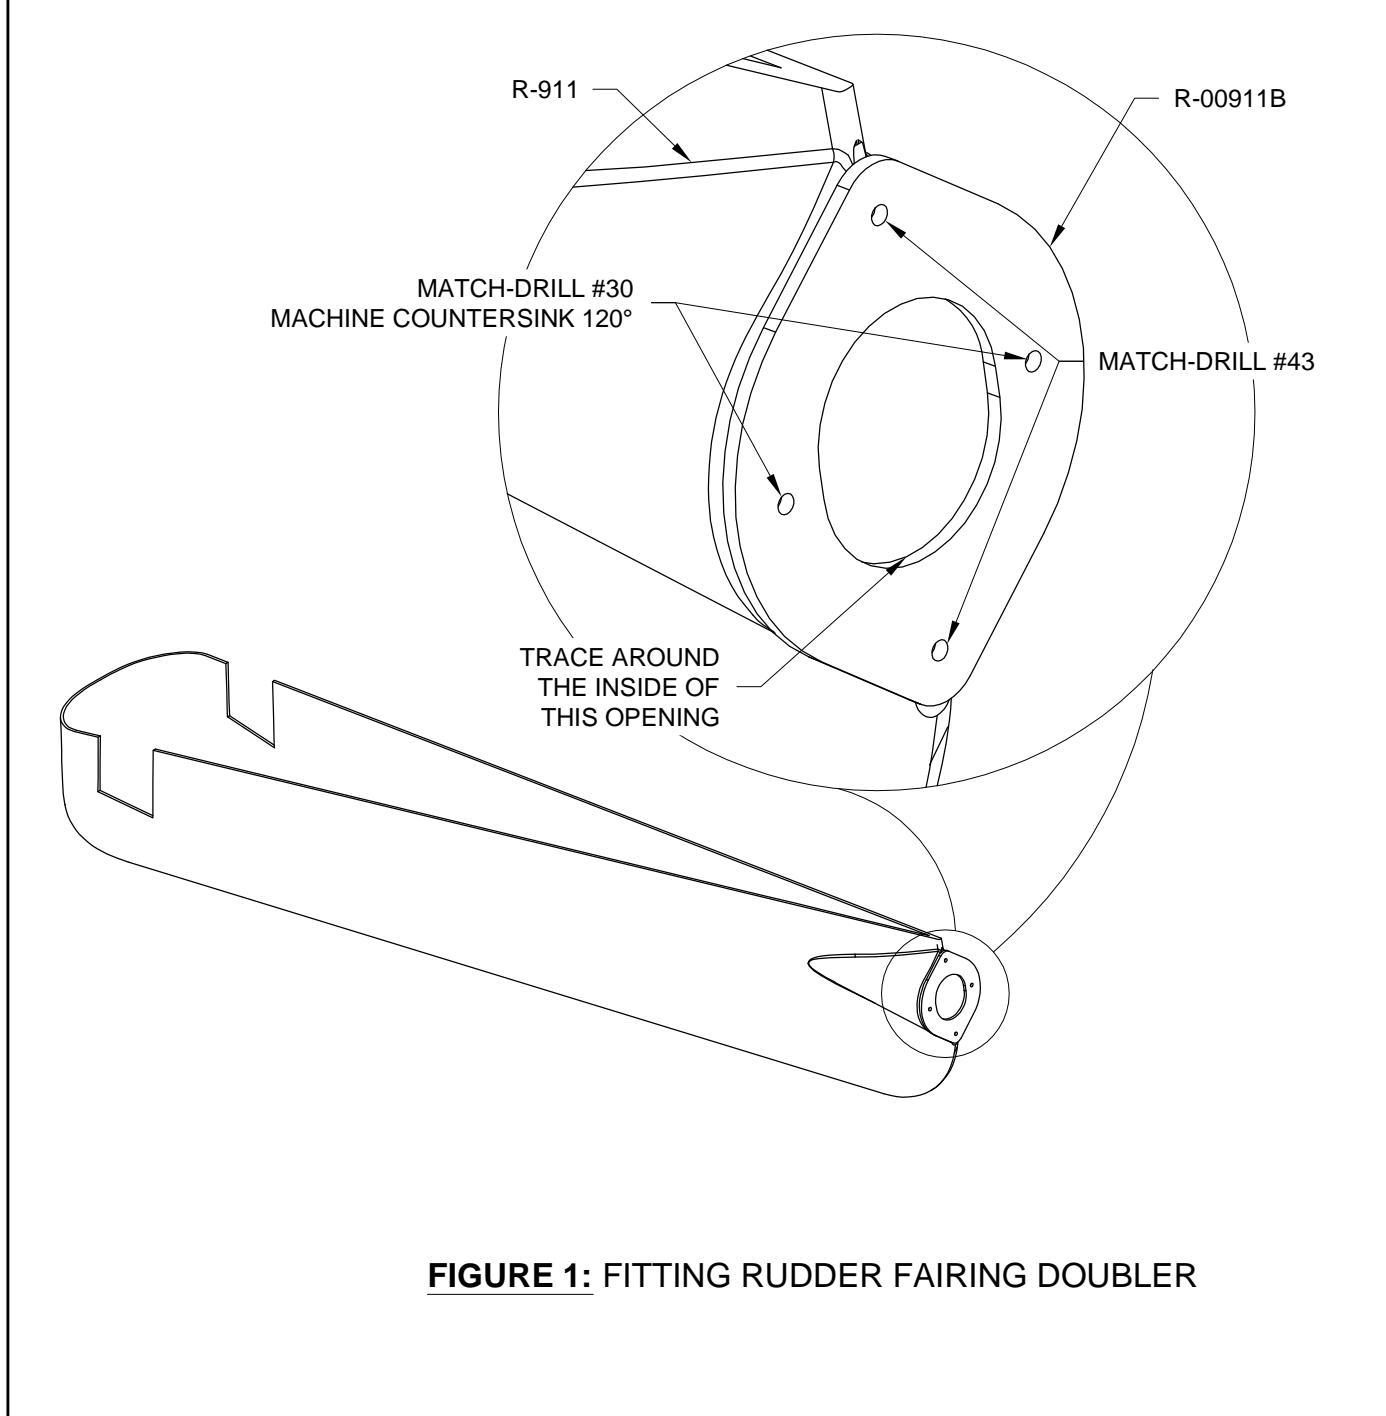
Step 2: Remove hatched area of the R-911 Rudder Bottom Fairing as shown in Figure 2. Drill several holes around the inside of the traced line, but stop short of the line traced in Step 1. Finish removing the material up to the traced line with sandpaper wrapped around a round object.

Install the R-00911B Rudder Fairing Doubler with the rivets called out in Figure 2. There should be enough of the epoxy resin flox mixture between the parts to come up to, or just beyond, the adjacent edges of the parts. These edges can be sanded to a smooth finish after curing.

Step 5: Tap 4-40 the holes for light mounting screws (screws installed in Section OP-56) as shown in Figure 2.

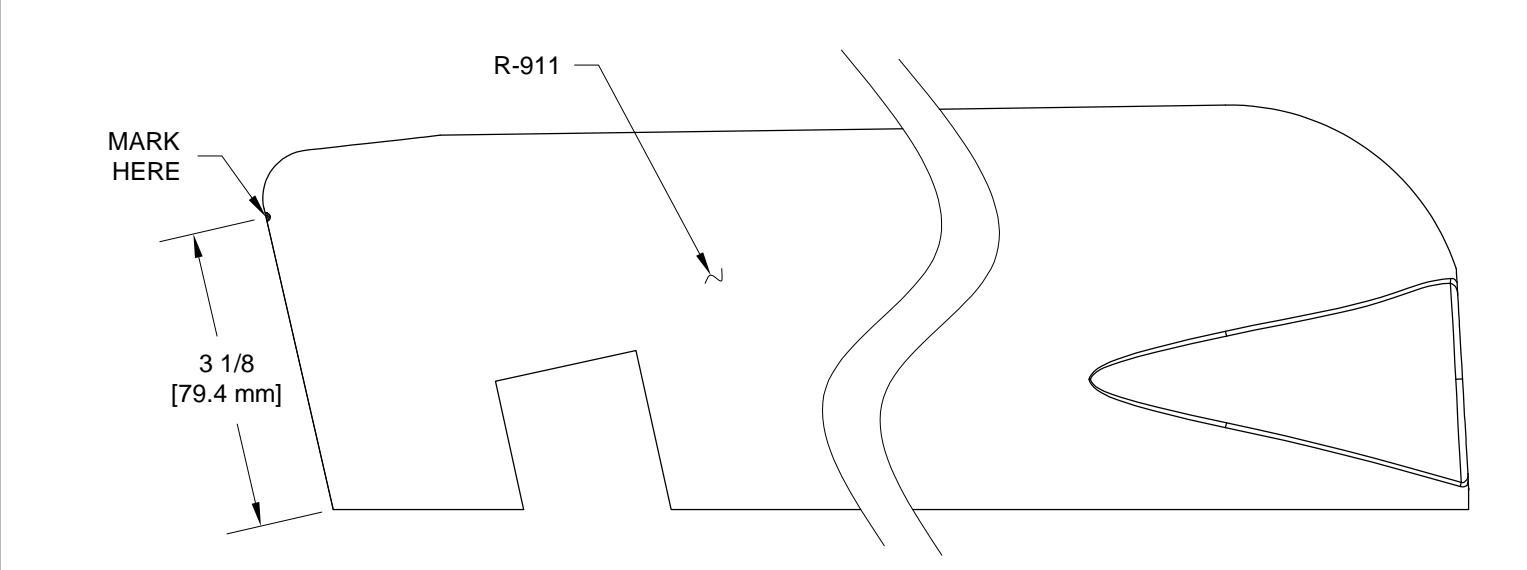
### FIGURE 1: MARKING RUDDER BOTTOM FAIRING

Step 1: Measure and mark the location shown in Figure 1 on the R-911 Rudder Bottom Fairing. The mark should be located along the center line of the part as shown in Figure 2.

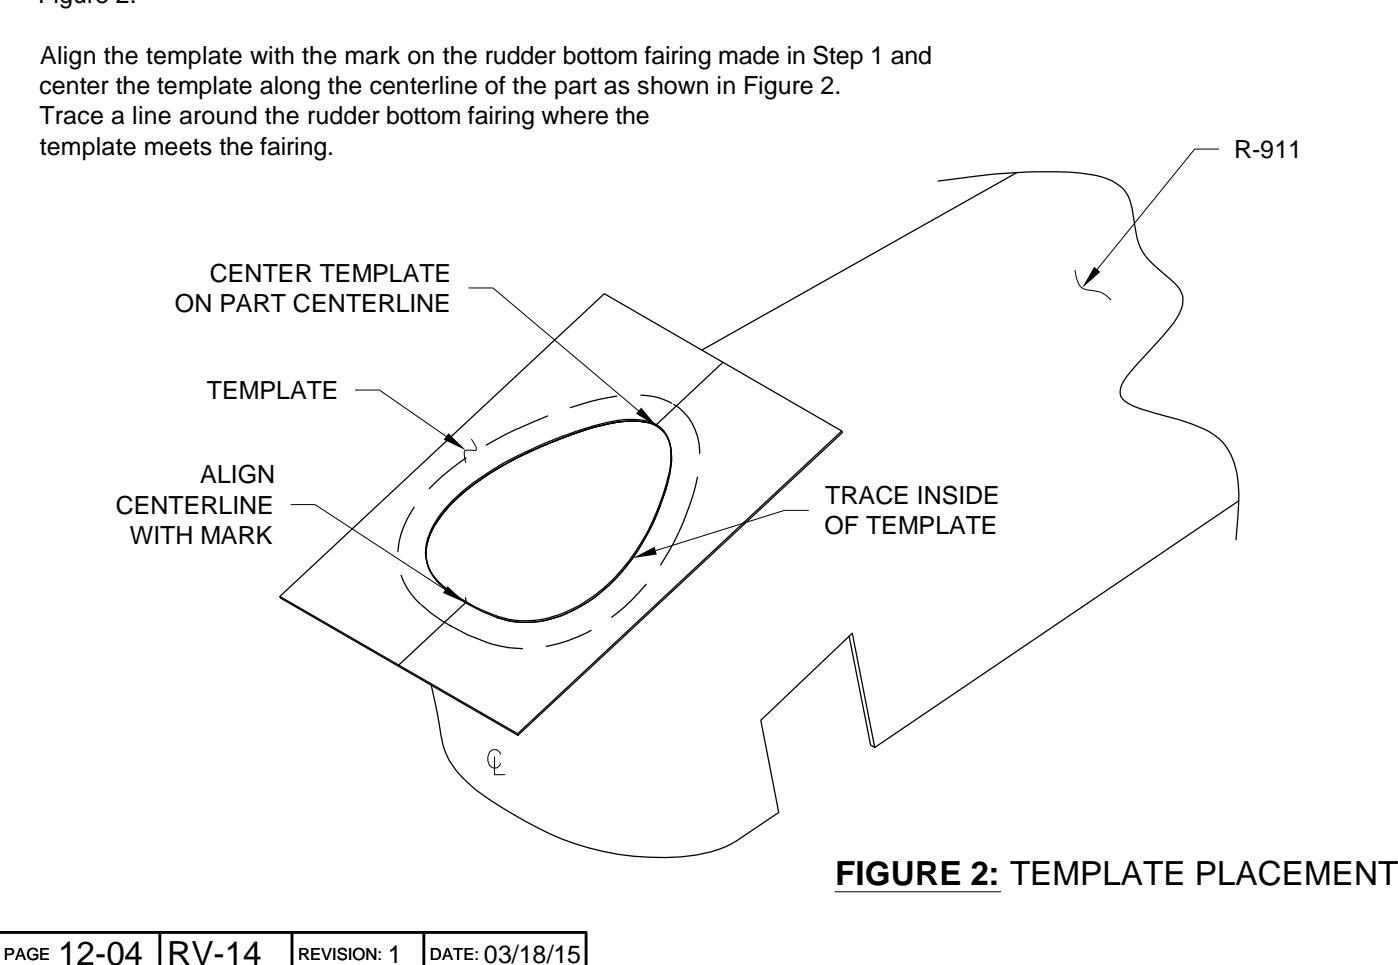
Step 2: Cut and paste the Rudder Bottom Fairing Trim Template (found on Page 12-13) to stiff material such as poster board. Remove hatched area in the center of the template so that it will fit over the end of the R-911 Rudder Bottom Fairing as shown in Figure 2.

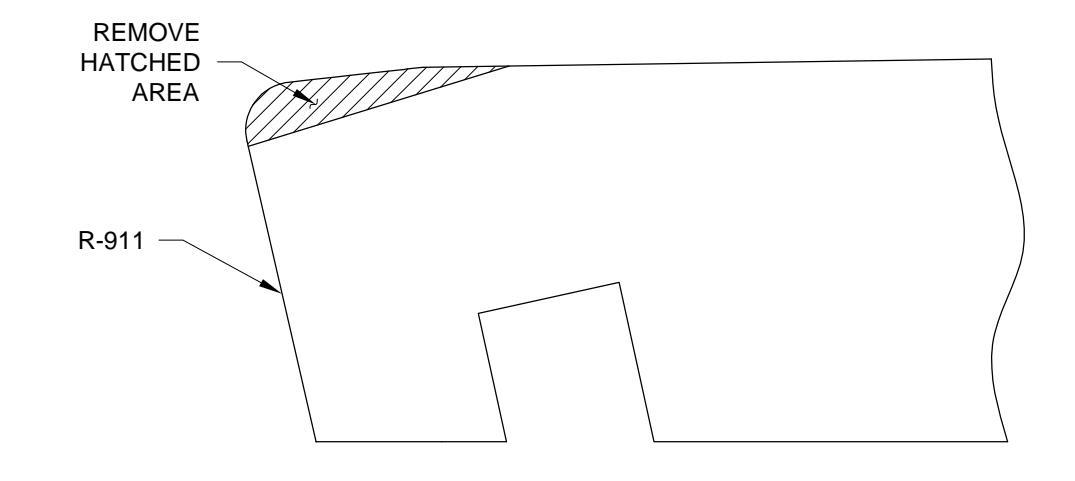
# FIGURE 3: RUDDER BOTTOM FAIRING

Step 3: Remove hatched area of the R-911 Rudder Bottom Fairing as shown in Figure 3, but stop short of the line traced in Step 2. Finish removing the material up to the traced line with a sanding block.

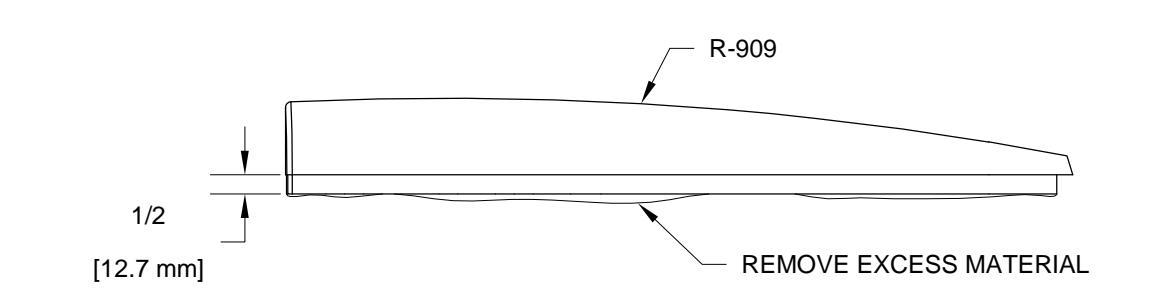
### FIGURE 1: RUDDER TIP MODIFICATION

<u>Step 1:</u> Trim any extra material from the recessed area of the R-909 Rudder Tip Fairing per dimension given in Figure 1. Coarse 80 grit sandpaper on a wood block works well for this step.

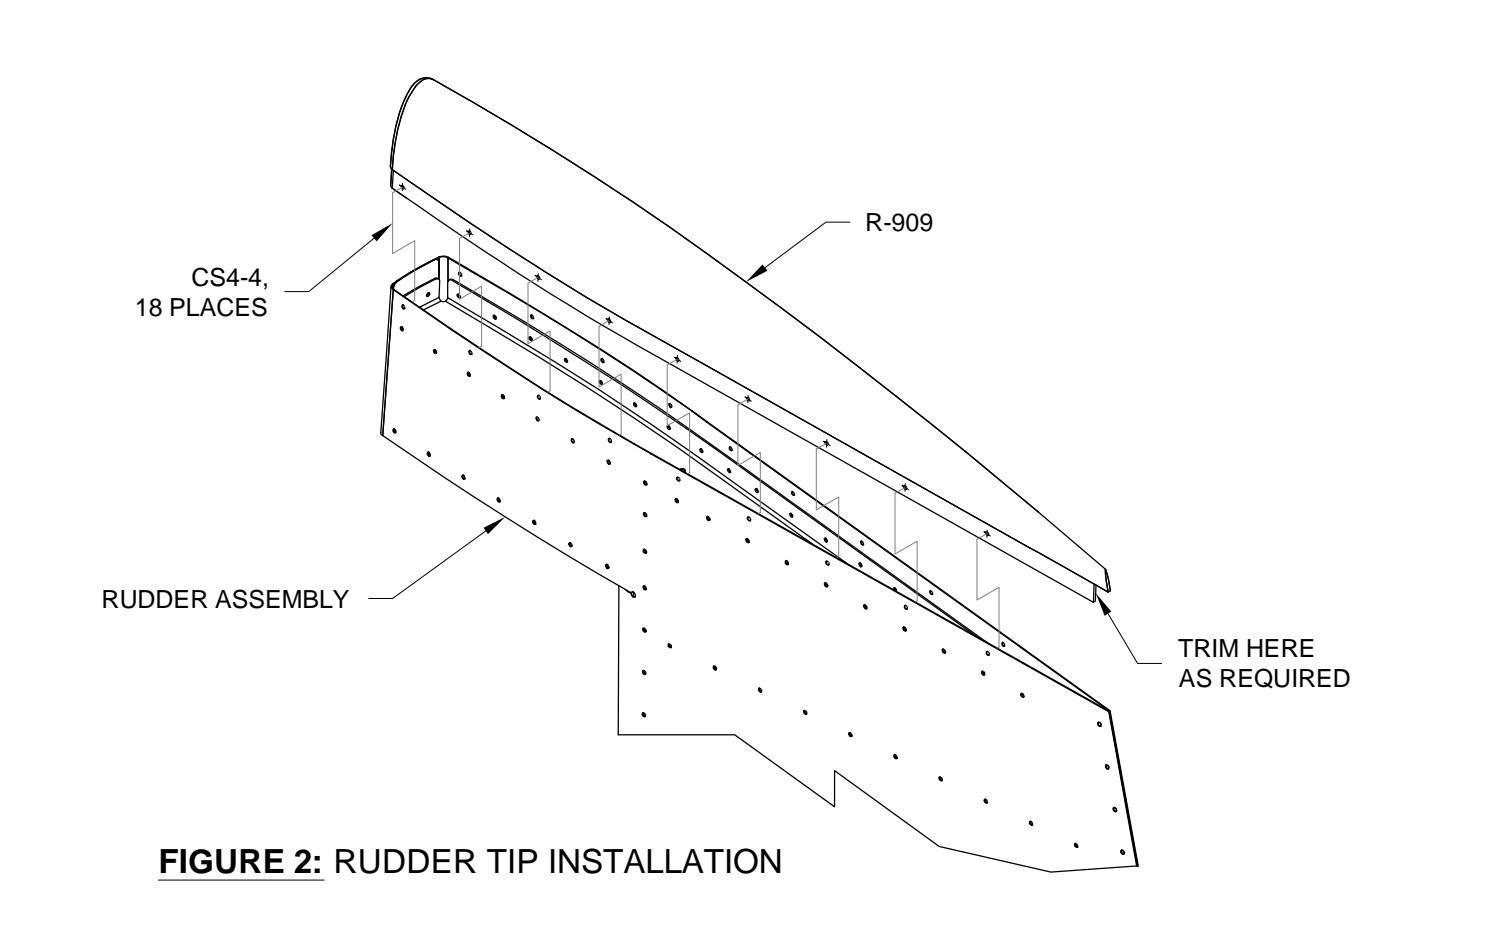
<u>Step 2:</u> Trim the aft edge of the flange on the R-909 Rudder Tip Fairing as shown in Figure 2 to remove interference between flange and the Rudder Assembly trailing edge.

Working from front to back, final-drill #30 the holes just drilled in the Rudder Assembly and rudder tip fairing. See Figure 2.

<u>Step 4:</u> Remove the R-909 Rudder Tip Fairing from the Rudder Assembly. Deburr and dimple the rudder tip attach holes in the Rudder Assembly for CS4-4 blind rivets as shown in Figure 2. Machine countersink the holes in the rudder tip fairing for the dimples in the Rudder Assembly.

Step 5: Cleco then rivet the R-909 Rudder Tip Fairing to the Rudder Assembly using the rivets called out in Figure 2.

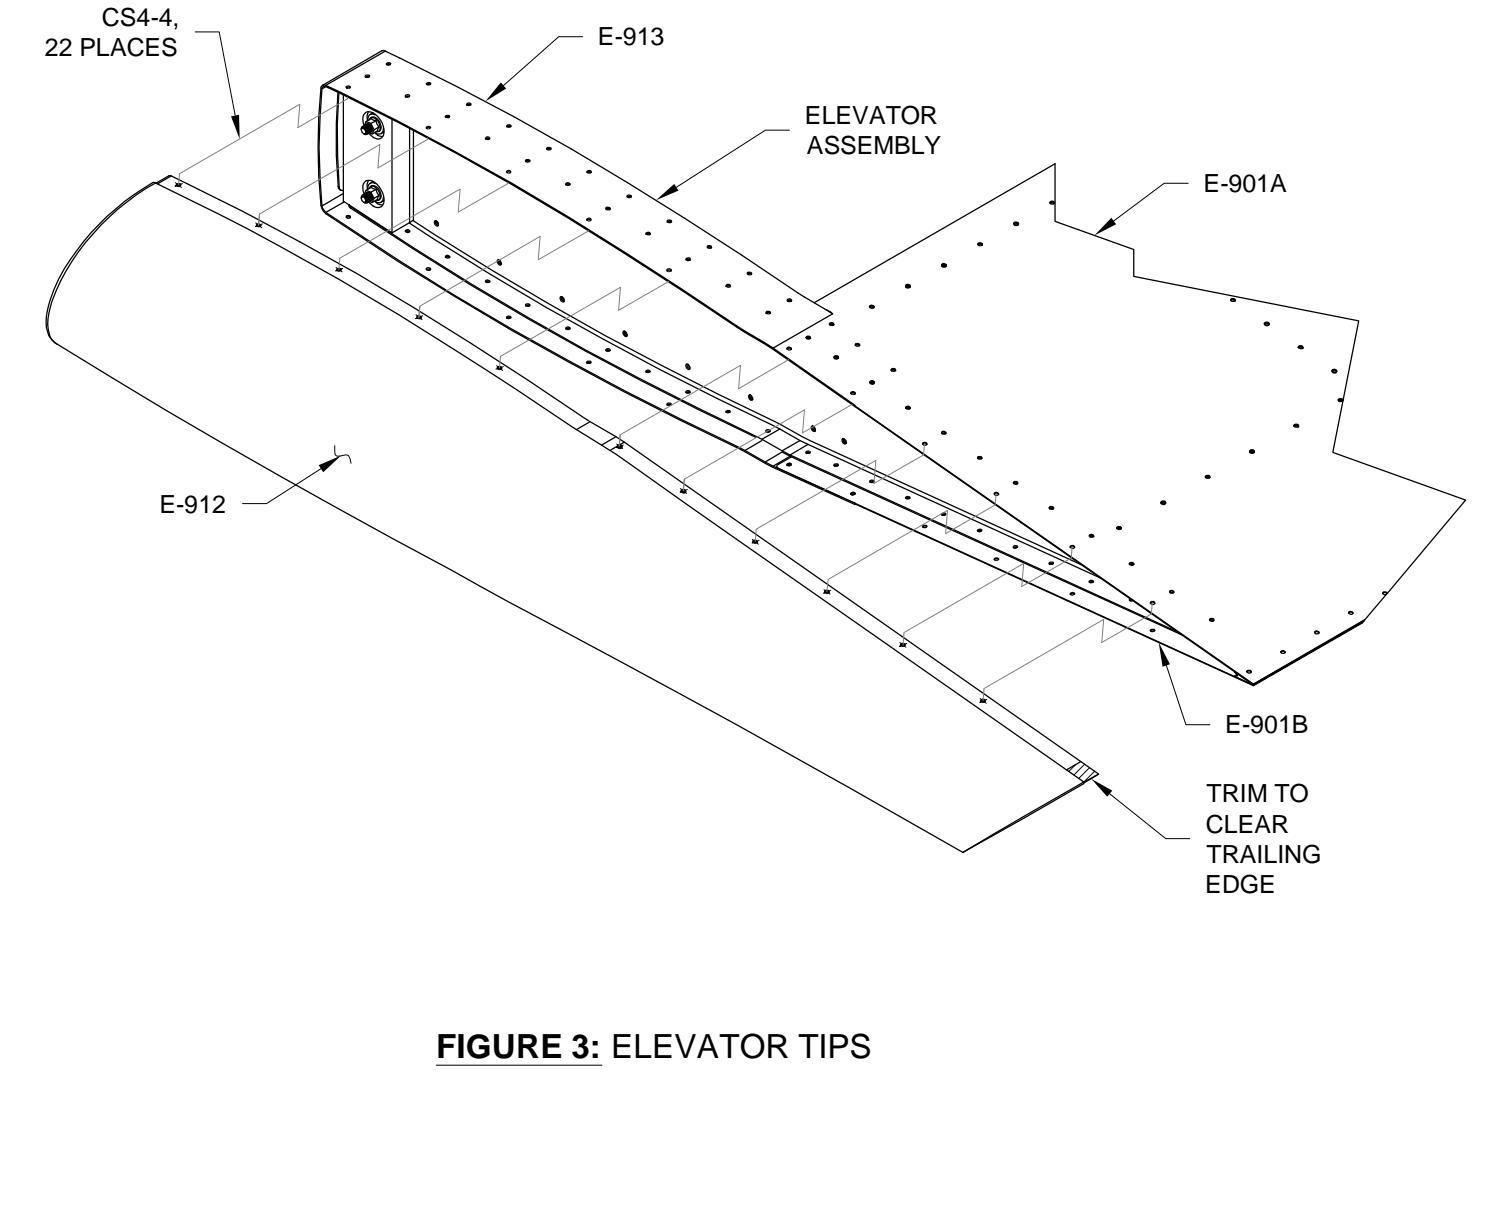
<u>Step 6:</u> Trim the aft edge of the flange on the E-912 Elevator Tip Fairing as shown in Figure 3 to remove interference between the flange and the elevator trailing edge and allow the tip to be fully inserted into the end of the elevator. Trimming the width of the molded flange may also be required. See Page 12-02 Figure 1 for the correct width.

Step 9: Cleco and rivet the E-912 Elevator Tip Fairing onto the Elevator Assembly per the callouts in Figure 3.

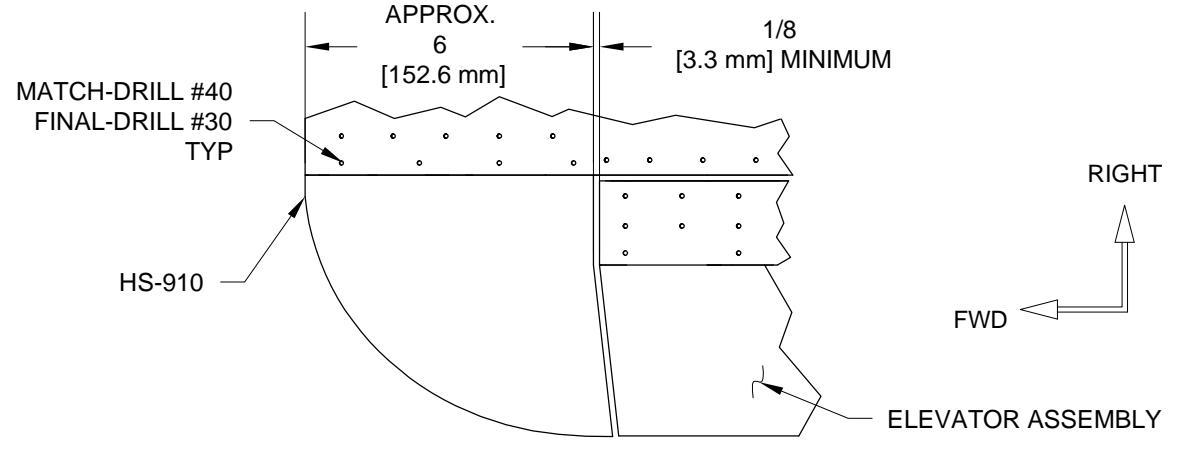
FIGURE 1: CREATING GAP

Step 1: Trim the width of the molded flange on the HS-910 Horizontal Stabilizer Tip Fairing if required to meet the dimensions given on Page 12-02 Figure 1. Progressively trim away the aft edge of the horizontal stabilizer tip fairing to leave a minimum 1/8 inch gap between the aft edge of the tip fairing and the forward face of the elevator counterbalance arm. Move the elevator to check clearance at all positions. See Figure 1.

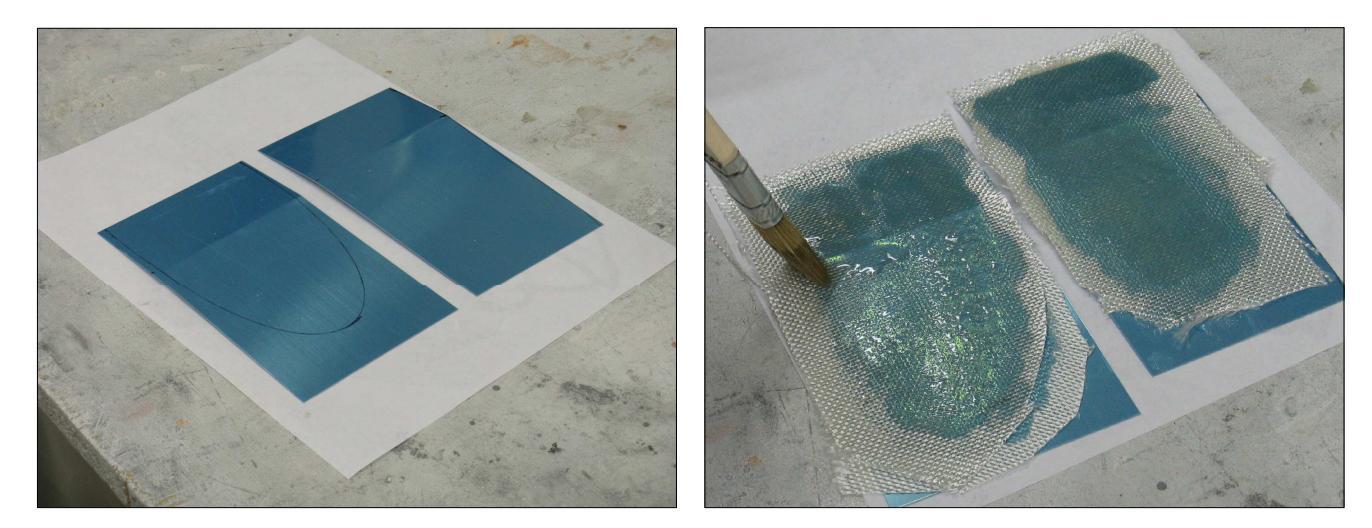
FIGURE 2: FIBERGLASS FABRICATION (LEFT AND RIGHT LAY-UPS SHOWN)

Step 4: Using the traced area as a guide, cut two layers of glass fabric larger than traced area to allow for trimming and sanding later. Lay up two layers of glass fabric using epoxy resin on the bent sheet. Apply peel ply or similar material over the patch for a good surface finish.

Allow patch to cure, then remove peel ply fabric. The patch should pop off of the aluminum sheet easily when the aluminum is gently flexed. See Figure 2.

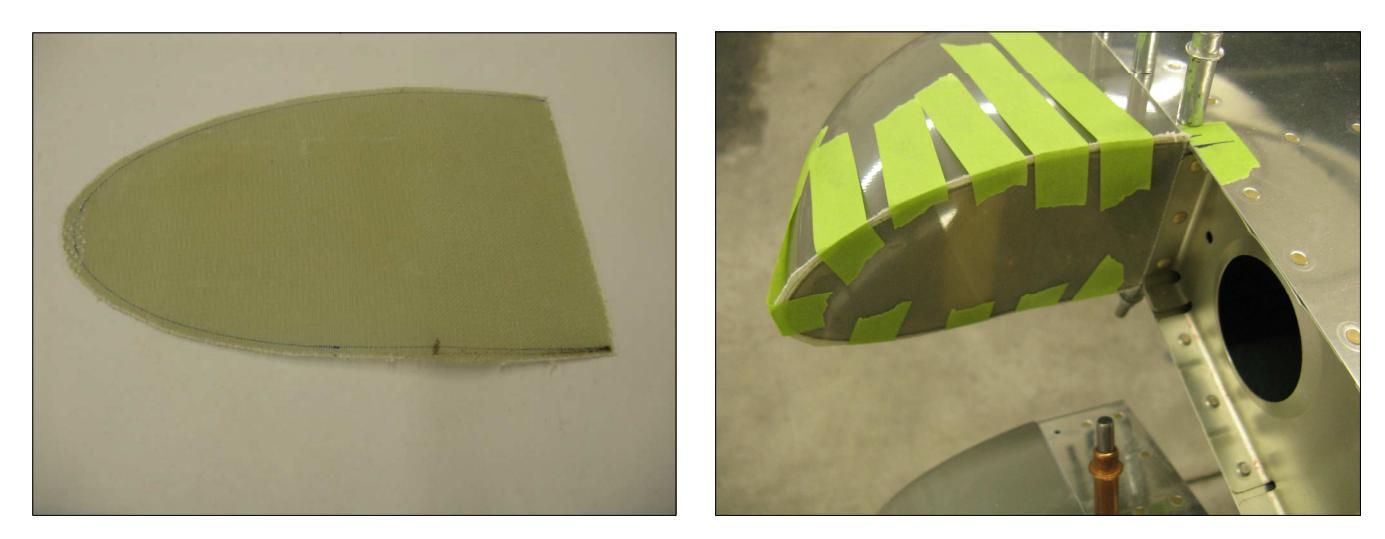
### FIGURE 3: FIBERGLASS PATCH

Step 5: Cleco the HS-910 Horizontal Stabilizer Tip Fairing to the Horizontal Stabilizer Assembly. Place the fiberglass patch over the opening in the HS-910 Horizontal Stabilizer Tip Fairing and trace edge of opening onto patch piece.

Remove patch and trim the piece, leave a small amount of material beyond the traced line. The edges will be sanded after the parts have bonded together. See Figure 3 and Figure 4.

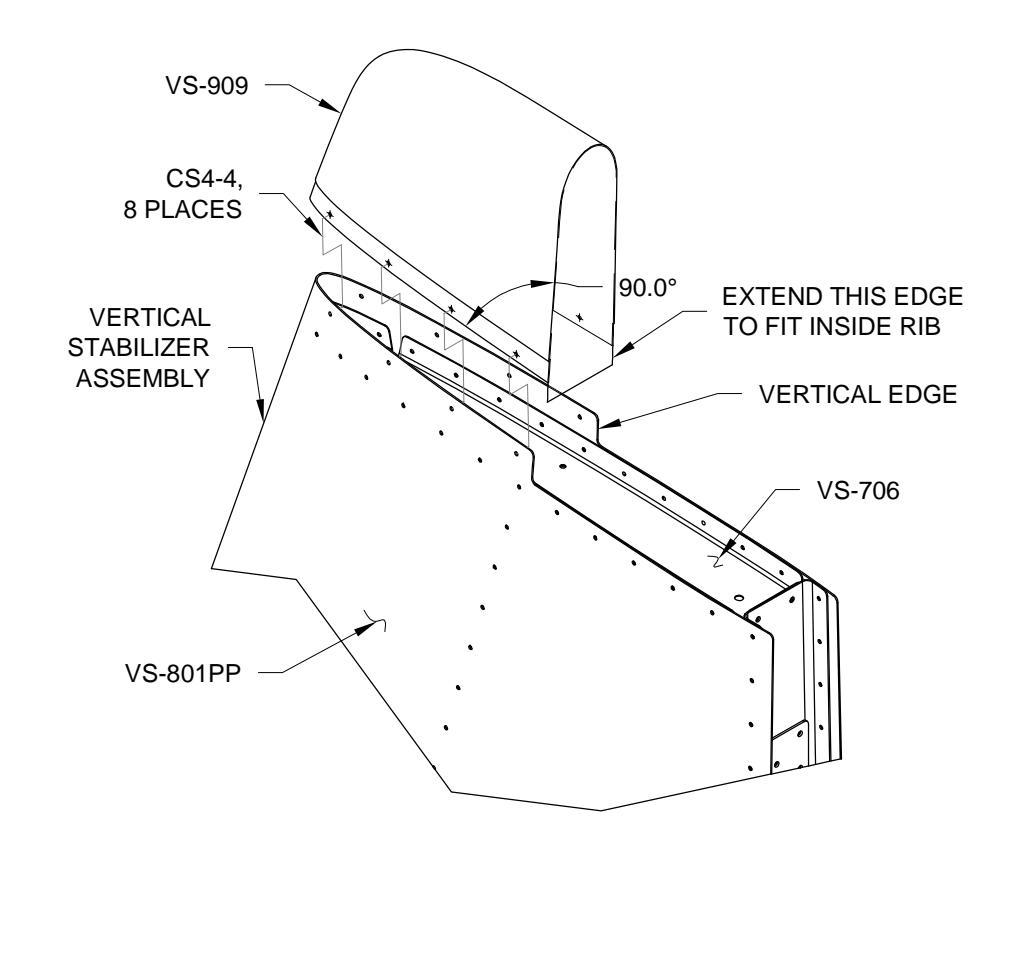
FIGURE 1: VERTICAL STABILIZER TIP FAIRING INSTALLATION

<u>Step 1:</u> Trim the width of the molded flange on the VS-909 Vertical Stabilizer Tip Fairing if required to meet the dimensions given on Page 12-02 Figure 1. Trim away the aft edge of the vertical stabilizer tip fairing so the aft edge is perpendicular to the bottom surface and flush with the vertical edge on the VS-801PP Skin as shown in Figure 1. This will provide a minimum 1/8 gap between the aft face of the vertical stabilizer tip fairing and the forward face of the rudder counterbalance arm.

<u>Step 5:</u> Rivet the VS-909 Vertical Stabilizer Tip Fairing to the Vertical Stabilizer Assembly using the hardware called out in Figure 1.

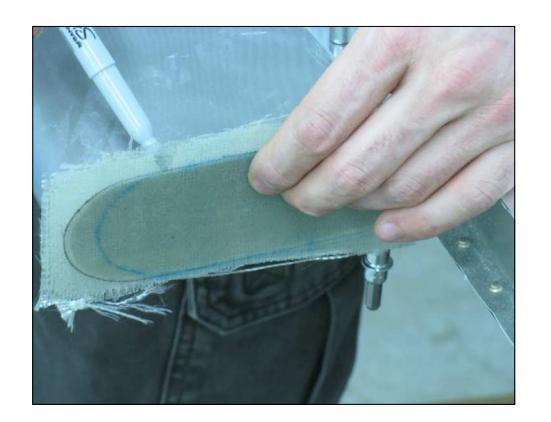
FIGURE 2: TRACE VERTICAL STABILIZER TIP FAIRING

<u>Step 3:</u> Close in the aft facing opening of the VS-909 Vertical Stabilizer Tip Fairing by fabricating a fiberglass patch. Lay up two layers of glass fabric on a sheet of aluminum scrap material which has been coated with wax. Note that the patch needs to be longer than the opening in the vertical stabilizer tip fairing to allow for gap between fairing and VS-706 Tip Rib.

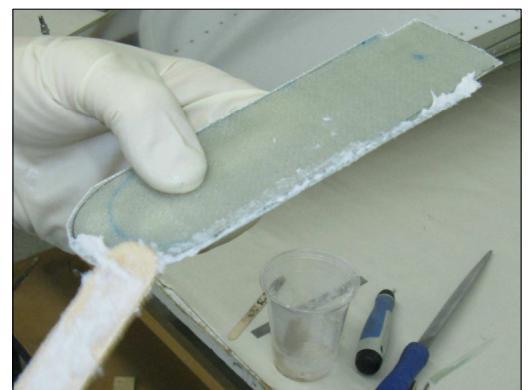
# FIGURE 3: TRIMMED FAIRING PATCH MATERIAL

Trace, trim and attach the patch to the aft edge of the vertical stabilizer tip fairing using the same technique described Page 12-06 Steps 4-7 for the HS-910 Horizontal Stabilizer Tip Fairing. See Figures 2, 3 and 4 this page.

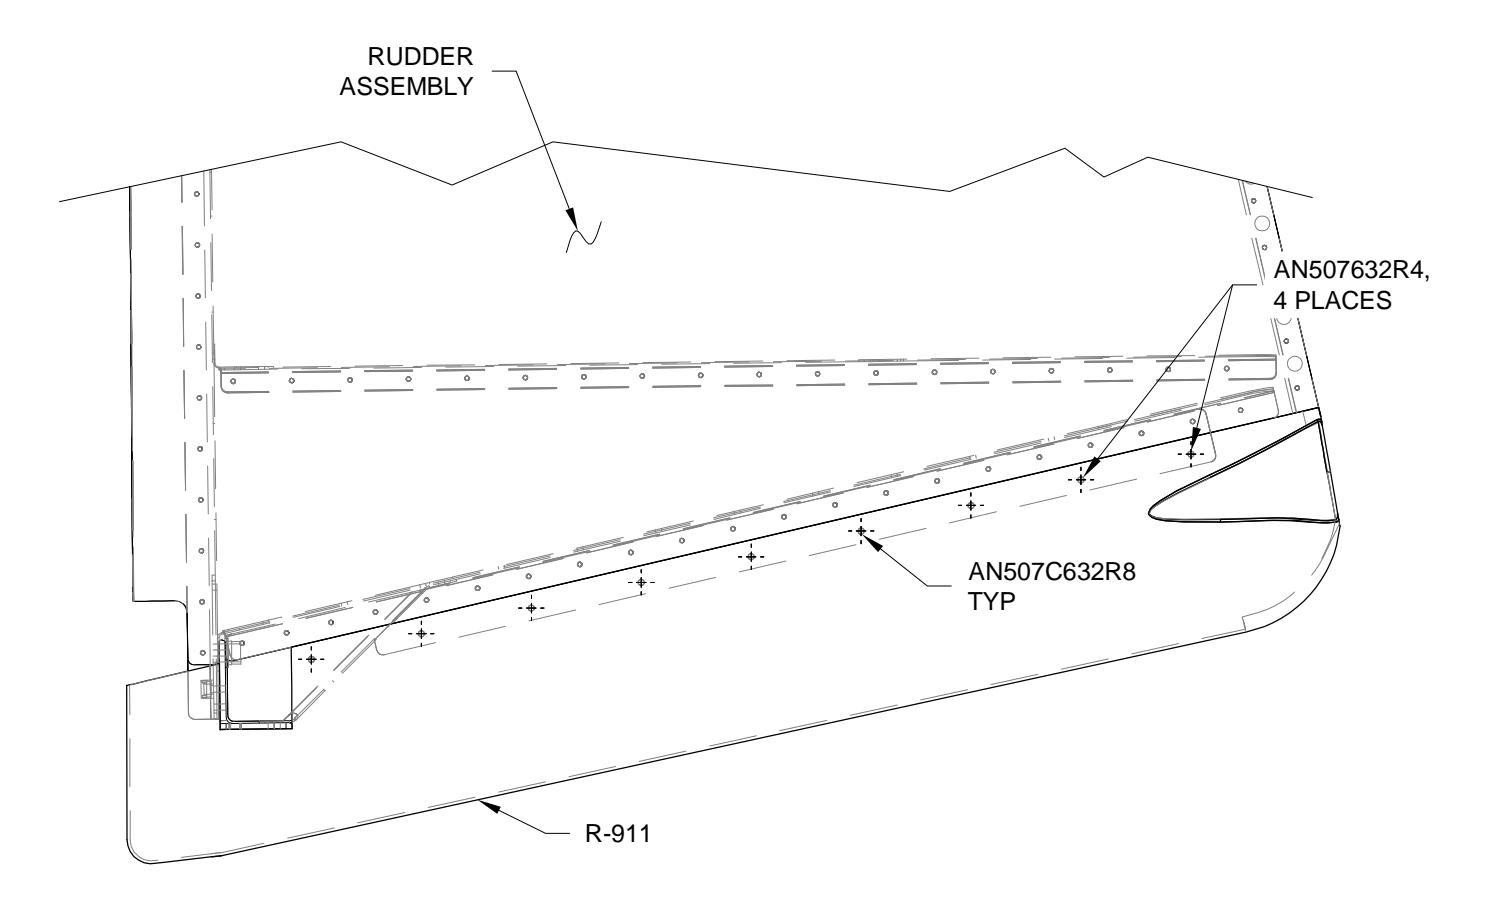
FIGURE 5: MATCH-DRILLING RUDDER BOTTOM FAIRING

Step 6: Attach the R-911 Rudder Bottom Fairing to the Rudder Assembly using the hardware called out in Figure 5.

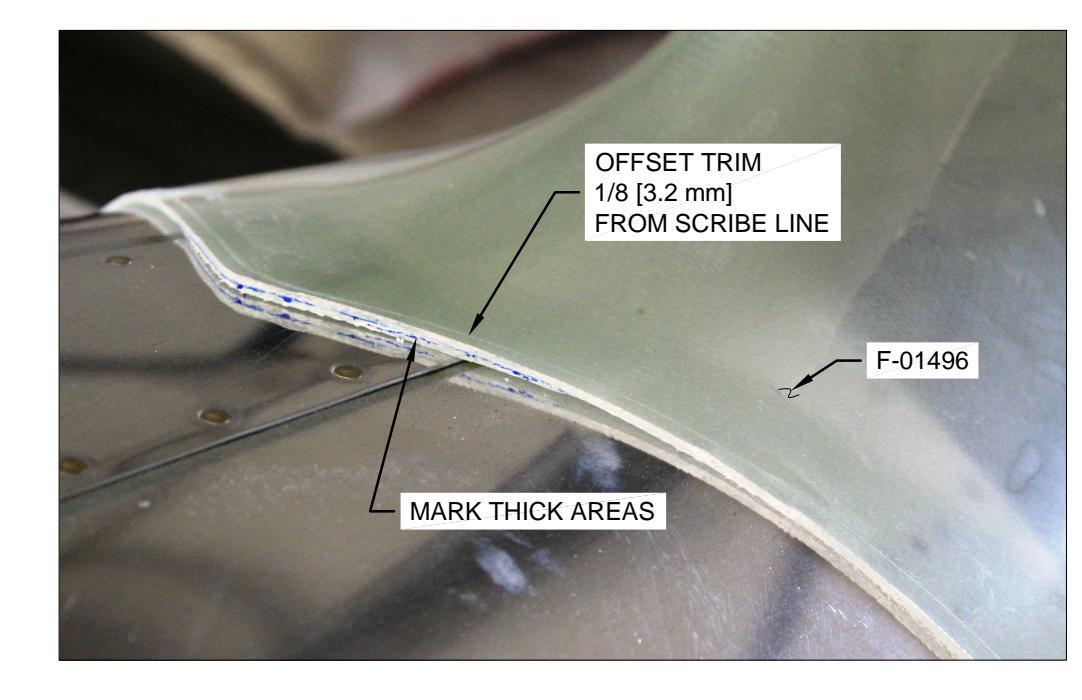
FIGURE 1: EMPENNAGE FAIRING TRIM

Step 1: Trim the F-01496 Empennage Fairing to 1/8 [3.2 mm] outside of the scribe line as shown in Figure 1.

Mark the fairing and sand to remove any thick spots. See Figure 1.

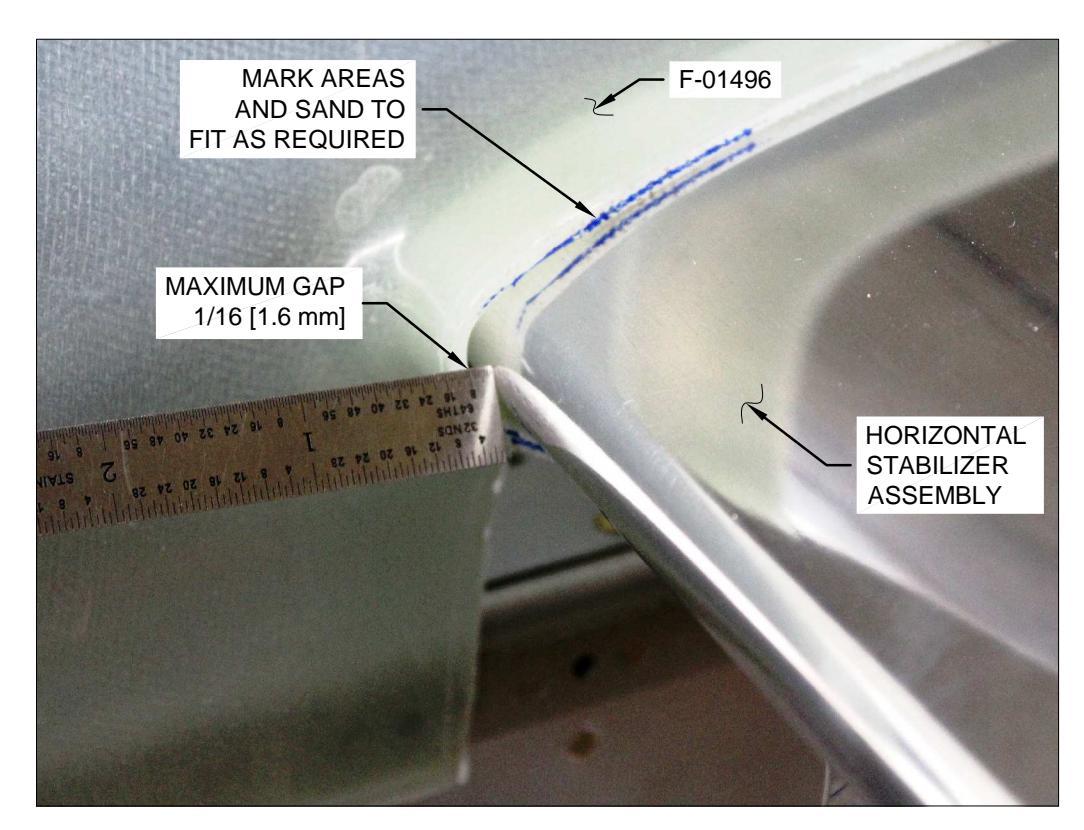
FIGURE 2: EMPENNAGE FAIRING PLACEMENT

Step 4: Hold fairing in position and check the empennage fairing fit to the leading edges of the Horizontal and Vertical Stabilizer Assemblies as shown in Figure 2.

It is acceptable to trim to or beyond the scribe line as required to allow the fairing to move aft into alignment with the Horizontal Stabilizer Assembly as shown in Figure 2.

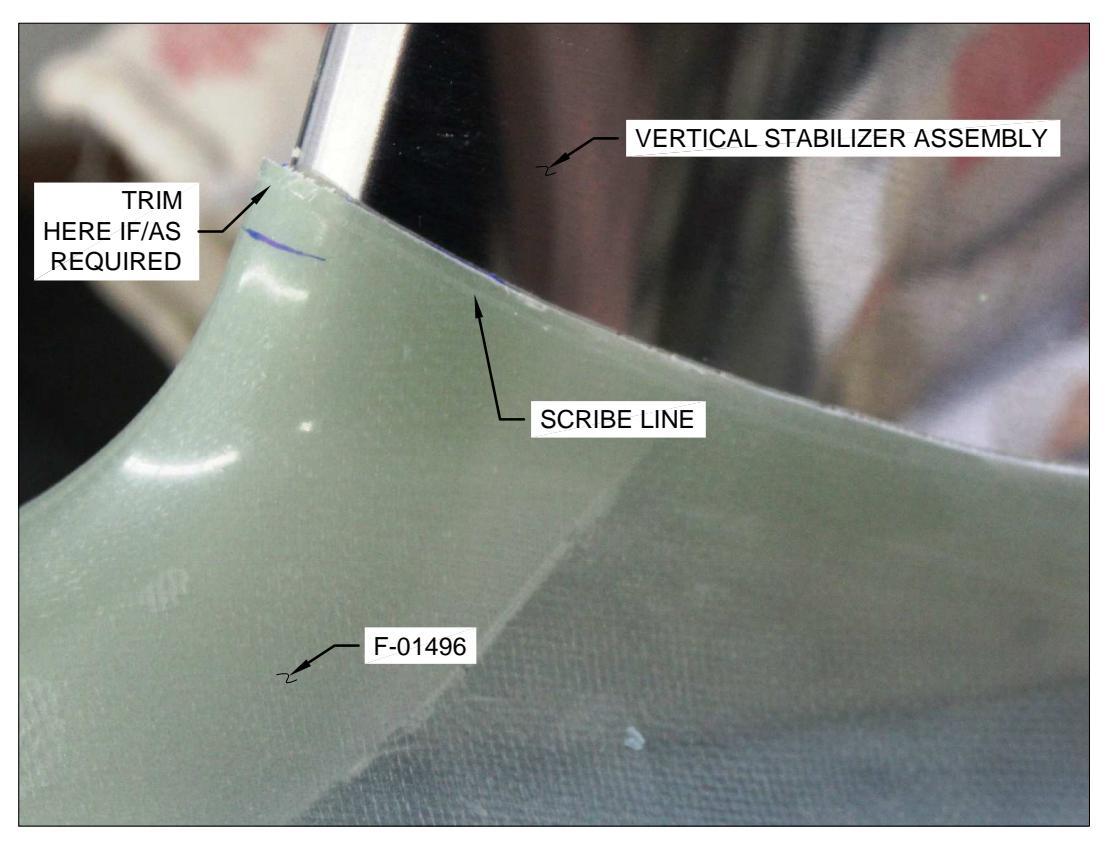
# FIGURE 3: EMPENNAGE FAIRING AT VERTICAL STABILIZER

Step 5: If there is a gap between the Horizontal Stabilizer Assembly leading edge and the empennage fairing that is more than 1/16 [1.6 mm] when the Vertical Stabilizer Assembly and fairing are in contact, trim the fairing at the contact point between the Vertical Stabilizer Assembly and the empennage fairing as shown in Figure 3.
