SERVICE BULLETIN 00041

Date Released:	December 30, 2021
Date Effective:	December 30, 2021
Subject:	HIC Module Strain Relief Inspection
Affected Models:	RV-12iS with Avionics Kits shipped before Sept. 2021
	SLSA RV-12iS aircraft: Serial Numbers 12075-12096
Required Action:	Inspect HIC module connections for intermittent electrical contact as described in this document. If intermittent contact is detected, install F-12334 and WH-00146.
Time of Compliance:	Inspect before further flight
	If no electrical contact issues are found: Re-inspect annually
	If electrical contact issues are found: Install F-12334 and WH-00146
Supersedes Notice:	N/A
Labor Required / SLSA Warranty Allowance: N/A	
Level of Certification:	SLSA: LSA Repairman Maintenance or A&P ELSA: Owner (certification not required) Check the rules of the local controlling authority/agency and the operating limitations for your aircraft.

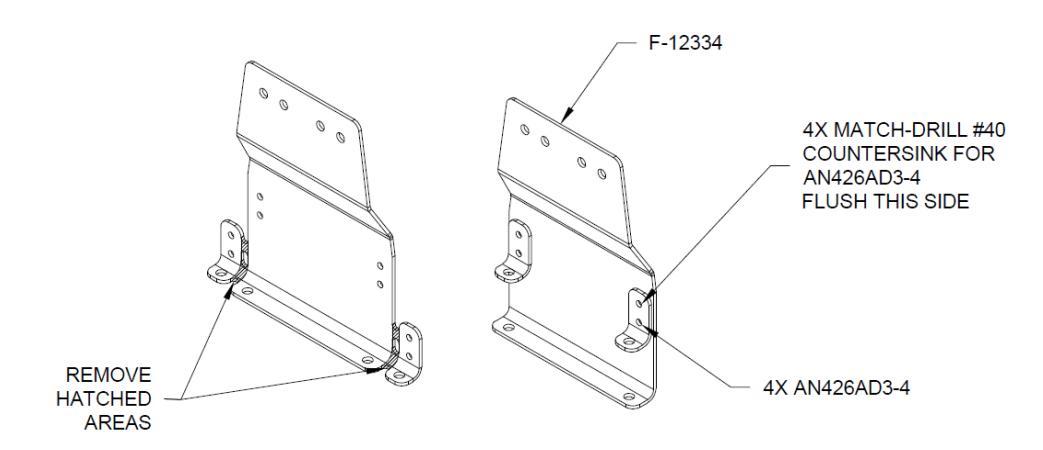
FIGURE 1: F-12334 STRAIN RELIEF PREPARATION

Intermittent and low fuel pressure readings have been reported in a small number of RV-12iS aircraft due to potentially loose contacts in the 8-pin Molex connector that attaches to the AV-60009 HIC Module. Complying with this service bulletin ensures that aircraft equipped with potentially affected parts are operating as intended.

<u>Step 5:</u> Prepare the F-12334 Strain Relief by removing the upper tabs and riveting them to the F-12334 as shown using rivets called out in Figure 1. Adhere MS21266-1N Grommet Strip to the top of F-12334 using RTV as shown in Figure 4.
