VAN'S AIRCRAFT, INC.

Service Bulletin

SB 07-2-6

Applies to: All two place RV's with dual control sticks.

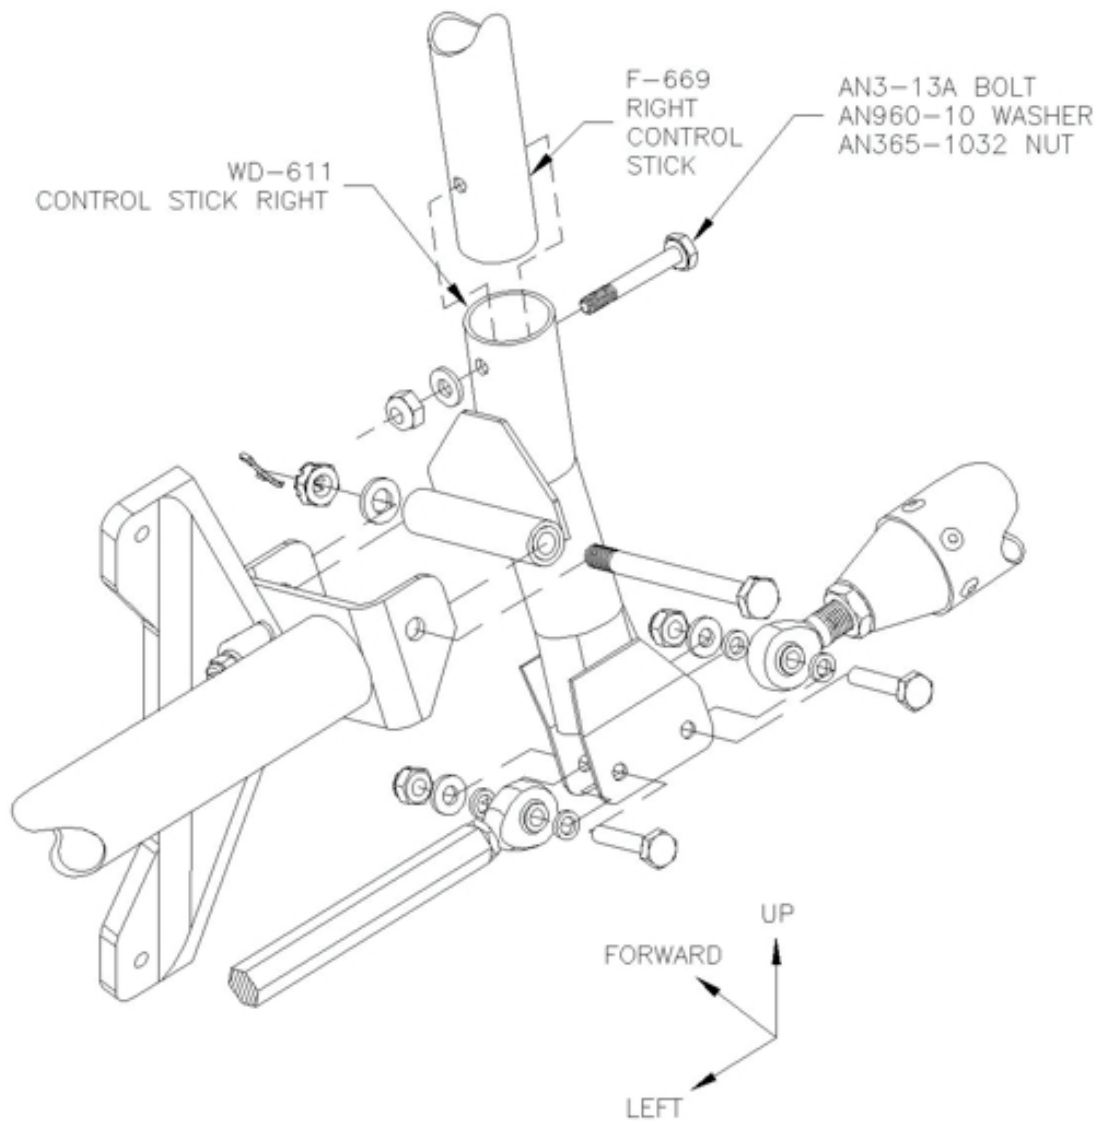
Synopsis: An incident was reported in which a side-by-side RV aircraft was involved in a hard landing after the passenger side control stick was inadvertently pulled from it's receptacle during the landing flare. The aircraft was being operated from the right seat at the time of the incident.

Recommended Inspection: To insure that the passenger stick is properly secured to the control column, gain visual access to the lower end of the control stick and determine if the stick is secured in the socket as described below. If the stick is secured, no action is necessary. If the stick is not secured, accomplish the following:

Recommended action: (Applicable to all passenger control sticks on two place RV models unless already accomplished): With the stick fully inserted in the socket, drill a 3/16" or #12 hole in the passenger stick socket and control stick 0.5" below the top edge of the socket. Secure the stick to the socket with an AN3-13A bolt, AN960-10 washer and AN365-1032 nut. (See drawing)
